LANDSLIDE INVESTIGATION 1106

May 7, 2012

**SUBJECT: GEOTECHNICAL INVESTIGATION FOR LANDSLIDE STABILIZATION,
2636 SW BERTHA BOULEVARD, PORTLAND, OREGON**

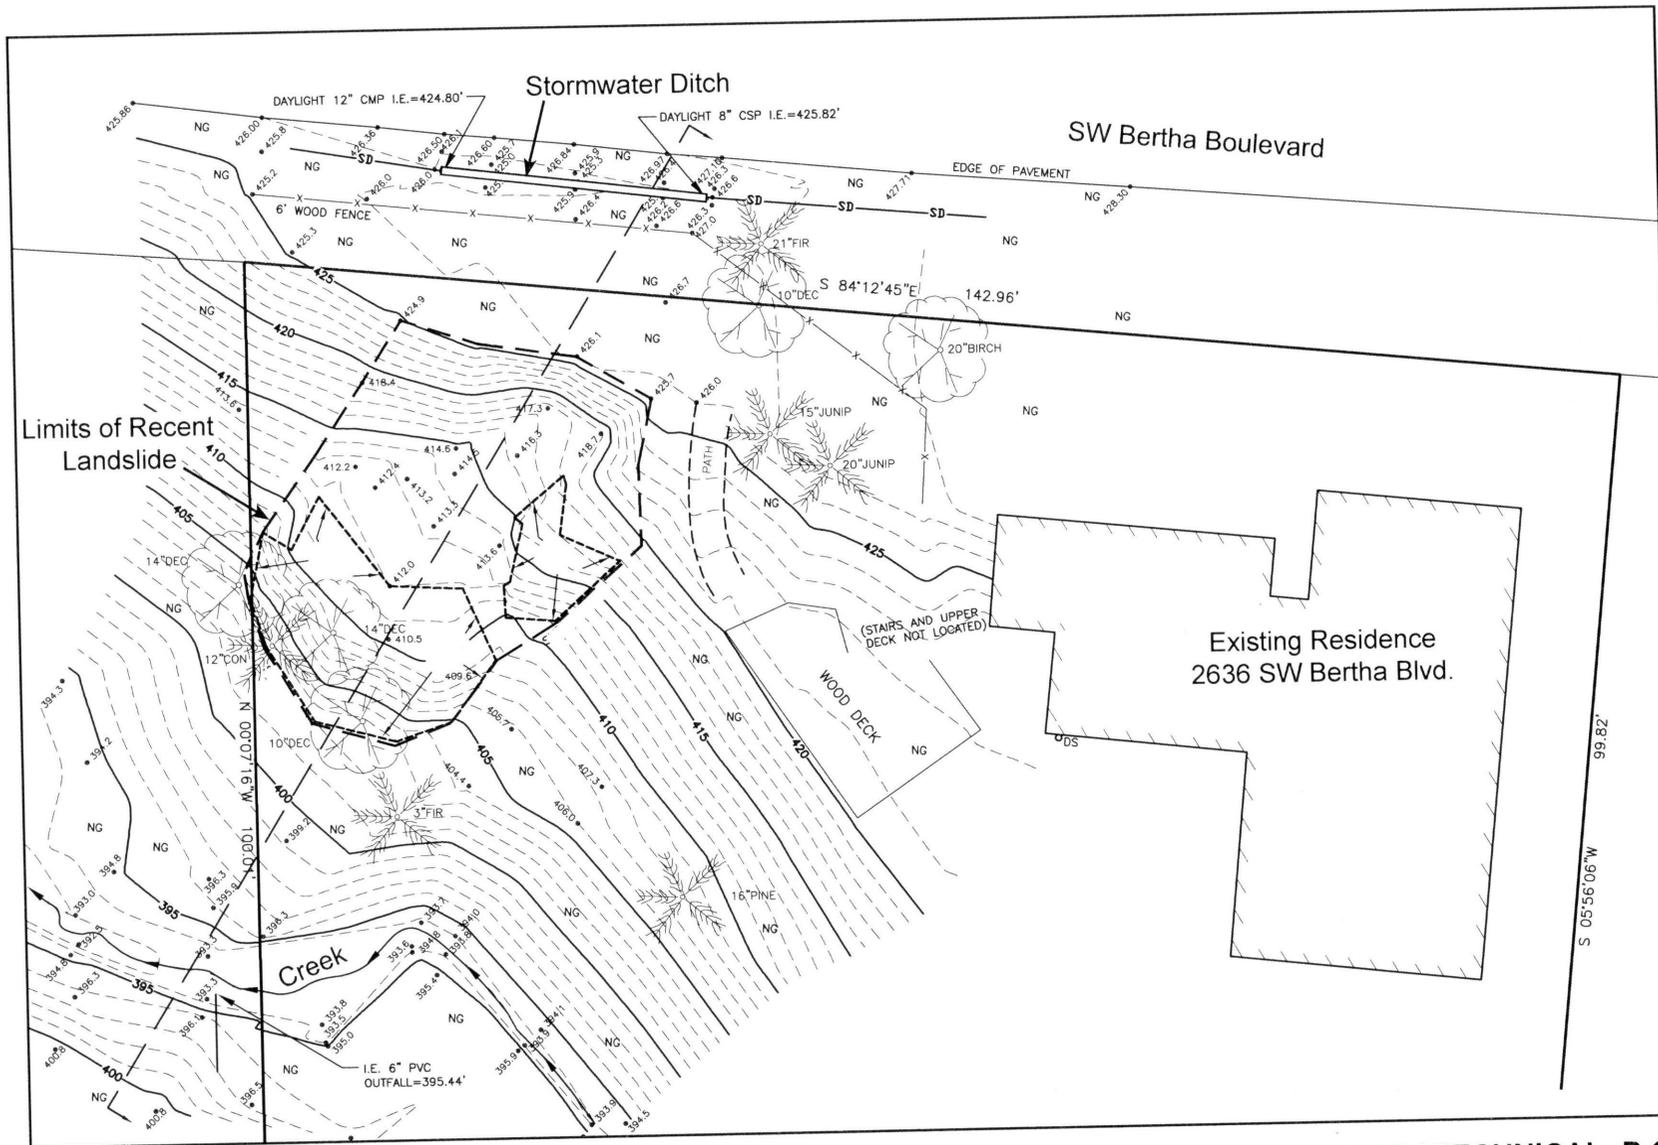
May 2012 Job No. 1106 Fig. 1

The Site Plan, Figure 1, shows the layout of the subject property and the limits of the subject (recent) landslide. The Landslide Plan, Figure 2, shows an expanded view of the landslide and many of the other features discussed in this report.

The location and approximate to-scale dimensions of the previously mentioned stormwater ditch, as surveyed on April 5, 2012 (about 3 weeks after the landslide and after you had excavated out the ditch), are shown on Figures 1 and 2. The approximate 28-ft-long ditch is about 15 to 20 ft north of the subject landslide and extends between the daylighted ends of buried stormwater pipes, the inverts of which are about 1 ft below the surrounding grade. On March 16, 2012, you observed that the ditch was almost completely filled/clogged with silty sediment and vegetation. The weather was fair on that date, and the small stream of water (estimated by you at about 10 gpm) exiting the upstream (eastern) pipe was ponding just downstream of the outfall. Only a small percentage of the water flowing from the upstream pipe was entering the downstream pipe. Most of the stormwater appeared to you to be seeping into the ground and migrating southward/downslope towards the subject landslide. As you began hand-excavating an approximate 1-ft-wide by 1-ft-deep (essentially vertical sided) channel along the ditch line, you observed water flowing rapidly back into the open ditch from its south side. When you completed the ditch excavation/clearing (removing what you estimate to be about 0.5-yd³ of soil along with weeds and grass), the ditch began to flow freely without any ponding water. We have reviewed photographs and videotapes you took on that date, which appear to confirm/document your above-described observations. Based on your observations at the property and your work clearing the stormwater ditch, you believe that sediment and vegetation present in the ditch at the time of the slide impeded stormwater flow in the ditch, resulting in the general redirection of the stormwater towards the landslide area instead of the downstream stormwater pipe, which caused excessive soil saturation in the landslide area, which in turn caused the landslide.

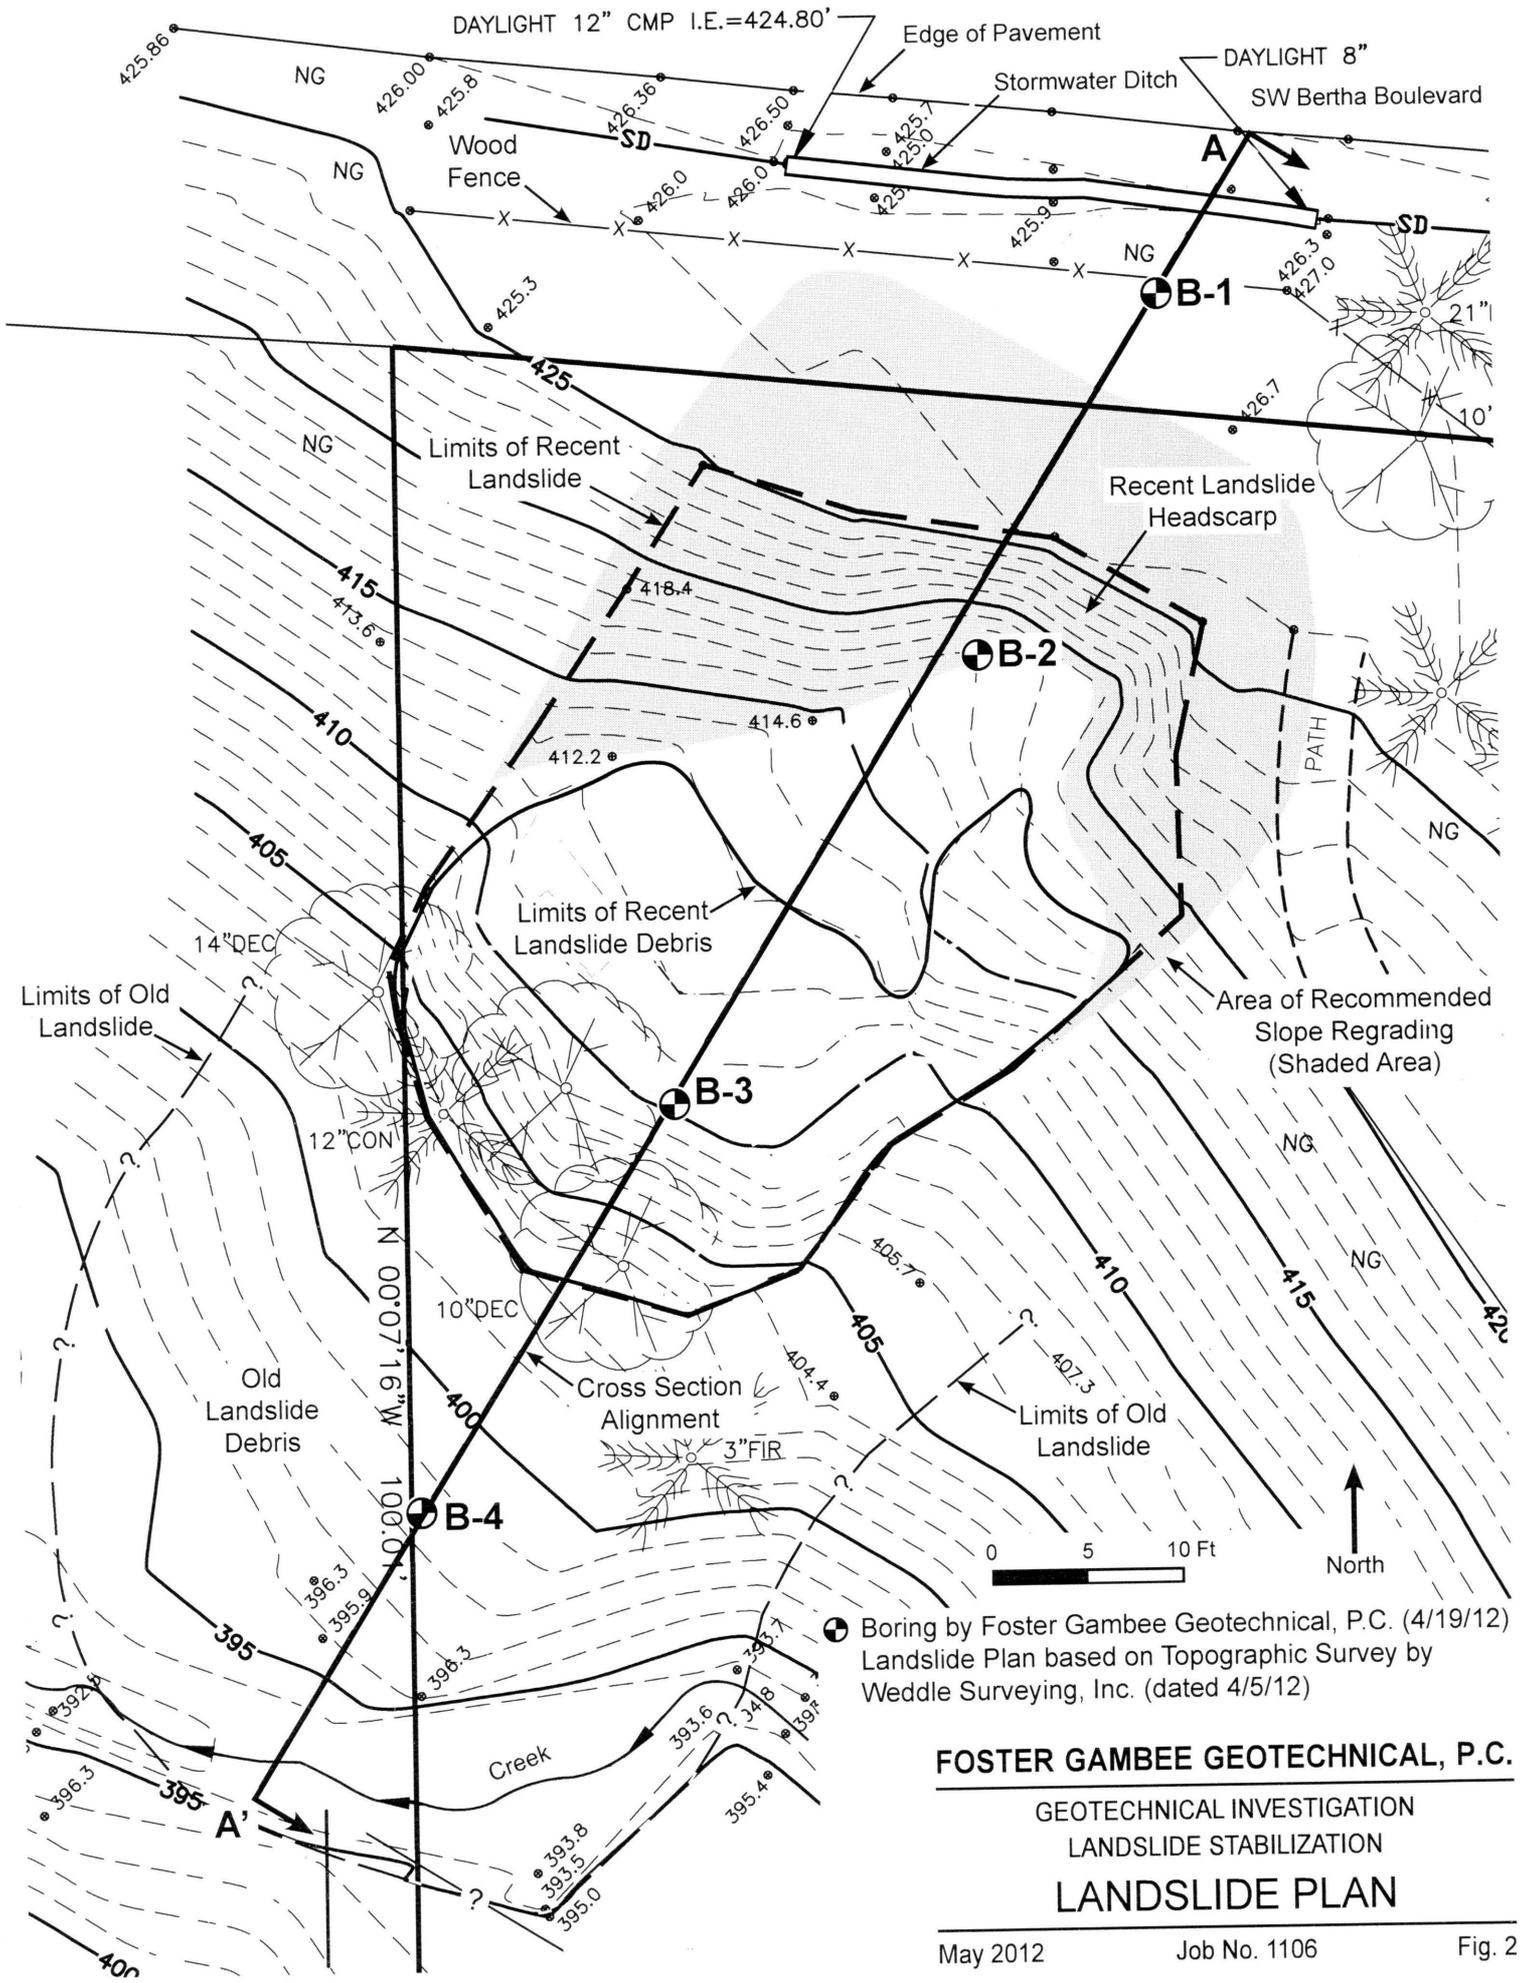
FOSTER GAMBEE GEOTECHNICAL, P.C.
 GEOTECHNICAL INVESTIGATION
 LANDSLIDE STABILIZATION
LANDSLIDE PLAN

- The landslide measures about 30-ft-wide and 50-ft-long (plan view dimensions). The landslide's approximate 10-ft-high, very steep (50 to 70°, locally near-vertical) headscarp is located 5 to 10 ft inside (south of) the northern property line (which is also the south edge of the Bertha Boulevard right-of-way), and about 20 ft south of the south edge of the SW Bertha Boulevard pavement. The landslide has no prominent lateral scarps. The middle portion of the landslide is an essentially unvegetated scour zone. The toe of the landslide consists primarily of a low (less than 5-ft-high/thick) mound of landslide debris.

Subsurface conditions in the vicinity of the landslide were explored on April 19, 2012 with four hand-auger borings, designated B-1 through B-4 and drilled to depths of 5.2 to 6.0 ft. Approximate locations of the borings are shown on Figure 2. The relative consistency/hardness of subsurface materials was evaluated by observing auger cuttings and noting the relative ease of auger advancement. Detailed logs of conditions and materials encountered in the borings were maintained. Representative soil samples were obtained for further examination in our laboratory, where their physical characteristics were noted and field classifications modified where necessary. The natural moisture content of each soil sample was determined in our laboratory in substantial conformance with ASTM D 2216. Materials and conditions encountered in the borings are summarized in Table 1 and on Figure 3. Terms used to describe soils are defined in Table 2.

The regrading work should at a minimum consist of flattening the headscarp (the approximate upper 10 ft or so of the slope) to no steeper than 2H:1V (27°) or as flat as practical to gradually transition the regraded slopes to existing, steeper drainage slopes lateral to the landslide headscarp. The approximate limits of the recommended headscarp regrading are shown on Figures 2 and 3. The slope regrading work will require the removal or realignment of an existing landscape path just east of the landslide headscarp. Due to slope stability considerations, we recommend the offsite disposal of all excavation spoils resulting from slope regrading. Disturbance and the removal of vegetation should be minimized in areas outside of the slope regrading area. Prior to the start of slope regrading, the regrading contractor should locate underground utilities in the regrading area and address related conflicts.

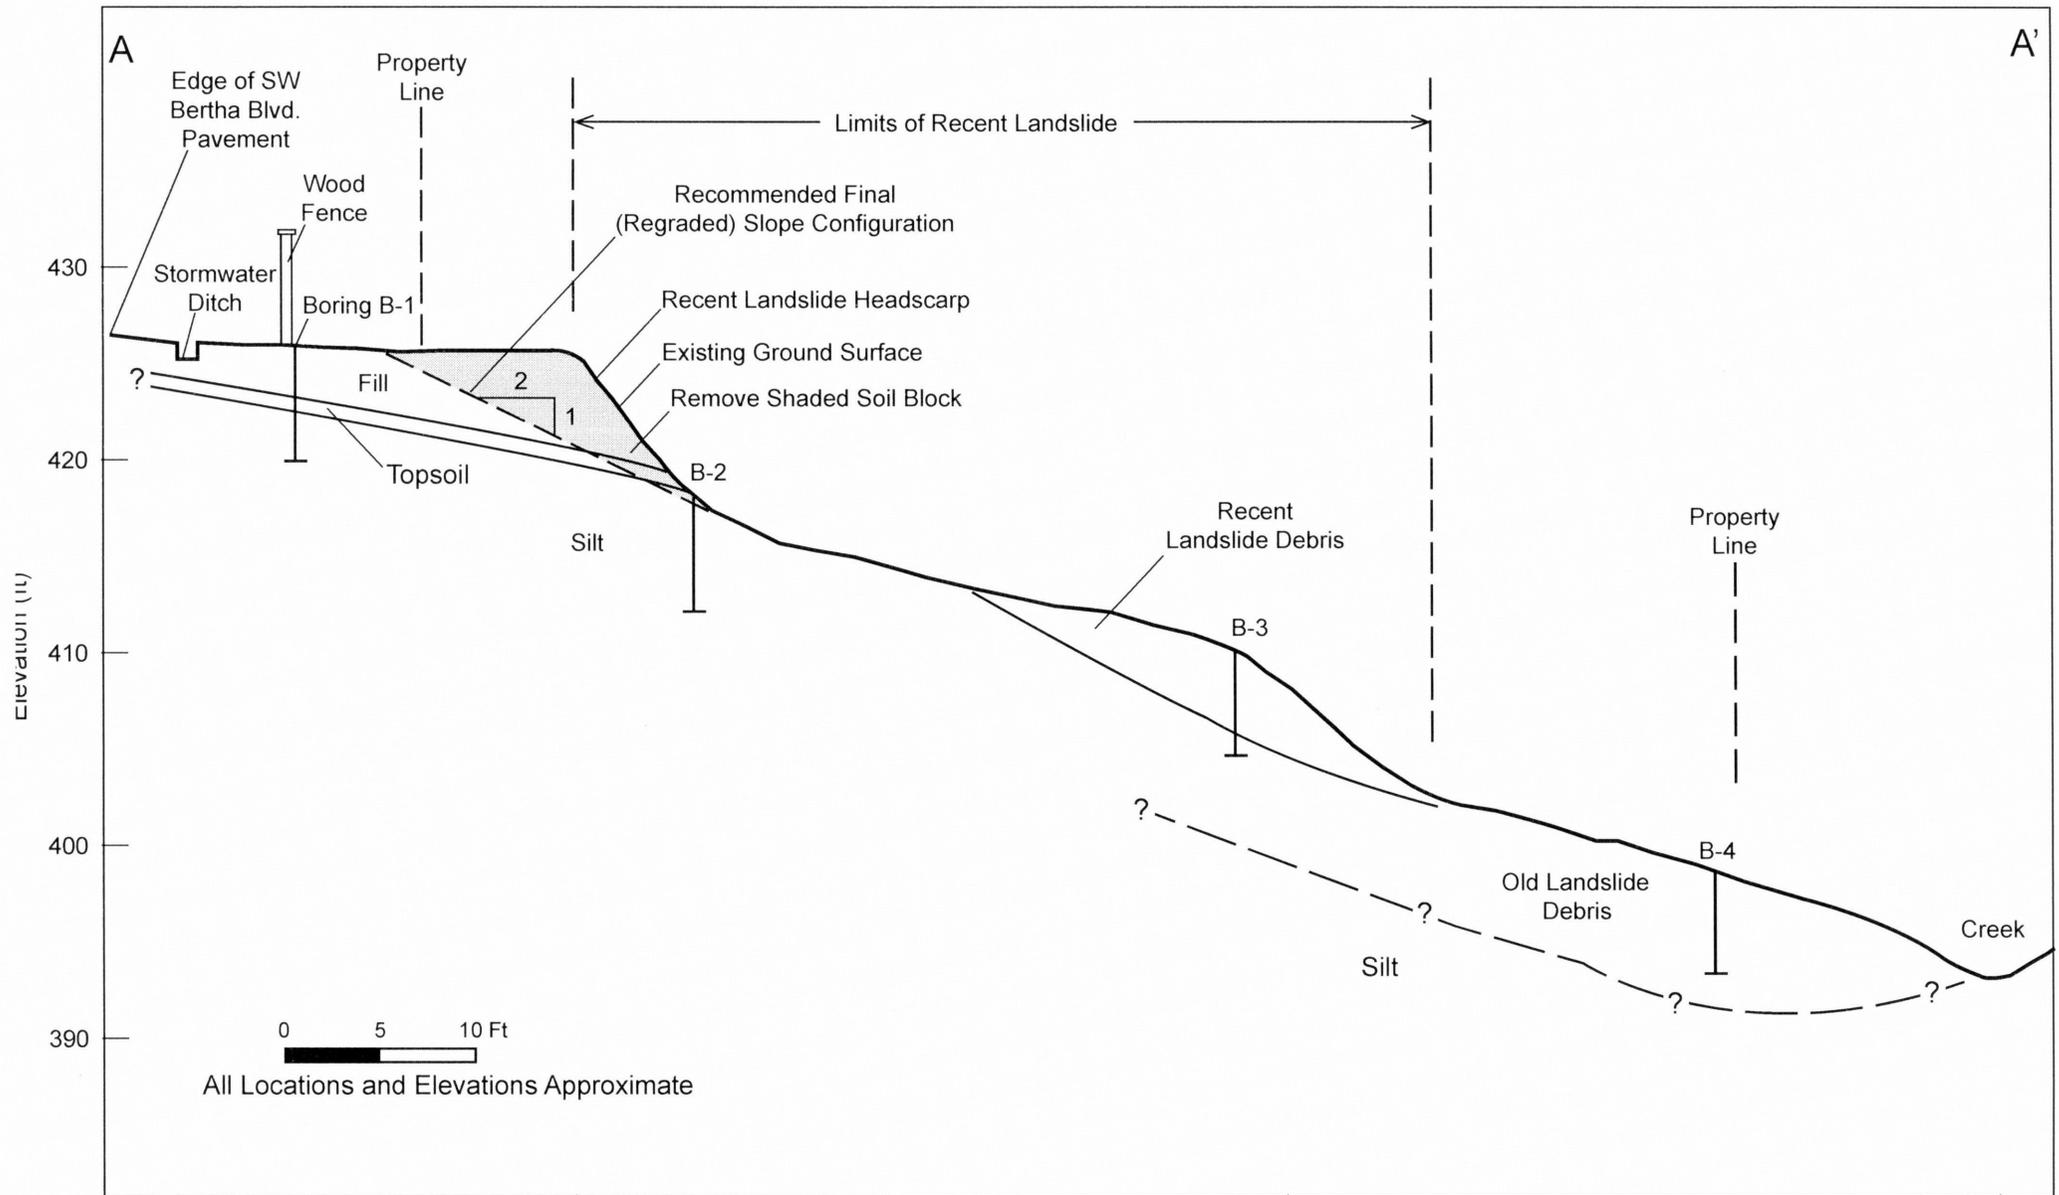
CROSS SECTION A-A'

- As shown on Figures 1 and 2, the property is located on the northeast side of a drainage that is a tributary to Fanno Creek. Cross Section A-A', Figure 3, shows a ground surface profile of the drainage slope in the area of the subject landslide. The overall drainage slope measures roughly 2H:1V (27°), but the slope is irregular with local flatter and steeper areas. Based on local topography and surface exposures, the natural drainage slope in the slide area is blanketed by several ft of fill that is part of a large embankment that was placed in the drainage to provide a crossing for SW Bertha Boulevard.

As disclosed by the subsurface explorations made as part of this investigation and as shown on Figure 3, several ft of fill material comprised primarily of silt mantle the landslide headscarp area and areas immediately upslope of the headscarp. The thickness of the fill decreases towards the northern property line/street right-of-way. Based on materials exposed in the headscarp, local topography, and our experience, it appears the fill also mantled most of the upper landslide area, but the slide removed and transported the fill downslope to form the low mound of debris at the toe of the landslide. As discussed in the Surface Conditions section of this report, fill exposed in the landslide headscarp consists primarily of soft to medium stiff, brown and gray-brown silt, and a shallow layer of similar fill was encountered in boring B-1.
