SFA Design Group, LLC
STRUCTURAL | CIVIL | LAND USE PLANNING | SURVEYING
9020 SW Washington Square Dr., Suite 505
Portland, Oregon 97223
P: (503) 641-8311 F: (503) 643-7905
www.sfadg.com

September 5, 2013

RE: Geotechnical Investigation Report, Proposed Foundation Underpinning
Macomber Residence
44 NW Macleay Blvd
Portland, OR 97210

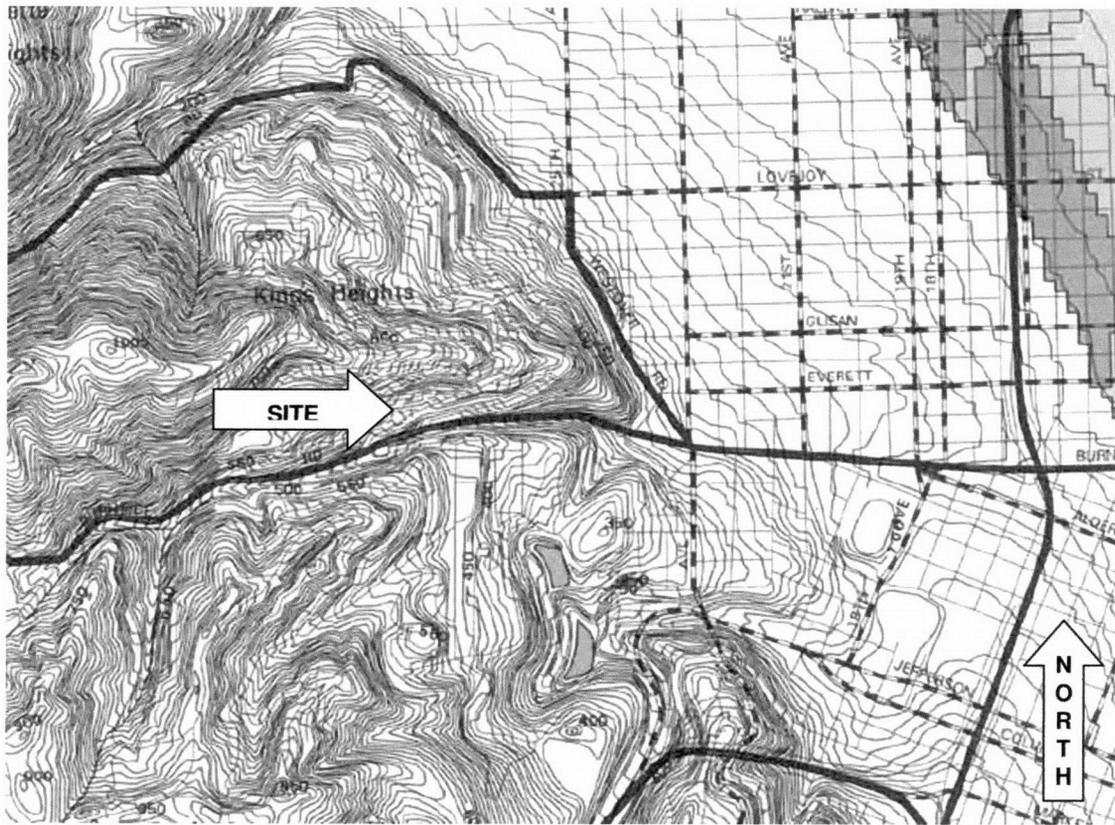
| | | <p>FIGURE-C</p> |

Indications of shallow groundwater were not encountered during the site specific explorations or research, thus the subject site is not located within an area having a potential for earthquake induced liquefaction, differential seismic settlement, or surface displacement due to lateral spreading. (Figure-C)

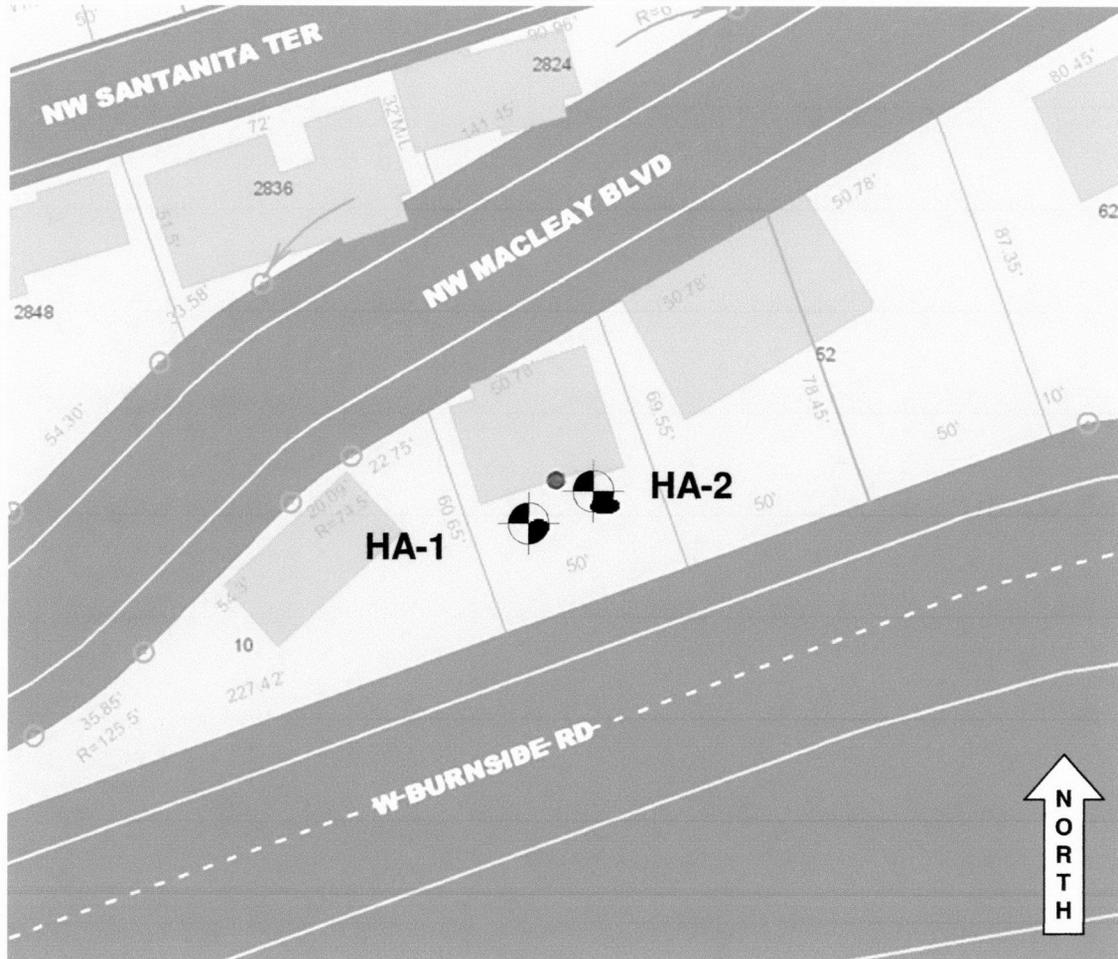
| | | Appendix-A |

On June 27, 2013 SFA conducted a field exploration at the above referenced property. The exploration involved (1) hand auger boring performed with a 3" diameter auger adjacent to the southern foundation perimeter of the residence. The hand auger borings (HA-1 and HA-2) extended to a depth of approximately 7'-0" below existing grade. Representative soil samples provided by the borings were logged and reviewed. The approximate locations of the boring(s) are indicated on the enclosed Boring Location Map (Appendix-A) and the depths and types of soil samples recovered are indicated on the borehole log (Appendix-B1 and B2). Subsequent to drilling all borings were backfilled with excavated soils.
