# Building Permit Application

Suite/bldg./apt. no.: Project name: **OUTFALL 10**

**STABILIZE EXISTING SANITARY SEWER OUTFALL  
INSTALL NATIVE PLANTS AND DRAINAGE  
CHANNEL IMPROVEMENTS**

**Project/Subject: Lewis & Clark College – Annual Outfall Monitoring Work Plan  
Outfall 10 Sewer Pipe Crossing**

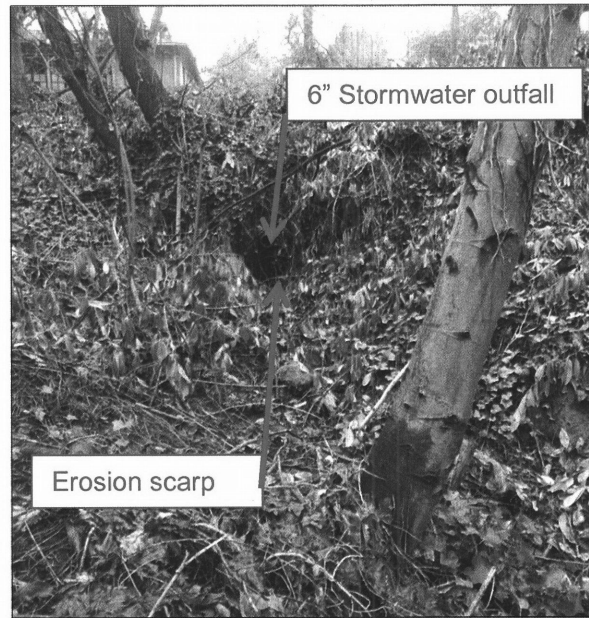
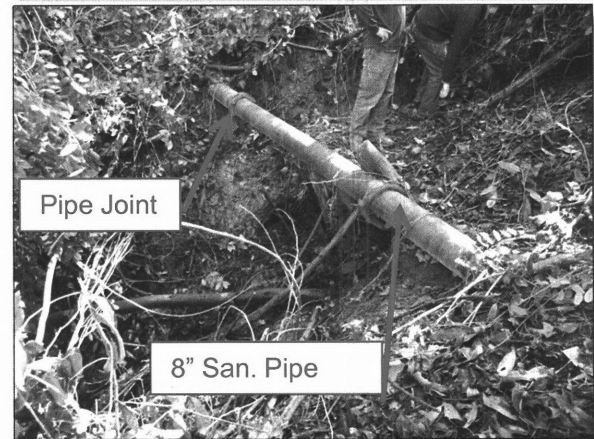
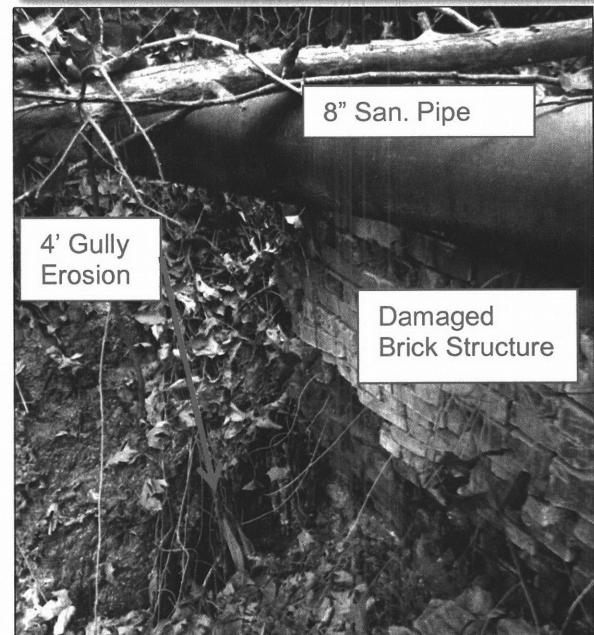
A six (6) inch diameter vitrified clay storm outfall is located below the Pool House and is located at the head of the drainage channel. There is an approximate 1.5 feet deep erosion scarp located immediately below the outfall, indicating gully erosion in the drainage channel. The drainage channel is not mapped in the E-Zone (C or P). Approximately 110 feet downslope of the six (6) inch storm outfall in the channel is the 8" steel sanitary sewer pipe crossing the drainage channel. It is not located in the E-Zone (C or P). The sanitary sewer outfall is minimally supported on a brick structure in the center of the drainage. It has an exposed support on the east side and no support was observed on the west side of the crossing. This sewer pipe serves much of the southern and eastern portion of the campus and ties into the public sanitary sewer to the east and off campus. The gully erosion is approximately four (4) feet deep at the sewer crossing with over-steepened side slopes approaching vertical. Vegetation has been undermined and fallen into the channel. The area outside of the channel is generally wooded with steep slopes. The channel slope gradient is approximately 32%.

No as-built sanitary sewer plans or documents were found to document the design of the pipe and brick support structure. It is not known whether the pipe was designed to span the drainage channel, or if the brick pier was embedded in the channel and has been exposed due to the ongoing gully erosion. The pipe may have buried prior to the erosion. Gully erosion usually occurs at a relatively fast rate compared with deep seated slope instability. Gully erosion reflects an eroded channel bed, over-steepened slopes, and adjacent vegetation falling into the channel. Slope movement occurs much slower and trees with "S" shapes in their trunks are often field indicators.

The gully erosion will continue to advance upslope toward the six (6) inch storm outfall without mitigation. Gully erosion typically erodes deeper in a channel, collapsing the side banks until the side bank material fills the channel bottom. The gully advance could potentially undermine the sewer outfall further causing pipe

failure as the channel widens and the structural span length of the pipe is exceeded. This could cause a sewerage spill in the steep channel and cut off service to several campus buildings.

Structural support for the existing sewer pipe shall be provided through construction of a new cast-in-place continuous concrete beam immediately below the full length of the pipe which is then supported off of drilled concrete piers. Adequate concrete pier foundation depth embedment shall be determined per a geotechnical engineers recommendations in order to sufficiently support both vertical and any code required seismic loading. Please see sheets C-3 & C-4 for plan view and proposed preliminary elevation.

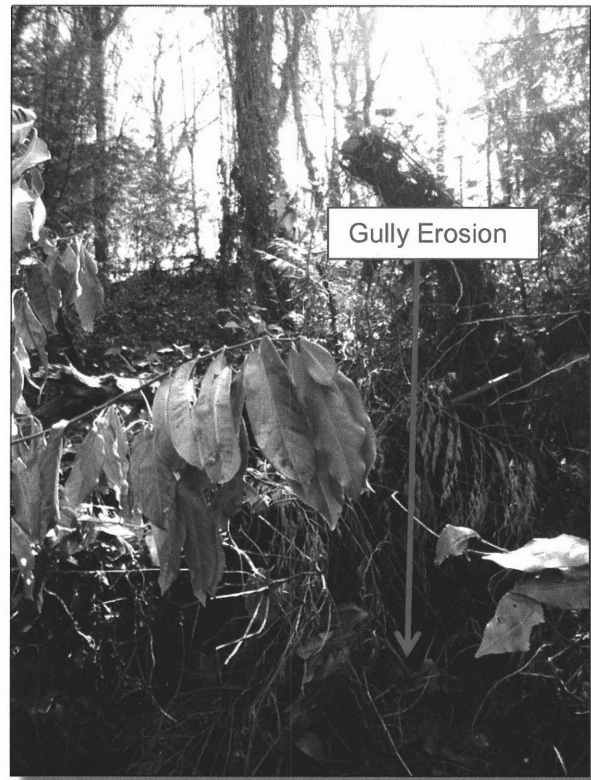
Stabilizing gully erosion generally requires energy dissipation measures at the outfall location, constructing a channel bed which minimizes infiltration of runoff and prevents subsurface flow, and installing grade control to arrest gully advancement/regrade and bed erosion. Decreasing side slope steepness is often employed to reduce further side slope erosion and to create a slope that allows for revegetation and bioengineering measures. Following are our proposed methods of arresting and mitigating the advancing gully erosion.

Energy Dissipation – An energy dissipater shall be constructed at the invert of the six (6) inch storm outfall. Minimal excavation will be employed and the subgrade will be compacted. A 12" thick sub base of 4" -0" aggregate will be placed and compacted. The compacted fines will reduce runoff infiltration and subsurface flow. The brick structure could be demolished and the bricks incorporated into the energy dissipater due to the difficult construction equipment access and the level of effort required to remove the bricks.

Channel Side Slopes – The side slopes will be scaled off and rounded to decrease erosion potential and to provide a slope suitable for revegetation and bioengineering methods. Removed soil material will be placed in the channel bed, if deemed suitable by the geotechnical engineer for compaction. It will be leveled to the bed form and compacted.

Channel Bed – Minimal excavation will be employed in the channel bed, primarily to move scaled material around and remove unstable soils. The soil will be placed, leveled and compacted in the channel bed to a smooth slope line. After installation of grade control boulders, a 15 – 18" thick layer of 4" -0" aggregate will be placed and compacted. A roughened channel mix will be installed, compacted, and watered in so that fines seal the bed armoring. The 4" -0" aggregate and roughened channel mix material should extend a minimum of one foot up the side slopes.

Grade Control – Grade control will consist of hard, angular and non-fractured boulders and be installed to an elevation 5 feet below the proposed finished grade of the channel bed. They will protrude above finished grade 3" to 6" to provide channel roughness and energy dissipation.
