**SUBJECT: PLAN REVIEW, GARAGE RENOVATION, ROSSLER RESIDENCE,
2505 SW HILLCREST DRIVE, PORTLAND, OREGON**

Foster Gambée Geotechnical, P.C., (Foster Gambée) has reviewed a copy of the project plans for the above-referenced garage renovation. The plans were prepared by Burry-Trice Architects and are undated. We understand a copy of the same plans was submitted to the City of Portland as part of a permit application on December 27, 2007. The project structural engineer is James G. Pierson Consulting Engineers, Inc.

SUBJECT: GEOTECHNICAL INVESTIGATION FOR GARAGE RENOVATION OR REPLACEMENT, ROSSLER RESIDENCE, 2505 SW HILLCREST DRIVE, PORTLAND, OREGON

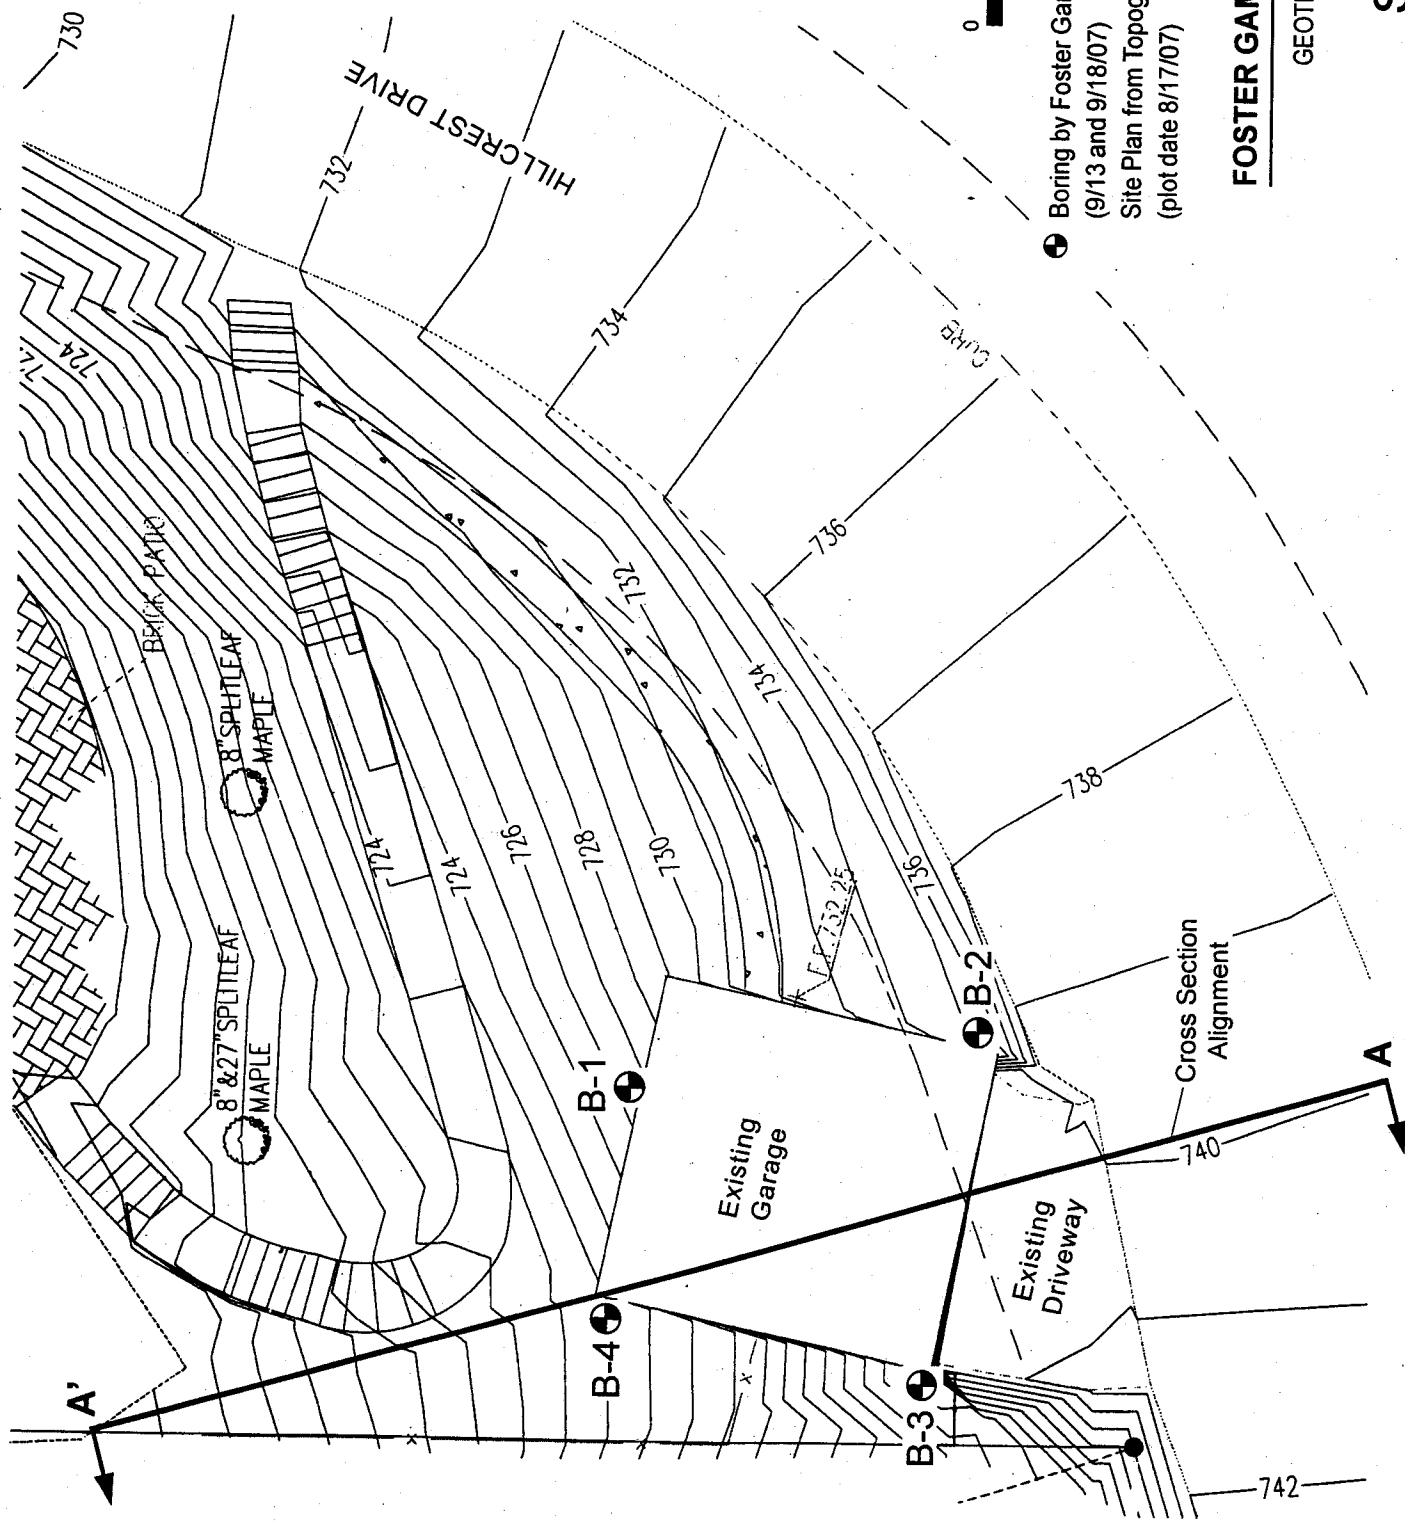
FOSTER GAMBEE GEOTECHNICAL, P.C.
GEOTECHNICAL INVESTIGATION
ROSSLER GARAGE
SITE PLAN

- The subject property is situated on a moderate to steep, north-facing hillside and is bordered by SW Hillcrest Drive to the north, south, and east. As shown by the topographic contours presented on Figure 1, the existing garage is located on the upslope (south) side of the site in an area of steeply sloping ground. Overall, the ground surface in the immediate garage area slopes down to the north at about 27° with areas of flatter and steeper ground present locally.

Subsurface conditions in the garage area were explored on September 13, and 18, 2007 with four hand-auger borings, designated B-1 through B-4 and drilled to depths of 6.2 to 11.5 ft. Approximate boring locations are shown on Figure 1. The relative consistency of subsurface materials was evaluated by observing auger cuttings and noting the relative ease of auger advancement. Detailed logs of conditions and materials encountered in the borings were maintained. Representative soil samples were obtained for further examination in our laboratory, where their physical characteristics were noted and field classifications modified where necessary. The natural moisture content of each soil sample was determined in our laboratory in substantial conformance with ASTM D 2216. Materials and conditions encountered in the borings are summarized in Table 1. Terms used to describe soil materials are defined in Table 2.

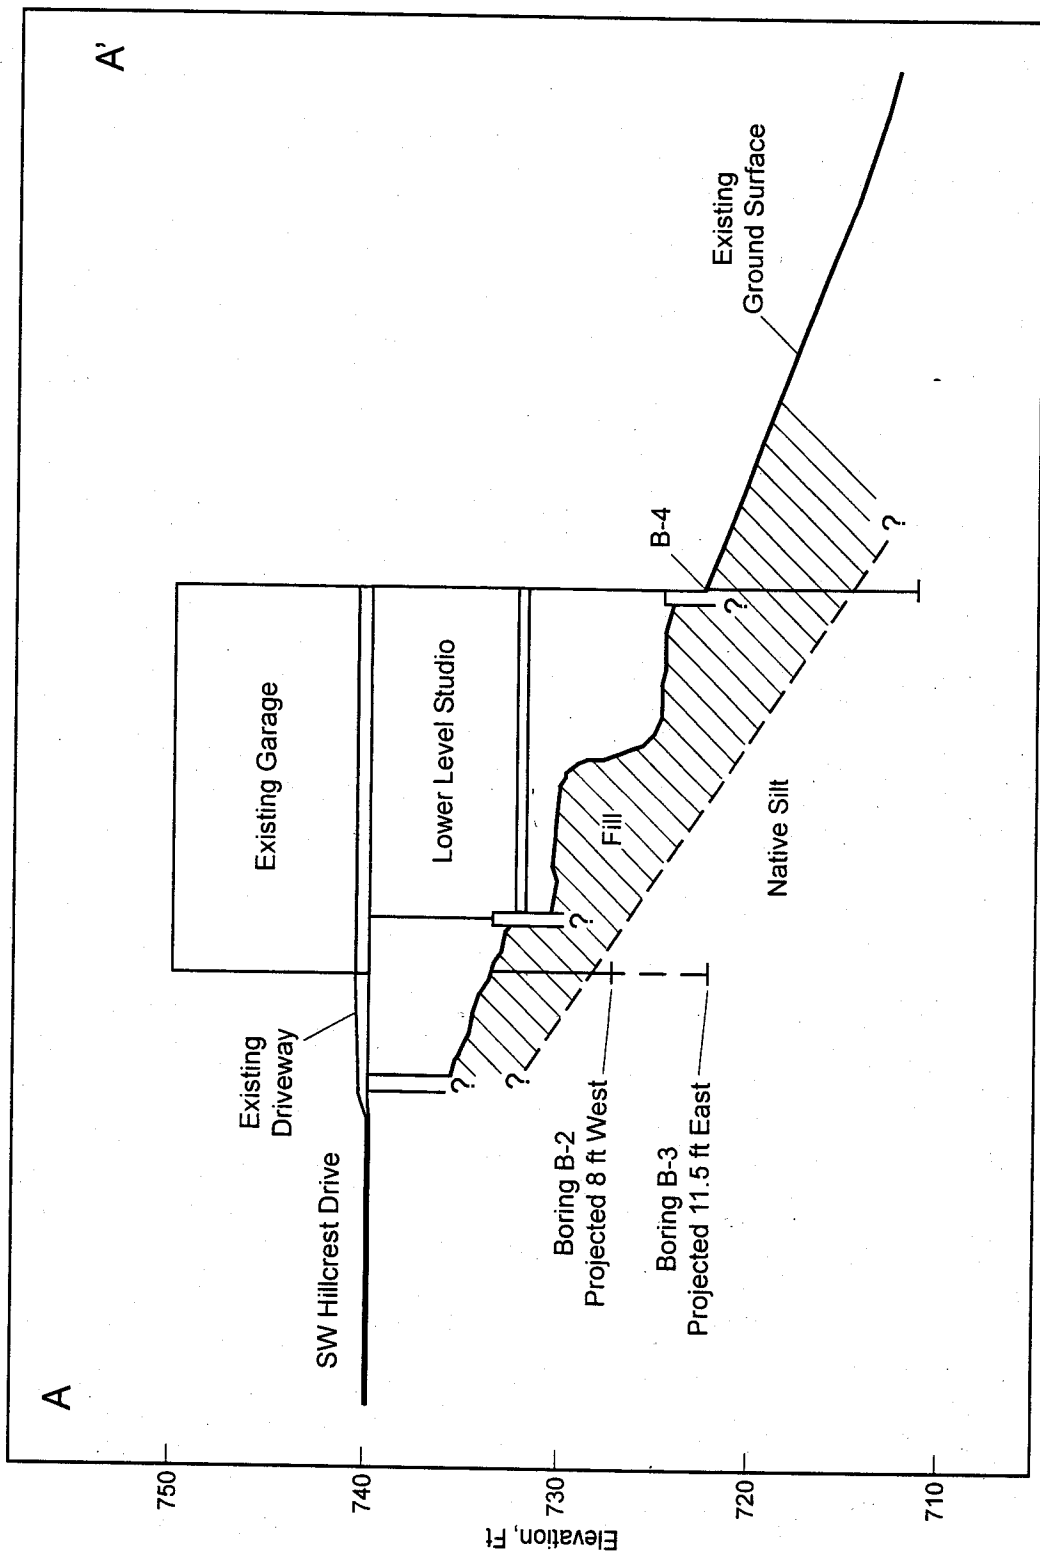
CROSS SECTION A-A'

- As depicted by Cross Section A-A', Figure 2, the existing two-story garage as well as the existing driveway are elevated over the steeply sloping ground surface. The garage has a dirt floor crawlspace and is supported by concrete pad and line foundations that appear to have limited embedment. An unretained, near-vertical cut up to about 5-ft-high is present within the crawlspace near the approximate midline of the garage.

As disclosed by the borings drilled as part of this investigation and as depicted on Figure 2, the garage area is mantled by fill soils ranging in thickness from 3.0 ft (borings B-1 and B-2) up to at least 7.5 ft and possibly 8.5 ft. The greater fill thicknesses were encountered on the west side of the garage. The fill is comprised primarily of silt with a trace to some clay and up to a trace of gravel. The fill contains scattered pieces of concrete, scattered organics, and is locally organic rich. The relative consistency of the fill is generally medium stiff, but locally soft. Based on its relative soft consistency and organic content, the fill does not appear to have been placed and compacted as structural fill. Natural moisture contents for the silt fill are in the range of 16 to 30%.
