Comments on Portland Building – LU 17-153413 HRM AD

5. *2013 FFA Architecture + Interiors Exterior Envelope Restoration Structure Improvements Assessment Phase 1*. FFA provided the City two repair options for the Portland Building.

FFA Architecture and Interiors was contracted by the City of Portland in September 2012 to provide a complete assessment of the existing exterior envelope condition. The project goal was to identify and quantify the scope of the ongoing problems with the exterior envelope.

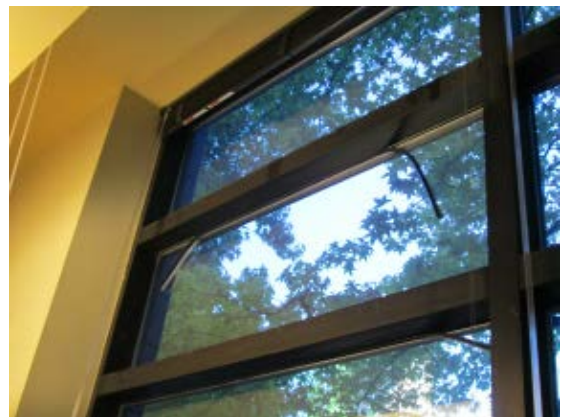
4. Interior Assessment Storefront SSF6

5. Interior Assessment Storefront SSF6 Close-up (note: failed glass gaskets)

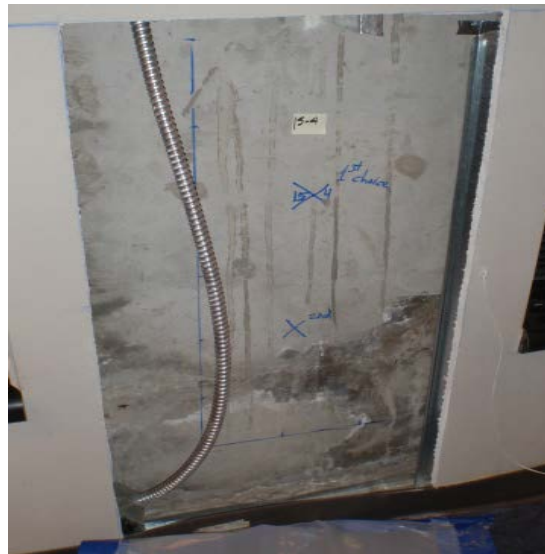
7. Test Site 4-10 Observation complete and wall repaired.

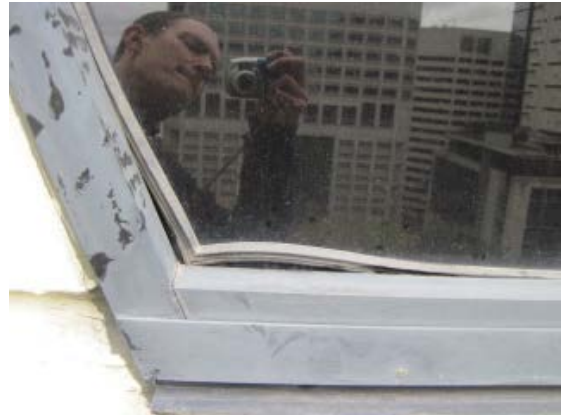
between the glass and the gasket hold both in place.

24. 'Punched' Window Gasket Failure

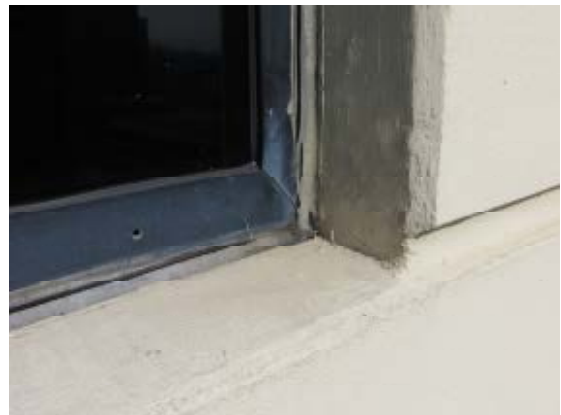
25. 'Punched' Window Sealant Failure

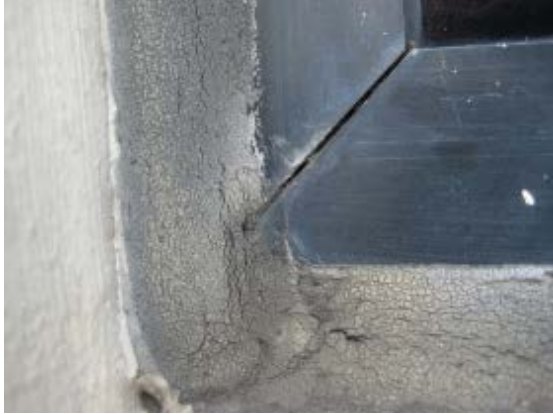
Adhesive failure is a condition whereby the failure mode of the sealant is typically caused by inadequate surface preparation or utilizing the incorrect sealant for the intended application. Failure occurs at the bond line between the sealant and the substrate where water and air are then allowed to enter the building.

26. 'Punched' Window Sealant Failure

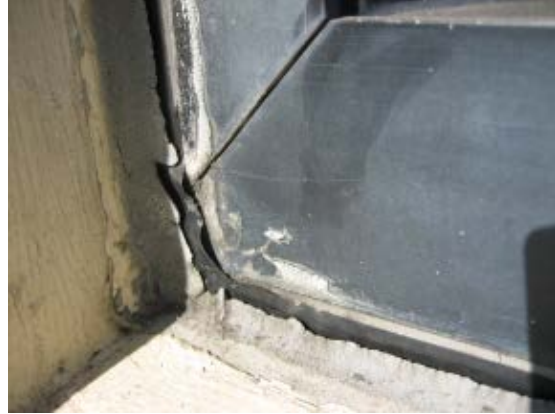
Joinery seals are the seals of the window assemblies where horizontal and vertical frame elements join together to form the frame of the window opening. At these junctures, a bead of sealant is typically run along the end of the frame member abutting the other frame member. When screwed together, the sealant forms a weather-tight seal. Omission or deterioration of the seal due to the thermal movements creates a condition where air and water can enter the assembly at a location that is not able to handle air and water.

27. 'Punched' Window Joinery Failure

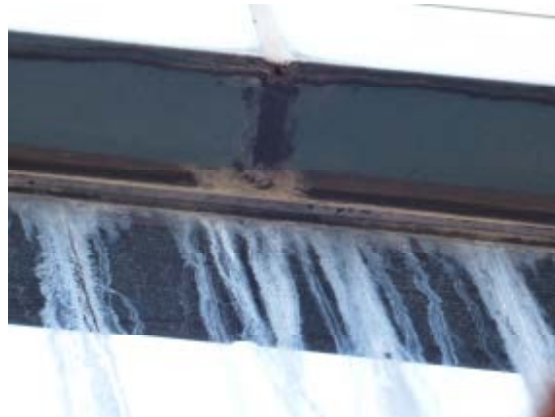
In various areas throughout the assembly locations, the aluminum is being attacked by these salts and leaves an irreversible scar on the finish.

28. 'Punched' Window Finish Damage

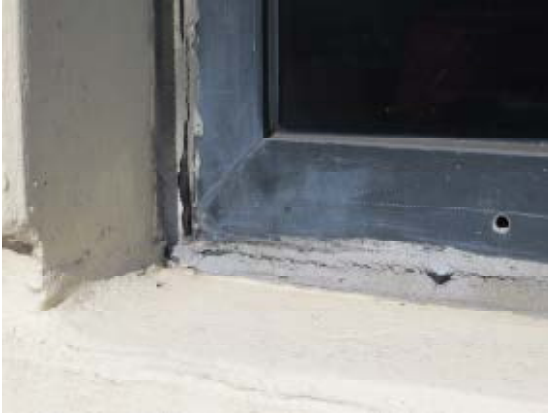
At all of the punched window assemblies, the black anodized finish is starting to exhibit a weathered, chalky appearance typically caused by substandard quality of coating.

29. 'Punched' Window Finish Damage

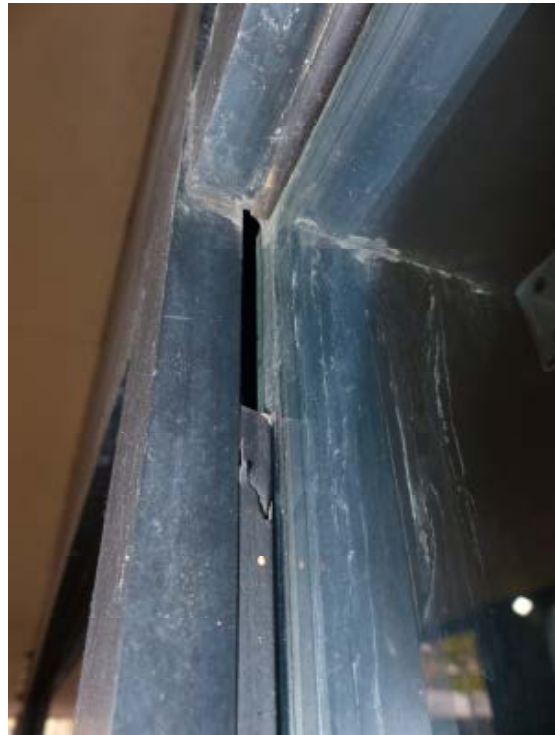
The glazing gaskets in the storefront window assemblies at the first floor (either storefront or curtain wall types) keep the glass in place within the window frame and provide a primary weather seal against air/water intrusion. The gasket is held in place by setting it in a gasket race formed into the window frame. Compression between the glass and the gasket hold both in place.

32. Storefront Failed Glazing Gasket

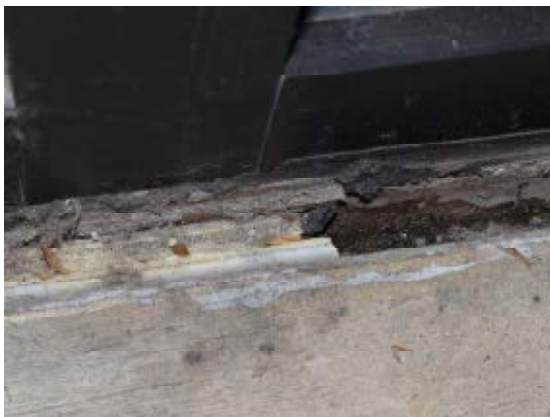
This has exposed the underlying intersection between the concrete walkway and the building.

33. Storefront Inadequate Flashing

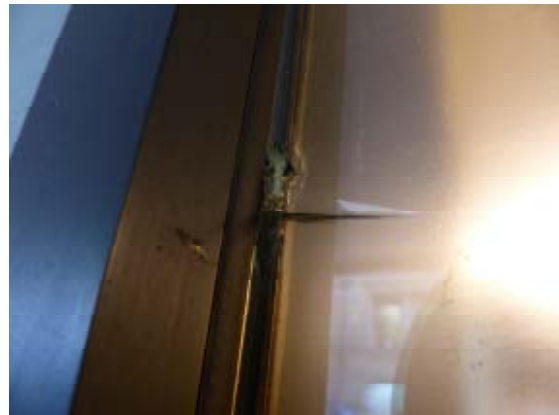
Localized cracked glass is typically indicative of an isolated incident whereby thermal expansion and contraction may have resulted in a pinching of the glass against the surround aluminum or may be caused by an edge defect in the glass.

34. Storefront Cracked Glazing

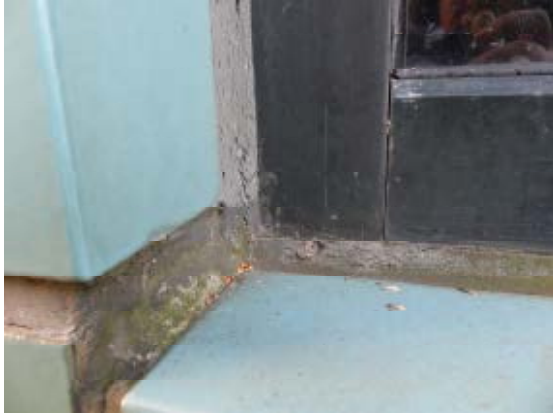
Joinery seals are the seals of the window assemblies where horizontal and vertical frame elements join together to form the frame of the window opening. At these junctures, a bead of sealant is typically run along the end of the frame member abutting the other frame member. When screwed together, the sealant forms a weather-tight seal. Omission or deterioration of the seal due to the thermal movements creates a condition where air and water can enter the assembly at a location that is not able to handle air and water.

### 35. Storefront Deteriorated Joinery Seals

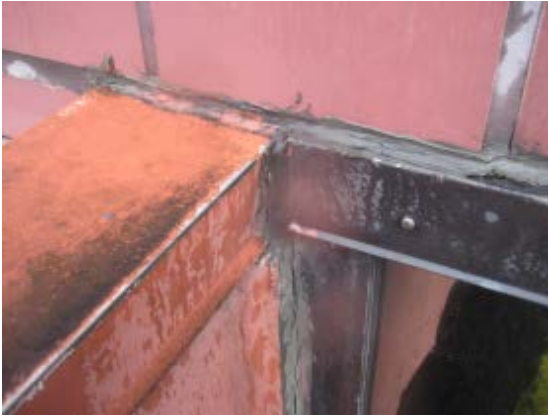
Adhesive failure is a condition whereby the failure mode of the sealant is typically caused by inadequate surface preparation or utilizing the incorrect sealant for the intended application. Failure occurs at the bond line between the sealant and the substrate where water and air are then allowed to enter the building.

44. Curtainwall Failed Perimeter Sealant

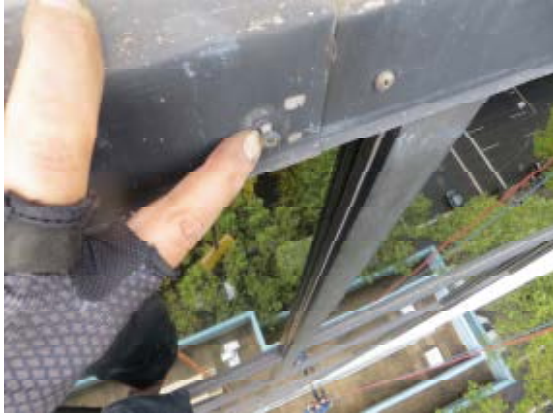
47. Curtainwall Inadequate Flashing Detailing

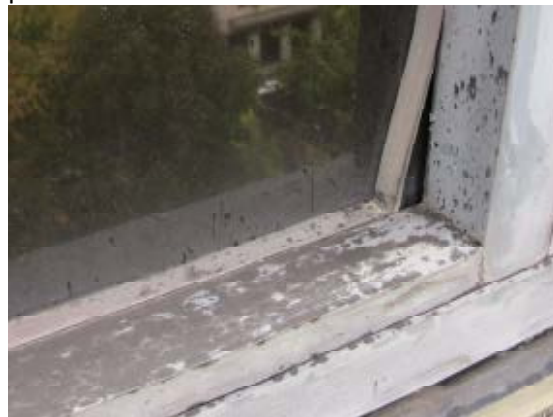
The glazing gaskets in the ribbon window assemblies keep the glass in place within the window frame and provide a primary weather seal against air/water intrusion. The gasket is held in place by setting it in a gasket race formed into the window frame. Compression between the glass and the gasket hold both in place.

53. Ribbon Windows Failed Gaskets

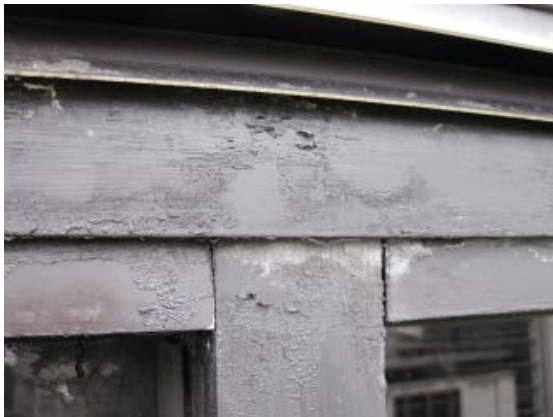
At all of the ribbon window assemblies, it appears that frames were painted with an unknown paint in an attempt to restore the finish and look of the original frames. This paint is flaking and cracking throughout. The underlying black anodized finish is exposed at the areas where the paint is flaking, revealing a weathered, chalky appearance typically caused by substandard quality of coating.

57. Ribbon Windows Deteriorated Finish

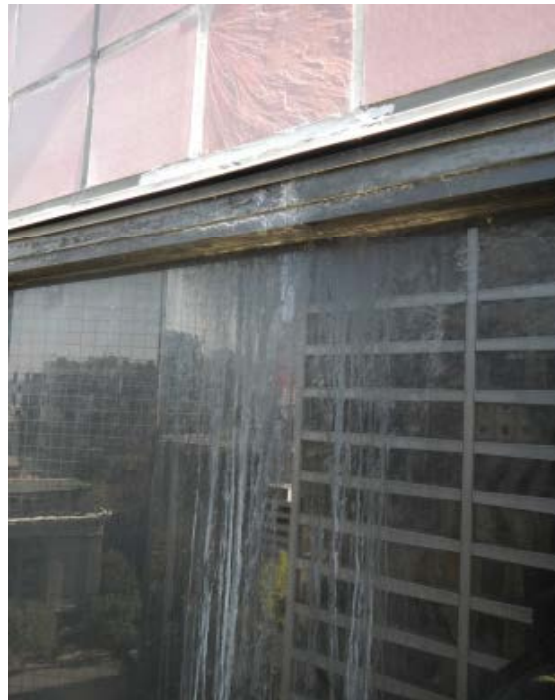
Drainage from the tile areas above appears to have brought with it salts that are attacking the aluminum finishes. In various areas throughout the assembly, the aluminum is being attacked by these salts and leaves an irreversible scar on the finish.

59. Ribbon Windows Corroding Window Frames

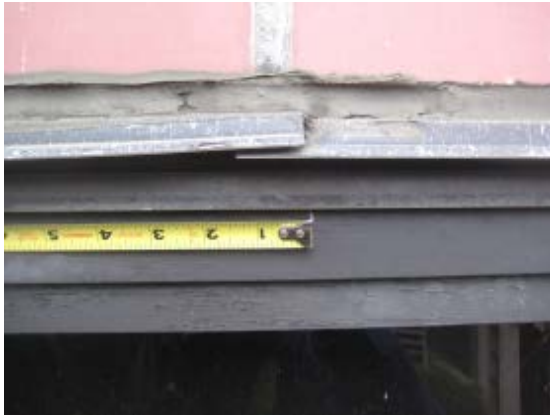
documented and a repair partially implemented as a result of the 1995 McBride study. The currently existing flashing is failing at the splice joints and suffers from an exposed-sealant dependent detailing at the ends of the ribbon windows.

60. Ribbon Windows Failed Flashing Detail

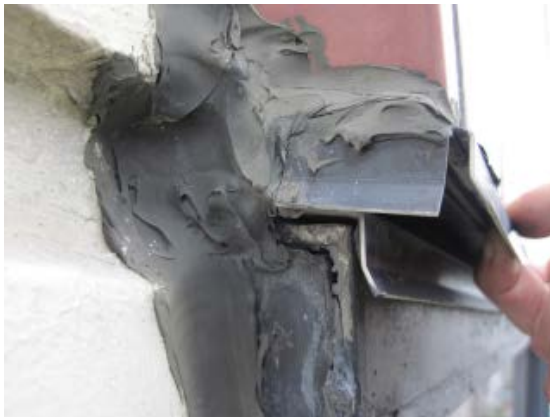
61. Ribbon Windows Failed Flashing Detail

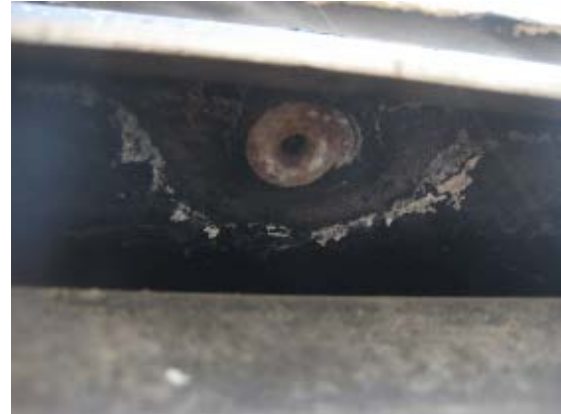
The flashing installed at the heads of the ribbon windows as a result of the 1995 McBride report were fastened through the window frame with pop rivets to secure them into place. Corrosion of the metal fasteners has occurred over time due to galvanic action.

62. Ribbon Windows Corroding Flashing Fasteners

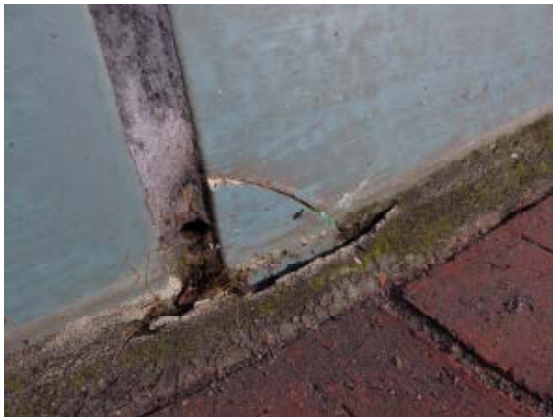
The tiles of the Portland Building are a glazed ceramic tile, wherein a smooth, impenetrable glaze is applied to the surface of a relatively porous substrate. The observed cracking of the glazed tile appears to be caused by either the freezing of moisture trapped behind the tile, corrosion of the expanded metal lath and associated anchorage directly behind the tile, or damage from maintenance operations. While rain water does not penetrate the glaze, it does penetrate the porous mortar between tiles. The glaze then acts as a barrier, preventing the moisture within the assembly from escaping. The moisture trapped against the inner surface of the glaze freezes and expands. In doing so, it exerts sufficient pressure to crack the tile.

65. Ceramic Tile, Cracked, Sealant Failure

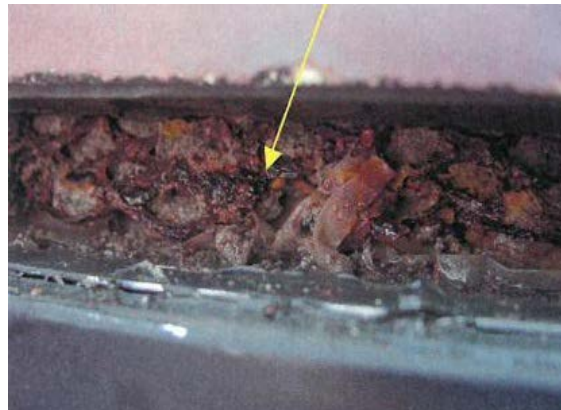
The reinforcing lath embedded within the setting bed is composed of expanded steel anchored to the concrete. As the setting bed is repeatedly wetted, corrosion of the steel reinforcing lath occurs. When steel corrodes, it expands up to eight to ten times its original size, and exerts enormous pressure on the surrounding setting bed. This pressure could affect the bond of the tile to the setting bed and the mechanical attachment of the setting bed to the concrete.

67. Corroded Metal Lath at Ribbon Window head

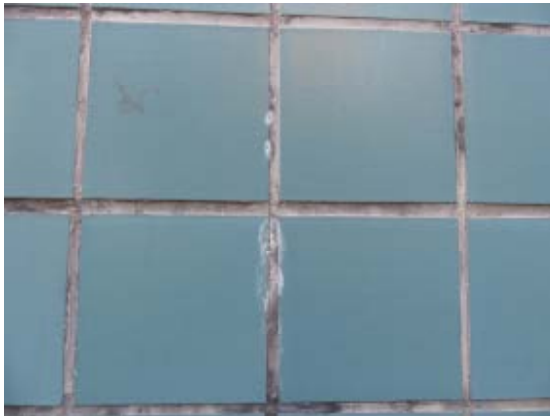
and a technical issue in that they salts can deteriorate adjacent aluminum and glass assemblies.

68. Ceramic Tile, Efflorescence

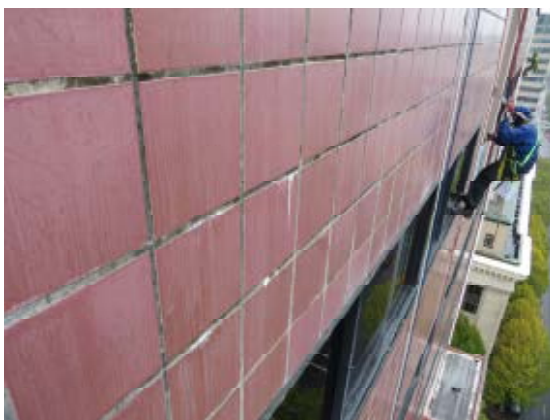
70. Ceramic Tile, Efflorescence

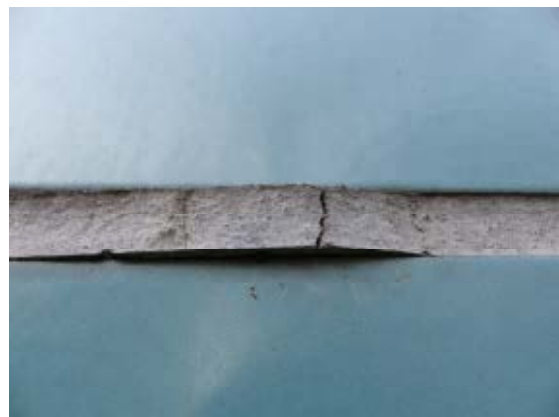
The erosion of the joints appears to be caused by normal weathering of the joints over the life of the building. However, deteriorated or eroded mortar joints permit intrusion of water which becomes trapped within the assembly. This ongoing deterioration, and related water intrusion, accentuates the efflorescence issue noted above.

71. Ceramic Tile Deteriorated Mortar Joints

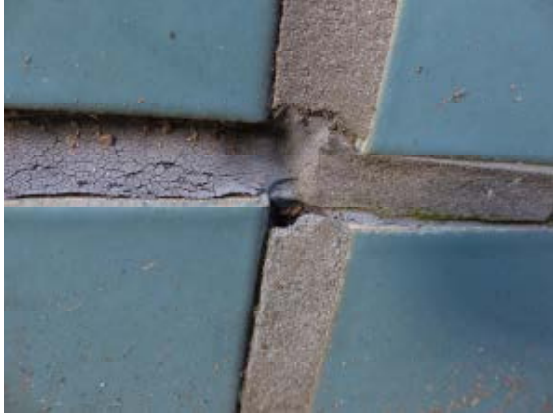
In previous repair campaigns, re-pointing of the mortar joints was attempted. Failure of those joints is, in most cases, caused by poor workmanship or design during that prior campaign, when replacement mortar was poorly formulated, and when mortar joints were not cut back deep enough or wide enough to achieve good bonding strength.

72. Ceramic Tile Ineffective Re-pointing Sealant Failure

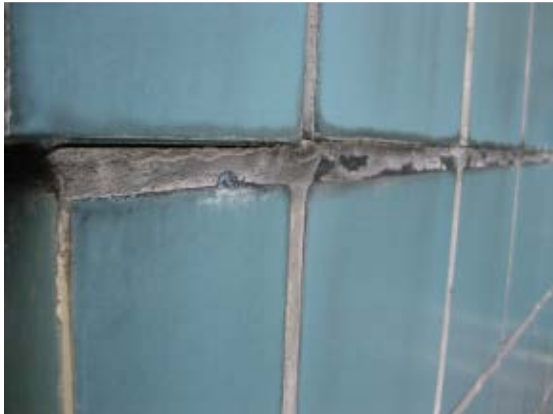
73. Ceramic Tile Ineffective Re-pointing Sealant Failure

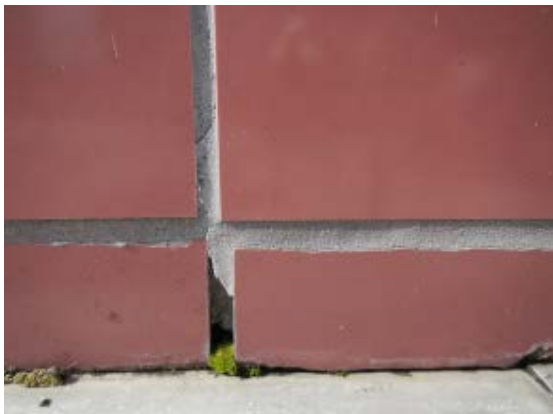
74. Ceramic Tile Ineffective Re-pointing

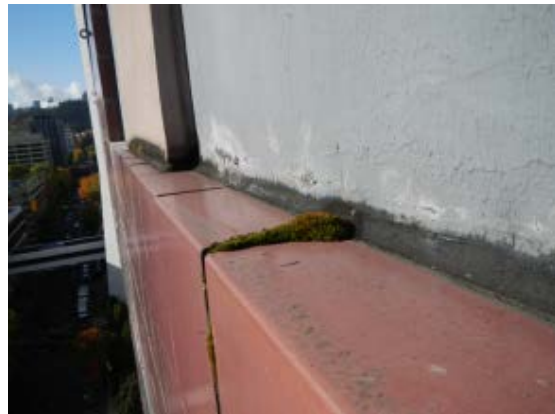
The 1998 Fowler report and subsequent additions/repairs attempted to address the issue of up-facing horizontal mortar joints at the fourth floor tile. The joints at that location have been retrofitted with a sheet metal flashing to protect them from direct weathering and moisture intrusion behind the tile. However, at the tile at the keystone element, this flashing is missing and signs of erosion, prior repairs and moss growth are evident.

75. Ceramic Tile Exposed Horizontal Joints and Sealant Failure

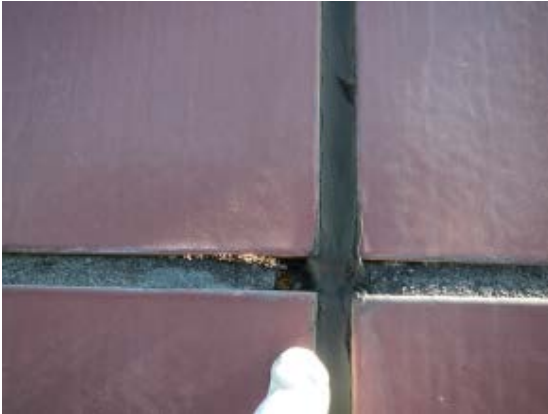
The expansion joints contained with the field of the tile have been confirmed to only be partial depth joints extending back to the face of the setting bed. Sealant has been utilized to seal between tiles on either side of the joint and is intended to provide for movement of the tile system. Adhesive and cohesive failure was observed throughout the building.

76. Ceramic Tile Sealant Failure

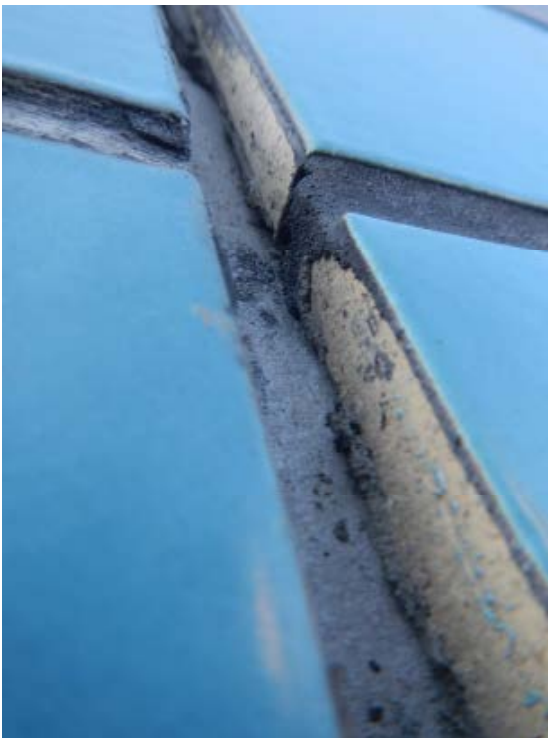
77. Ceramic Tile Sealant Failure

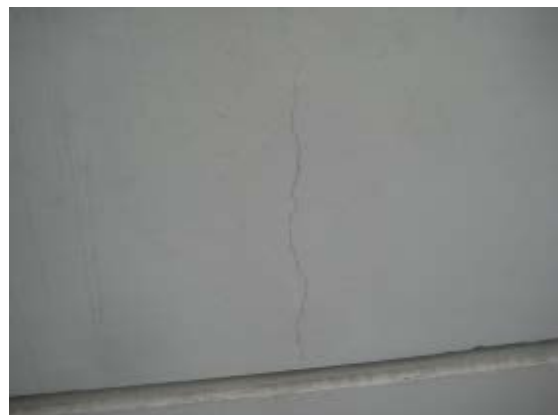
80. Concrete Cracking

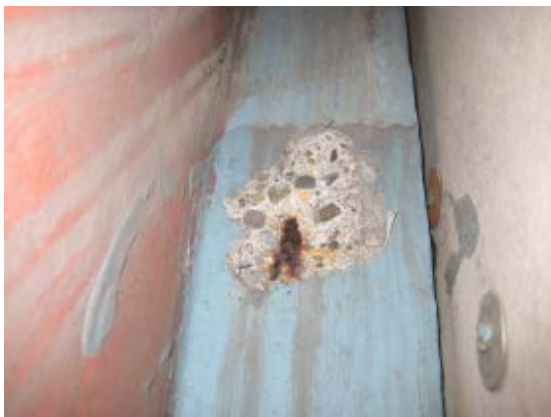
“Spalling” is a condition where fragments of concrete become dislodged from the surface of a concrete structure. When steel corrodes, it expands up to eight to ten times its original size, and exerts enormous pressure on the surrounding concrete, causing portions of it to dislodge or crack. Steel corrosion is caused by the penetration of water which occurs when the steel reinforcing is too close to the surface of the concrete, and there is not adequate coverage to protect it. As the crack or spall opens, more water is introduced, accelerating the corrosion rate.

81. Concrete Spalling

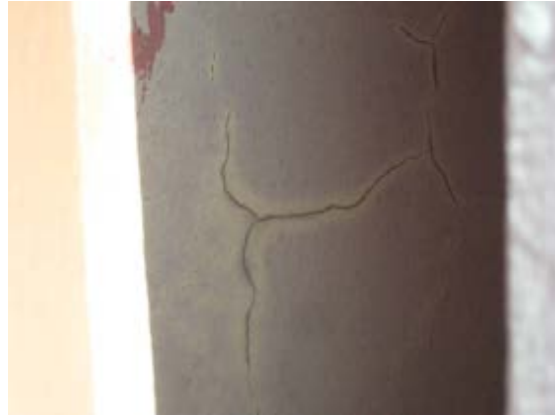
82. Concrete Spalling

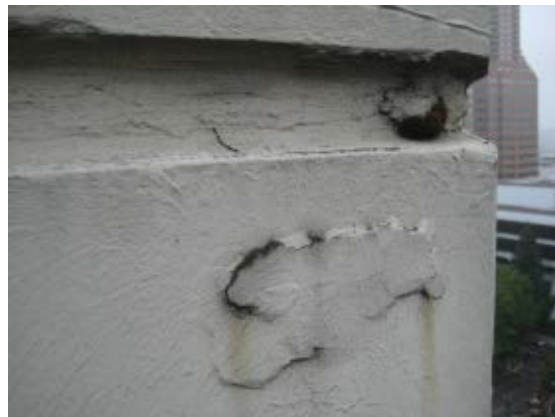
83. Concrete Spalling

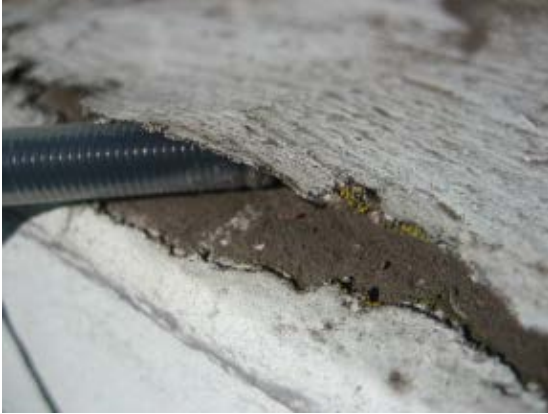
Elastomeric coatings also have the tendency to collect dirt due to the migration of plasticizers to the surface of the coating and the nature of the coating to have several surface pores that can hold dirt.

84. Concrete Elastomeric Paint Failure

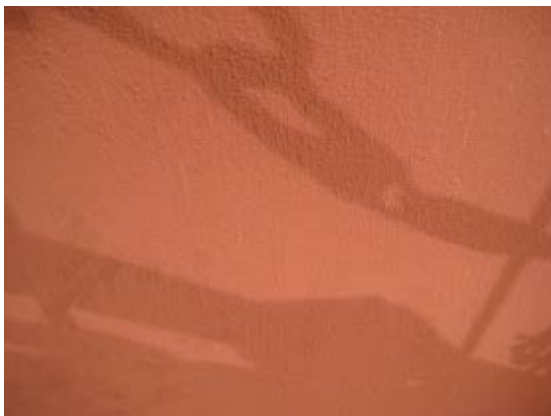
Cracking in the stucco appears to be caused by thermal movements or shrinkage of the stucco over time.

#### 87. Stucco Cracking

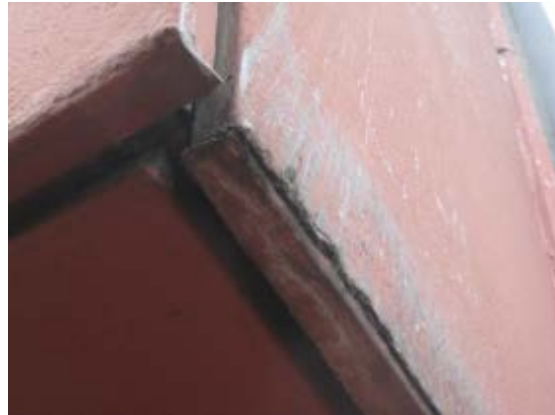
At the vertical joints in the stucco near the corners,  $\frac{3}{4}$ " gaps were observed to be open, directly exposing the underlying building paper.

88. Stucco Omitted Sealant Joints

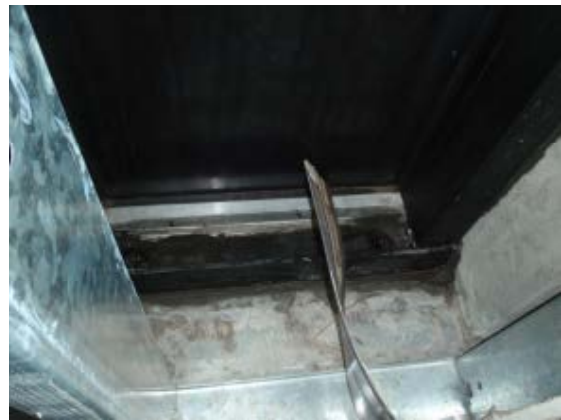
The wall framing showed extensive signs of water and moisture. The concrete floor slab was saturated and there was standing water in the curtainwall sill track

92. 4.10 Sill Track Standing Water

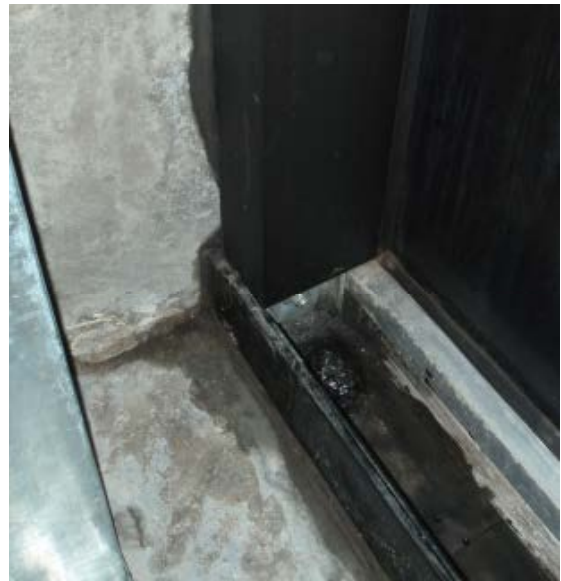
93. 4.10 Water Stains

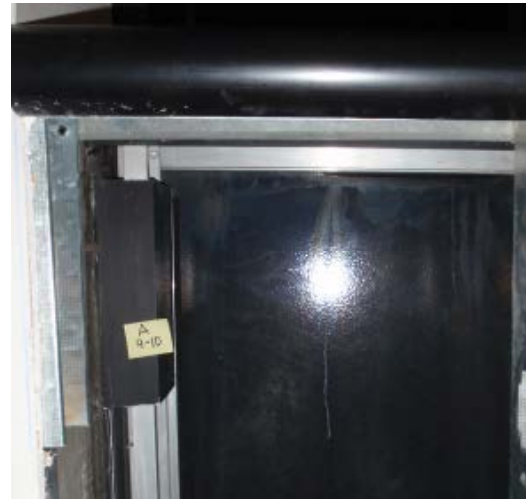
99. 9.10 Moisture Stains on Spandrel Panel

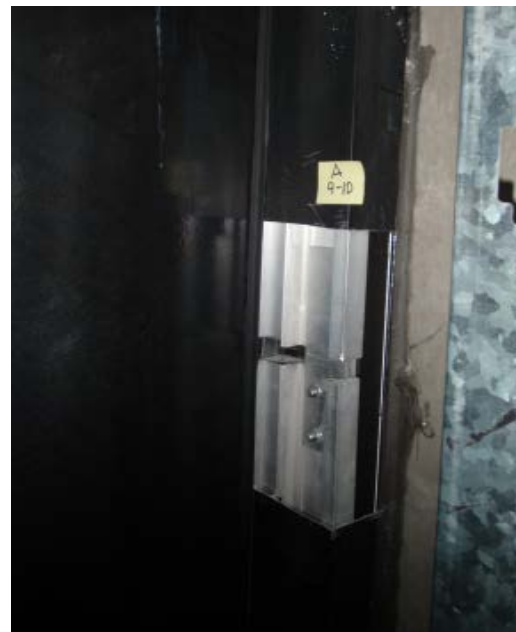
not allow for thermal expansion of the curtain wall frame.

100. 9.10 Expansion Detail

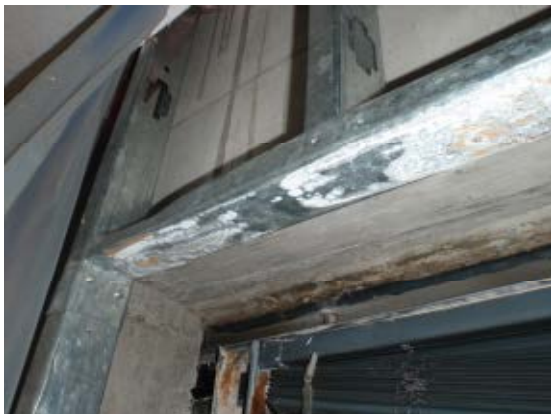
Water damage from leaks in the exterior ceramic tile at window head was significant.

102 14.10 Head at South End.
