1034 SW DOUGLAS PL REV-01 RS11-168370

## Field Memo Report

To: Mr. Bob Schatz (Atkins Architecture)  
From: Jason Stanek, PE  
CC:  
Date: November 29, 2011  
Re: 11-049 Atkins Remodel and Addition

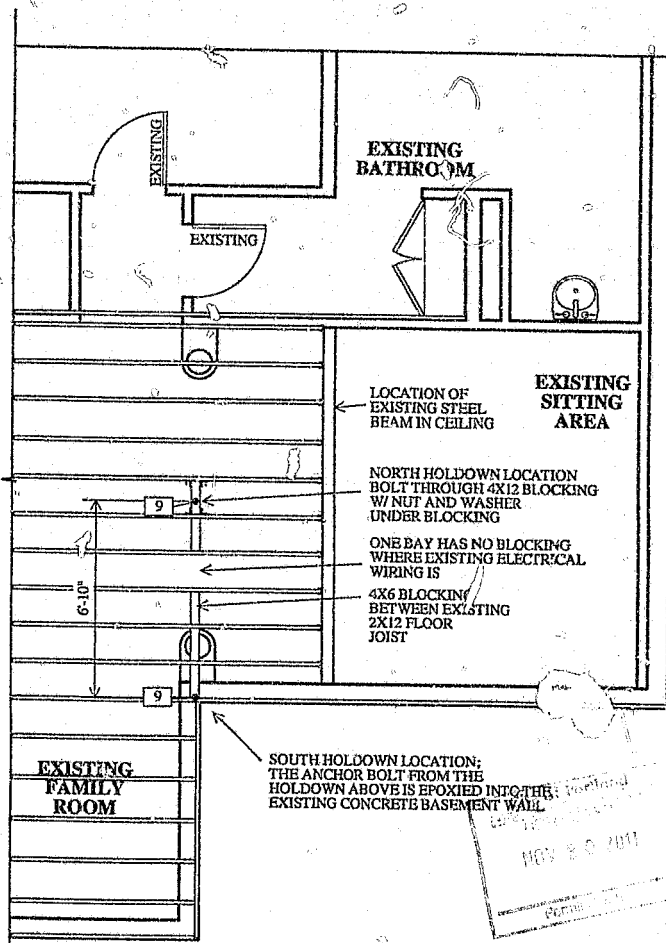
**BASEMENT FLOOR PLAN WITH FLOOR FRAMING ABOVE**

**Question:** During the preparation to begin the installation of the new shearwall sheathing on the existing hallway wall, we discovered that the steel wide flange beam that we initially thought was located directly under this location is instead located under the wall on the opposite side of the hall. We would like to keep the shearwall in the location that we are showing it now, however this changes the configuration of the lateral force transfer (no beam there to transfer loads over in to the existing concrete basement wall), and we now need to have the holdown anchoring in to blocking between existing joists. What do we need to add to make this configuration acceptable.

**Answer:** It appears that it will be acceptable to keep the shearwall in the current location, however we will need to add blocking under the wall in order to get our wall bottom plate anchorage down into the floor system. We will also place one holdown anchor rod down through blocking with oversized washer and nut, and attach the blocking to the 2 adjacent joists with Simpson brackets, and the other holdown appears to be capable of being installed in to the top of the existing concrete basement wall. This configuration assumes that the existing wood diaphragm transfers the lateral load over to the existing concrete wall. Through the connections of the sheathing to the continuous rim joist and end nailing of the rim in to the end of the joists and toe nails of the joists in to the mud sill, and finally, anchor bolts into the top of the concrete wall, the lateral load is transferred down where it is intended to go. Please refer to the attached plan of this area with additional information and details of the required revisions. Please also refer to the calculations attached herewith for the
