# NORTH AND EASTSIDE PORTLAND UNREINFORCED MASONRY BUILDING SURVEY PROJECT REPORT

Prepared for The City of Portland  
by Robert Dortignacq, Architect and Kim Lakin, Historic Preservation Consultant  
August 2013

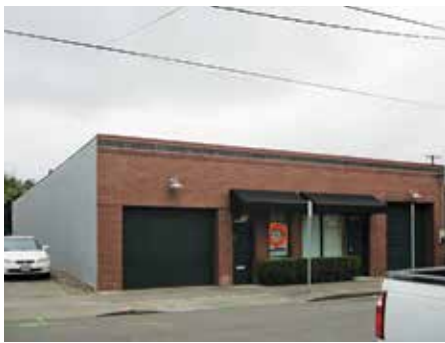
1940s concrete block, low occupancy structure in good condition, likely to have some reinforcement. This indicates a stronger structure with a minimal life safety exposure.

- The building is a single-story auto repair shop constructed in the 1940s of concrete block (cmu) with an occupancy of less than five people. Due to the nature of the business, few people are ever on the interior, and only during work hours. There is likely at least minimal reinforcement in the concrete block, and the block and mortar quality and condition is good. This indicates a higher quality, stronger structure with minimal life safety exposure.

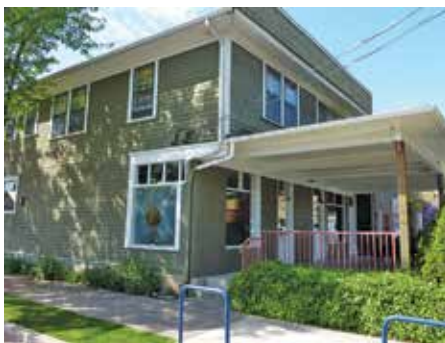
Wood frame structure with its single story front load bearing wall replaced by concrete block, this renovation may be a liability.

- The building is a small two story wood framed apartment house with its single-story front load-bearing wall replaced by concrete block due to the former wood wall having deteriorated. Although the owners may have thought the renovation was an improvement, it may be a liability.

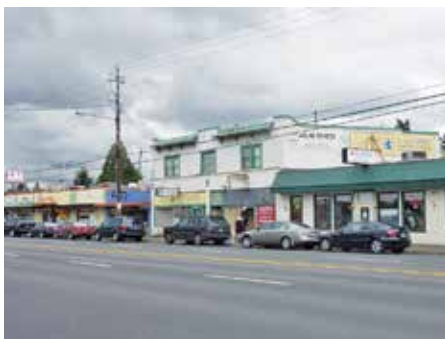
A continuous row of masonry and mixed construction buildings, the differing roof levels can exhibit lateral forces to the intervening walls, but they can also provide some support.

- There is a continuous row of masonry and mixed construction single storied buildings with differing roof, parapet heights and storefront types. They also vary in condition, age and level of maintenance. The different roof levels can exhibit lateral forces to the intervening walls, but they can also provide some support.

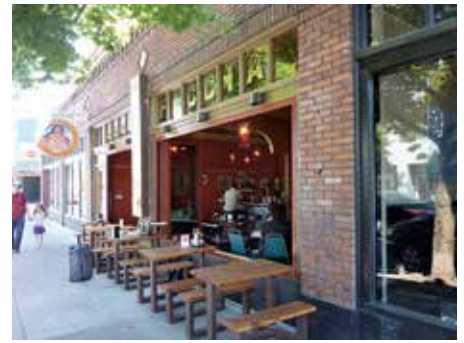
Bella Faccia storefront

This is a simply constructed building with minimal hazard. A phased or limited seismic improvement plan should not be expensive (relatively).

Develop a flexible strategy and long term or easy finance option to provide at least the minimal level of seismic upgrade needed to ensure safe exiting of patrons.

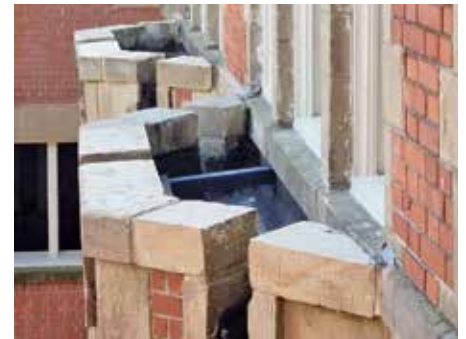
Bay bracing on Trinity Place Apartment building

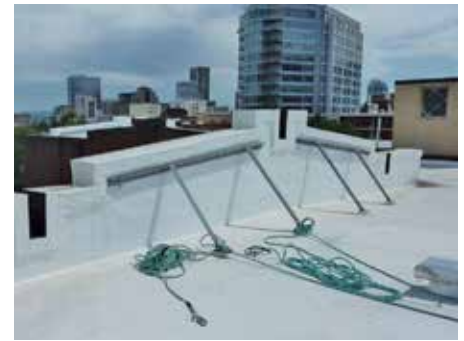
Trinity Place Apartments, parapet bracing

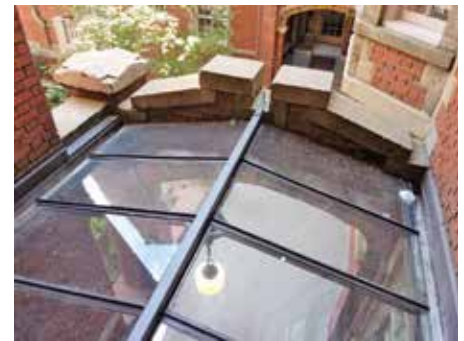
Trinity Place Apartments, entry bracing

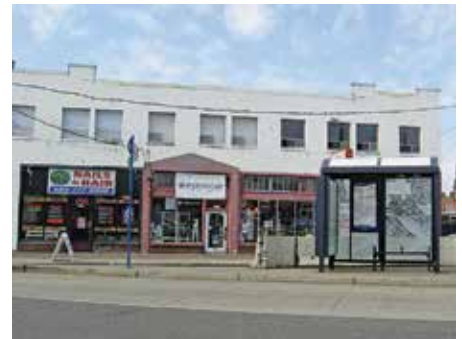
Example of actively used main level with upper level not upgraded and modestly utilized
