ELK FOUNTAIN SALVAGED
GRANITE STORAGE PLAN

Elk Fountain Condition Update- September 10, 2020

Elk Fountain granite basin component inventory and condition

August 26, 2020

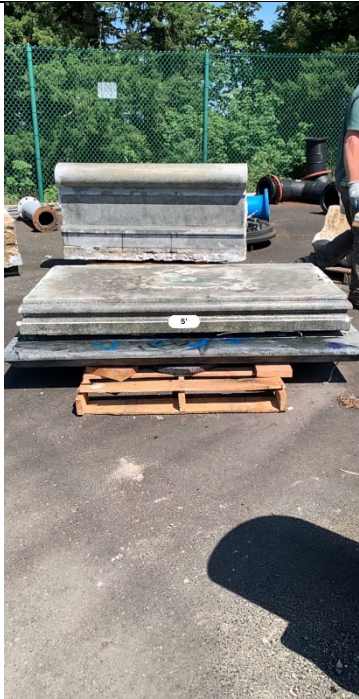
P4	Pedestal base-fourth section	5'W x 3' D x 9" H	Moderate – chips

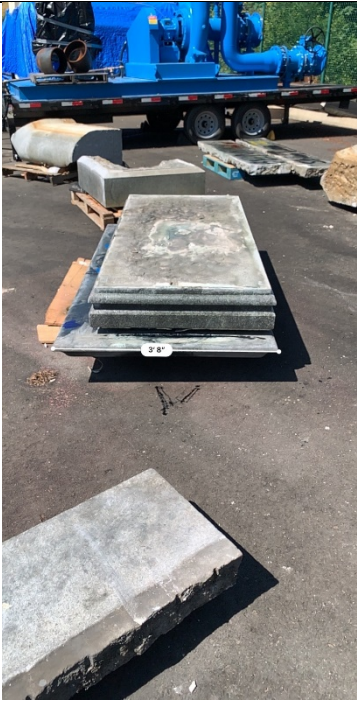
P5	Pedestal cap	6'2" W x 3'8" D x 5" H

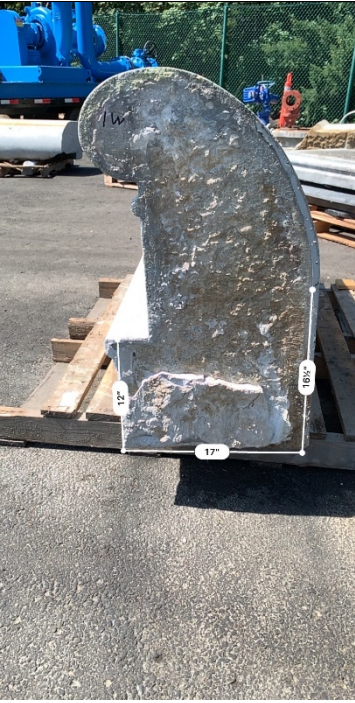
1W	West basin wall-north side	5'6" W x 17" H x 30" D

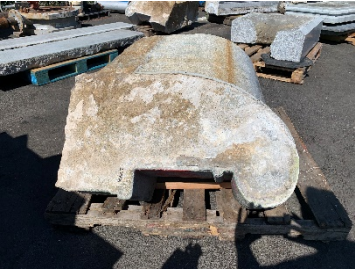
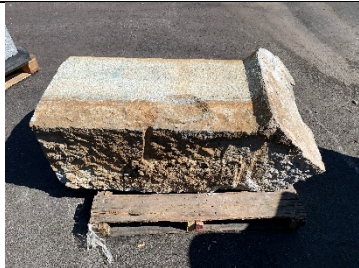
2WA	West basin wall- north half of broken granite wall	Overall: 3'11" W x 30" D x 25" H	Chips on top and at side on the scroll where it had attached.

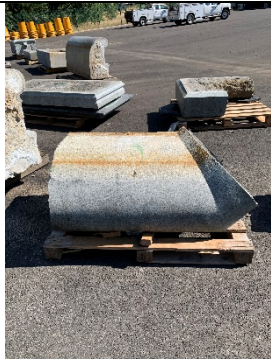
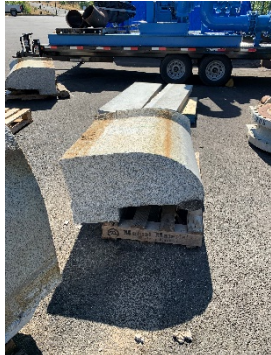
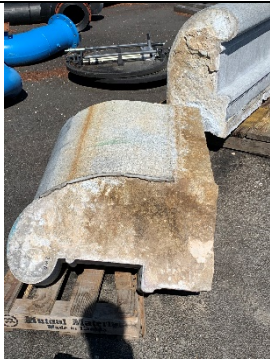
2WB	West basin wall-west side, south half of broken granite wall	Not recorded

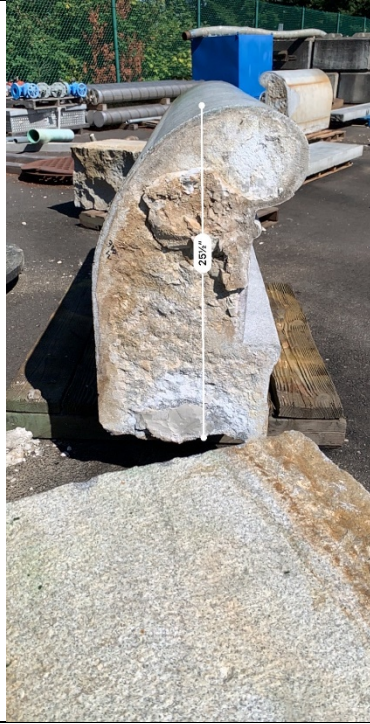
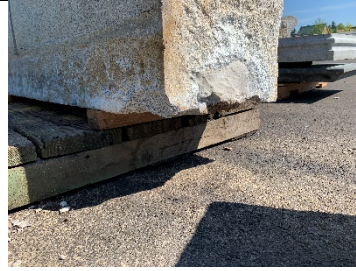
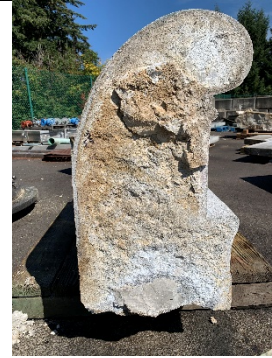
3W

West basin wall-south
side

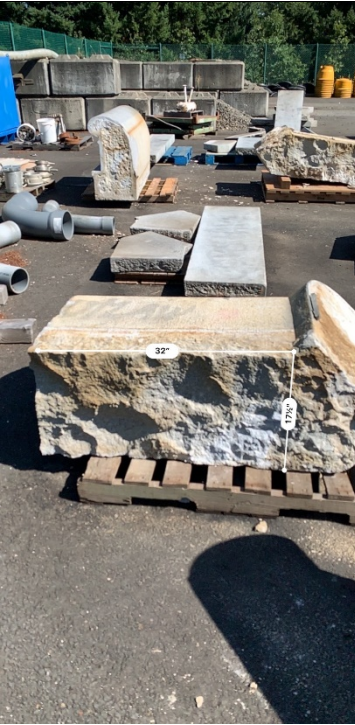
<p>1S</p>	<p>South basin wall-west half of broken granite wall</p>	<p>32" x 18" x 53"</p>

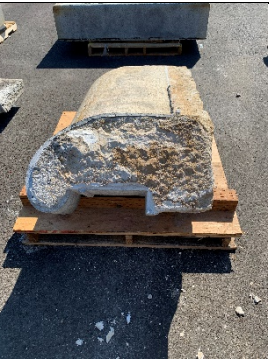
<p>2S</p>	<p>South basin wall-east half of broken granite wall</p>	<p>3'9" W x 33" D x 18" H</p>

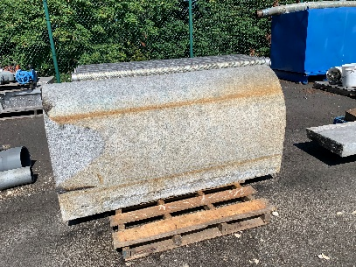
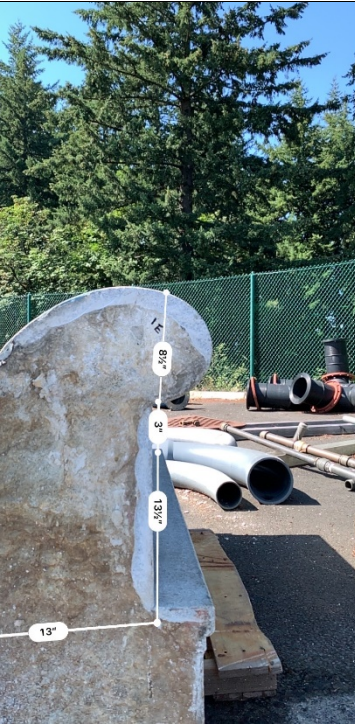
1E	East basin wall-south side	5'W x 16" H x 3'2" D

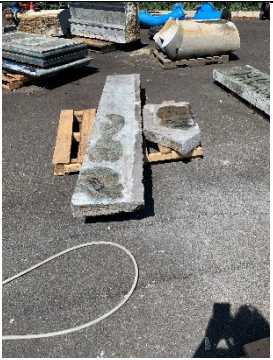
SE1	Top step-adjacent to 1E, broken in 2 pieces

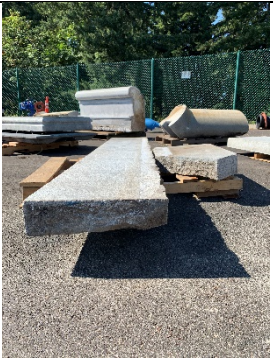
SE2	2 nd step-below SE1

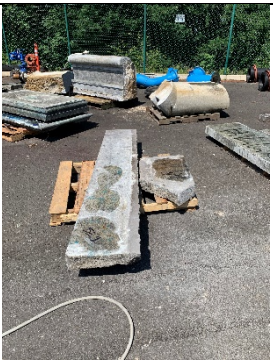
SE3	Filler step-north of SE1

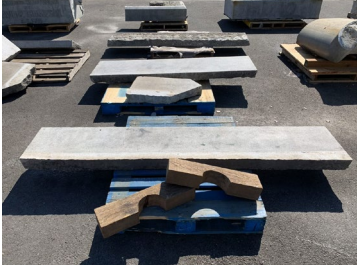
NE3	Filler step-west of NE1	Not identified at storage area		
NE4	Filler step-south of NE1	Not identified at storage area		
NE2	Long bottom step, NE side of fountain

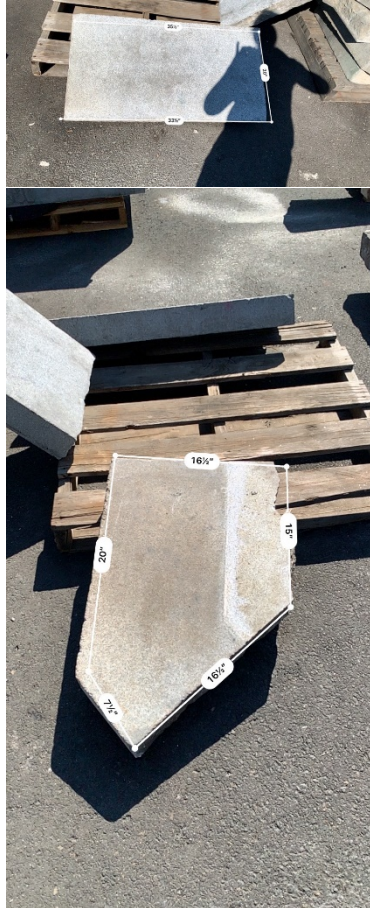
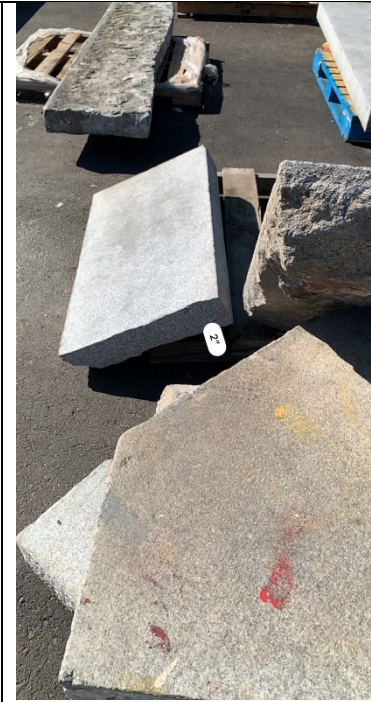
Larger filler steps-
location not identified

Unmarked, quantity =5

Many breaks, varying conditions
between moderate and poor.

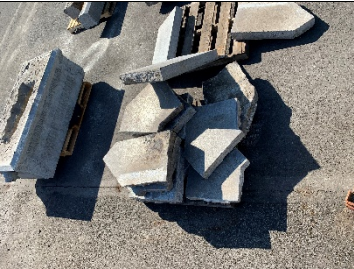
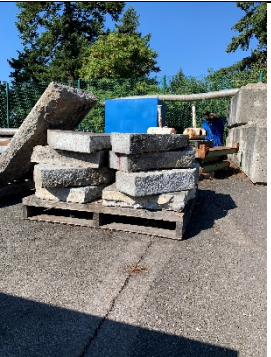
<p>Smaller filler steps, location not identified</p>	<p>Unmarked, quantity=8</p>
