Trees that require pruning and/or advanced aerial
assessment in the South Park Blocks between SW Market
and SW Main street

Hazard Trees South Park Blocks 7-12

TREES IN THE SOUTH PARK BLOCKS
IDENTIFIED BY ARBORIST MORGAN HOLEN
FOR PRUNING
BLOCK 7 (between Clay and Market)

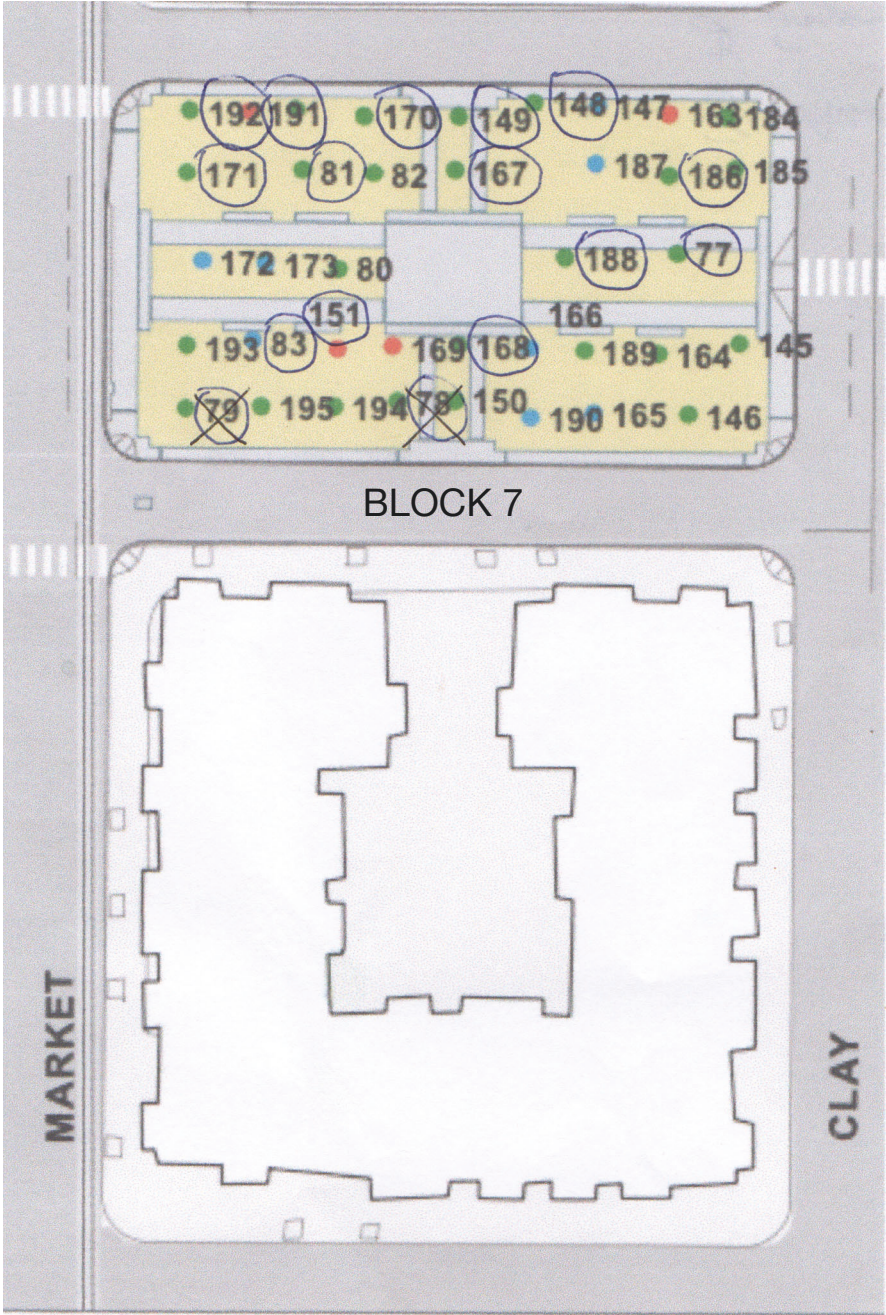
BLOCK 7

192 American Elm 35.5" Dead branches high in crown over street, epicorms

191 Japanese Zelkova 3.5 DYING - remove

81 Sugar maple 21.5" Trunk wound NW face with hollow on top, trunk swelling, may be decay in plane of lean - consider advanced assessment

77 American Elm 36.5 Numerous epicorms limit VTA, history of scaffold branch failure, consider aerial

83 American elm 29" Consider cable/brace for co-dominant leader

151 Green ash 16.5 DYING - remove. History of scaffold branch failure, hollows with decay, progressive decline

168 Green ash 30" Co-dominant leaders consider aerial assessment to assess union

78 American elm 42" History of co-dominant leader failure, hollow with decay seam on S face, consider advanced assessment, to reduce excessive crown weight over street

Fell in Feb 2021 ice storm.

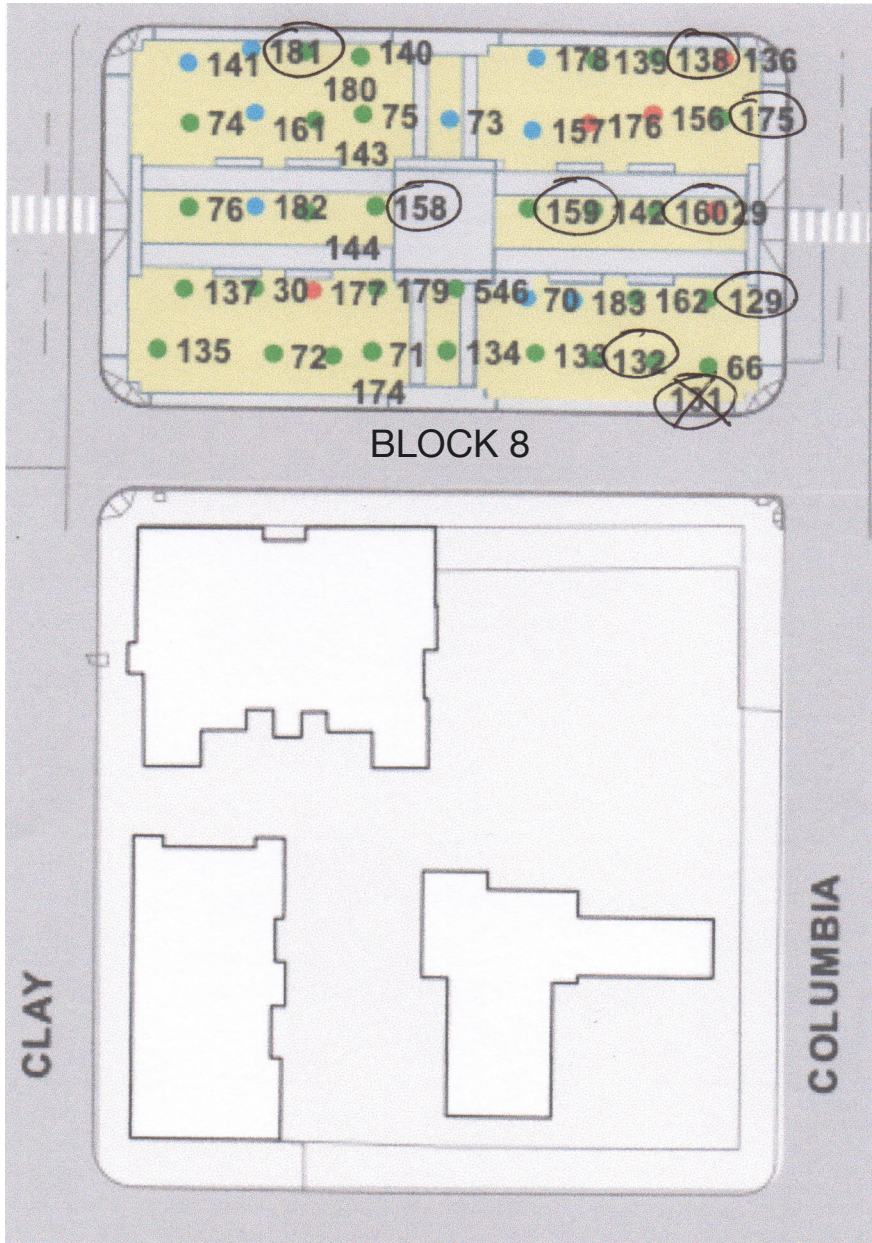
BLOCK 8

175 sugar maple 30.5" History branch failure, scaffold branch and trunk decay. consider aerial

158 Accolade elm 3.5" needs young tree structural pruning
159 American elm 35" few dead and decaying branches
160 American elm 37" some history of branch failure, hollow with decay in scaffold branch high in crown on south side, smaller dead and decaying branches

132 American elm 25" small dead branches, epicorms, upright structure
131 American elm 31.5" one sided to E, large diameter scaffold branch over street

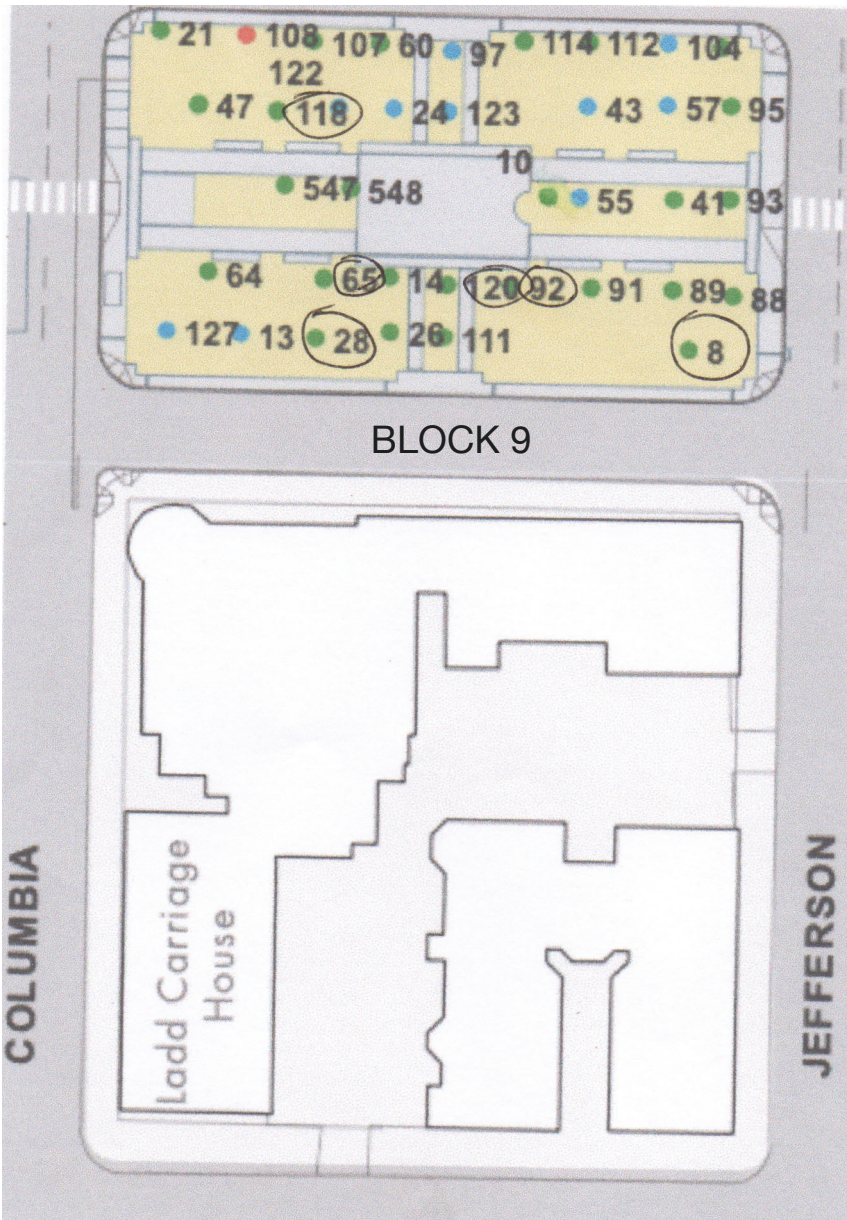
BLOCK 9

118 American elm 34 inches Multiple leaders, previous scaffold branch failure, large wound at junction, warrants aerial

92 American elm 39.5 inches History of large branch failure, warrants aerial assessment and pruning

8 American elm 46 inches History of major scaffold brach failures, large open wound NE face at juncture of remaining leaders, hollows in branches higher up - warrants aerial assessment

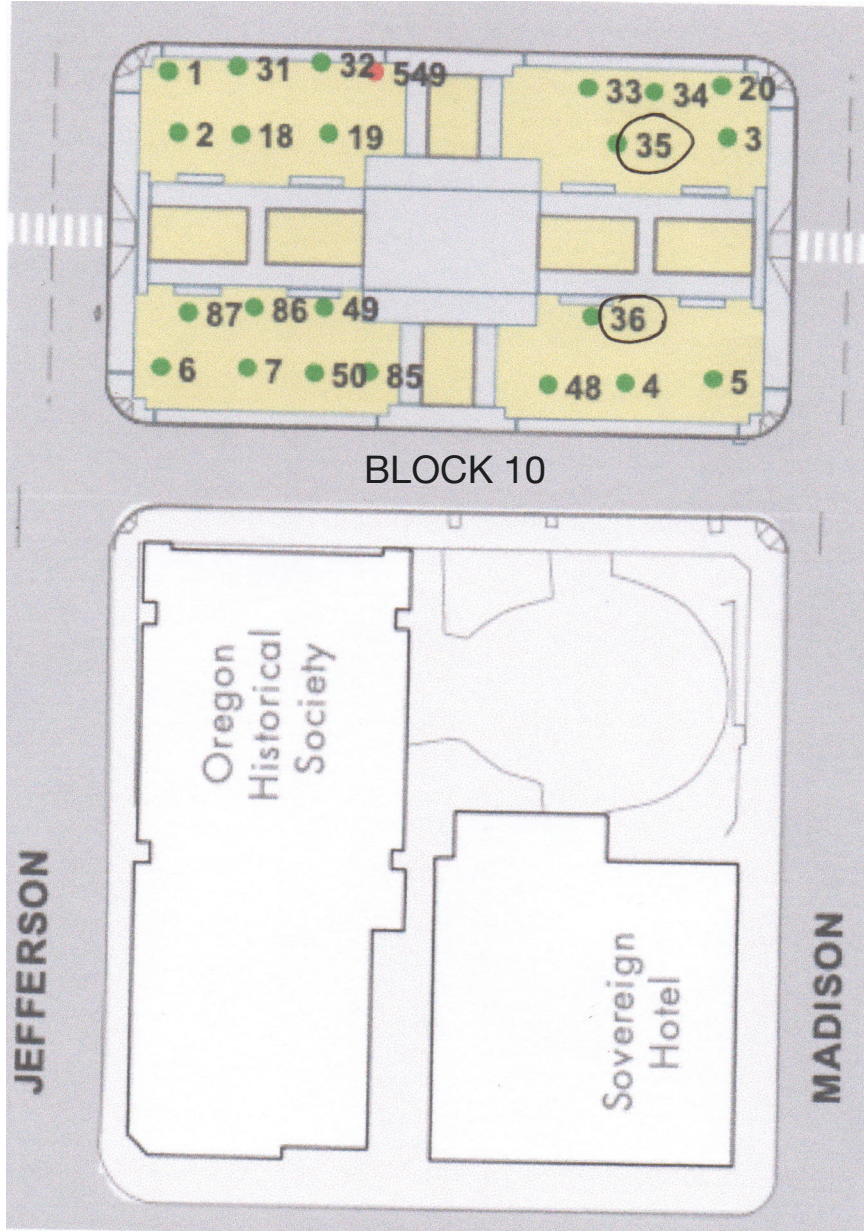
BLOCK 10

middle west row
35 American elm 40 inches History of scaffold branch failure, numerous epicorms limit VTA

middle east row
36 American elm 38 inches Small dead branches, epicorms, probably best elm inventoried

HAZARD TREES
none identified

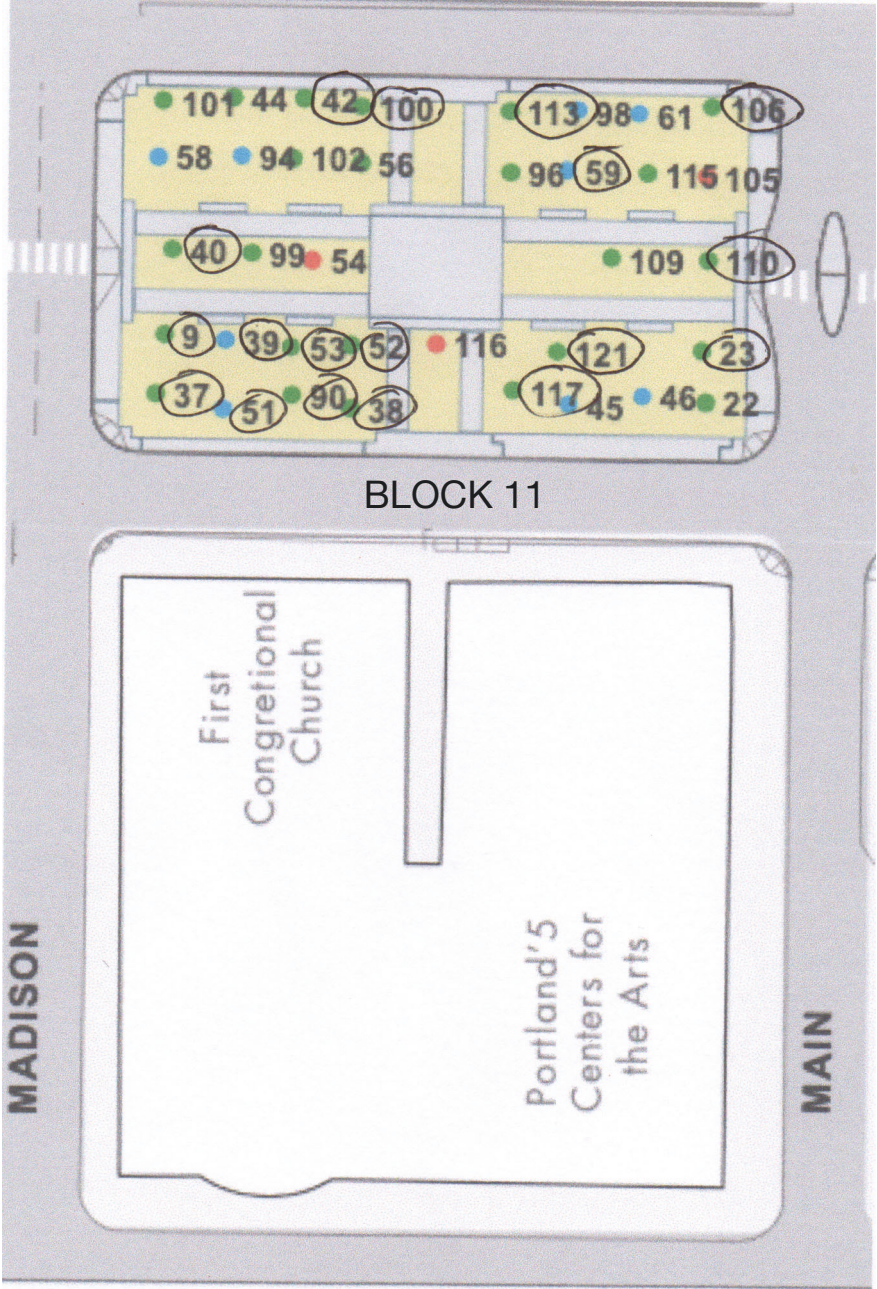
BLOCK 11

42 American elm 38 inches Tremendous crown weight over street, small dead branches, old wound from co-dominant stem failure S face

100 American elm 33 inches One-sided west with crown over street, small dead branches.

40 red oak 21 inches Natural lean S., small dead branches, some leaf infection, infestation

110 American elm 32.5 inches Co-dominant leaders, one to N over street, small dead branches, old co-dominant leader failure with large wound, some deca, epicorms

121 sugar maple 32.5 inches Several dead and decaying branches on S side

23 American elm 25.5 inches Prune to improve growing space for beech to E. and reduce crown weight over road N, leans N, mostly one-sided, large scaffold branch over street
