# **City of Portland / Outfall 17 / Contaminated Sediment Source Identification**

Prepared for: Dawn Sanders/BES

Prepared by: Ali Dirks/BES

Date: June 30, 2003

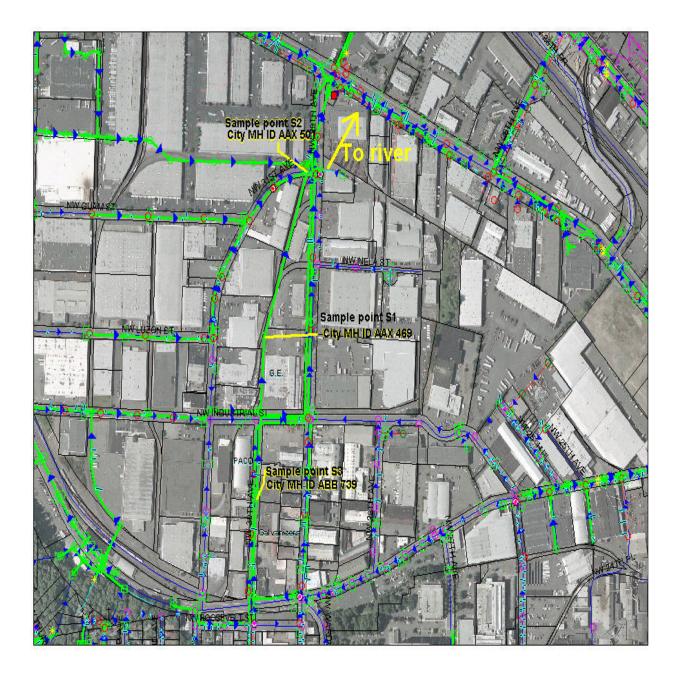
Figure 1. Location of Stormline Samples in Basin 17

Sample point one (S1) is located 450 feet north of the intersection of NW Industrial St. and NW 30<sup>th</sup> Ave (see Figure 1). S1 is a City manhole and is located on the railroad tracks. This manhole's City ID number is AAX 469. The sediment analysis indicated a high level of PCB 1260 (6,770 ug/kg).

Sample point two (S2) is located 65 feet west of the intersection of NW 29<sup>th</sup> Ave and NW 31<sup>st</sup> Ave (see Figure 1). S2 is a City manhole and is located in the middle of the street.

This manhole's City ID number is AAX 501. The sediment analysis indicated an elevated level of PCB 1260 (617 ug/kg).

Sample point three (S3) is located 580 feet north of the intersection of NW Nicolai St. and NW 30<sup>th</sup> Ave (see Figure 1). S3 is a City manhole and is located in the middle of the street. This manhole's City ID number is ABB 739. The sediment analysis indicated high levels of zinc (20,400 mg/kg), lead (531 mg/kg) and cadmium (11.1 mg/kg).
