Prepared by: **BTD/MT**
BO Letter Number: **3010523**

Engineering Addendum

Project Name: Javiena Group Fremont St Remodel (Portland) 2810523
Project Location: 5935 NE Fremont St
 Portland, Oregon 97213
Project Number: 2810523
Date: 5/10/2023

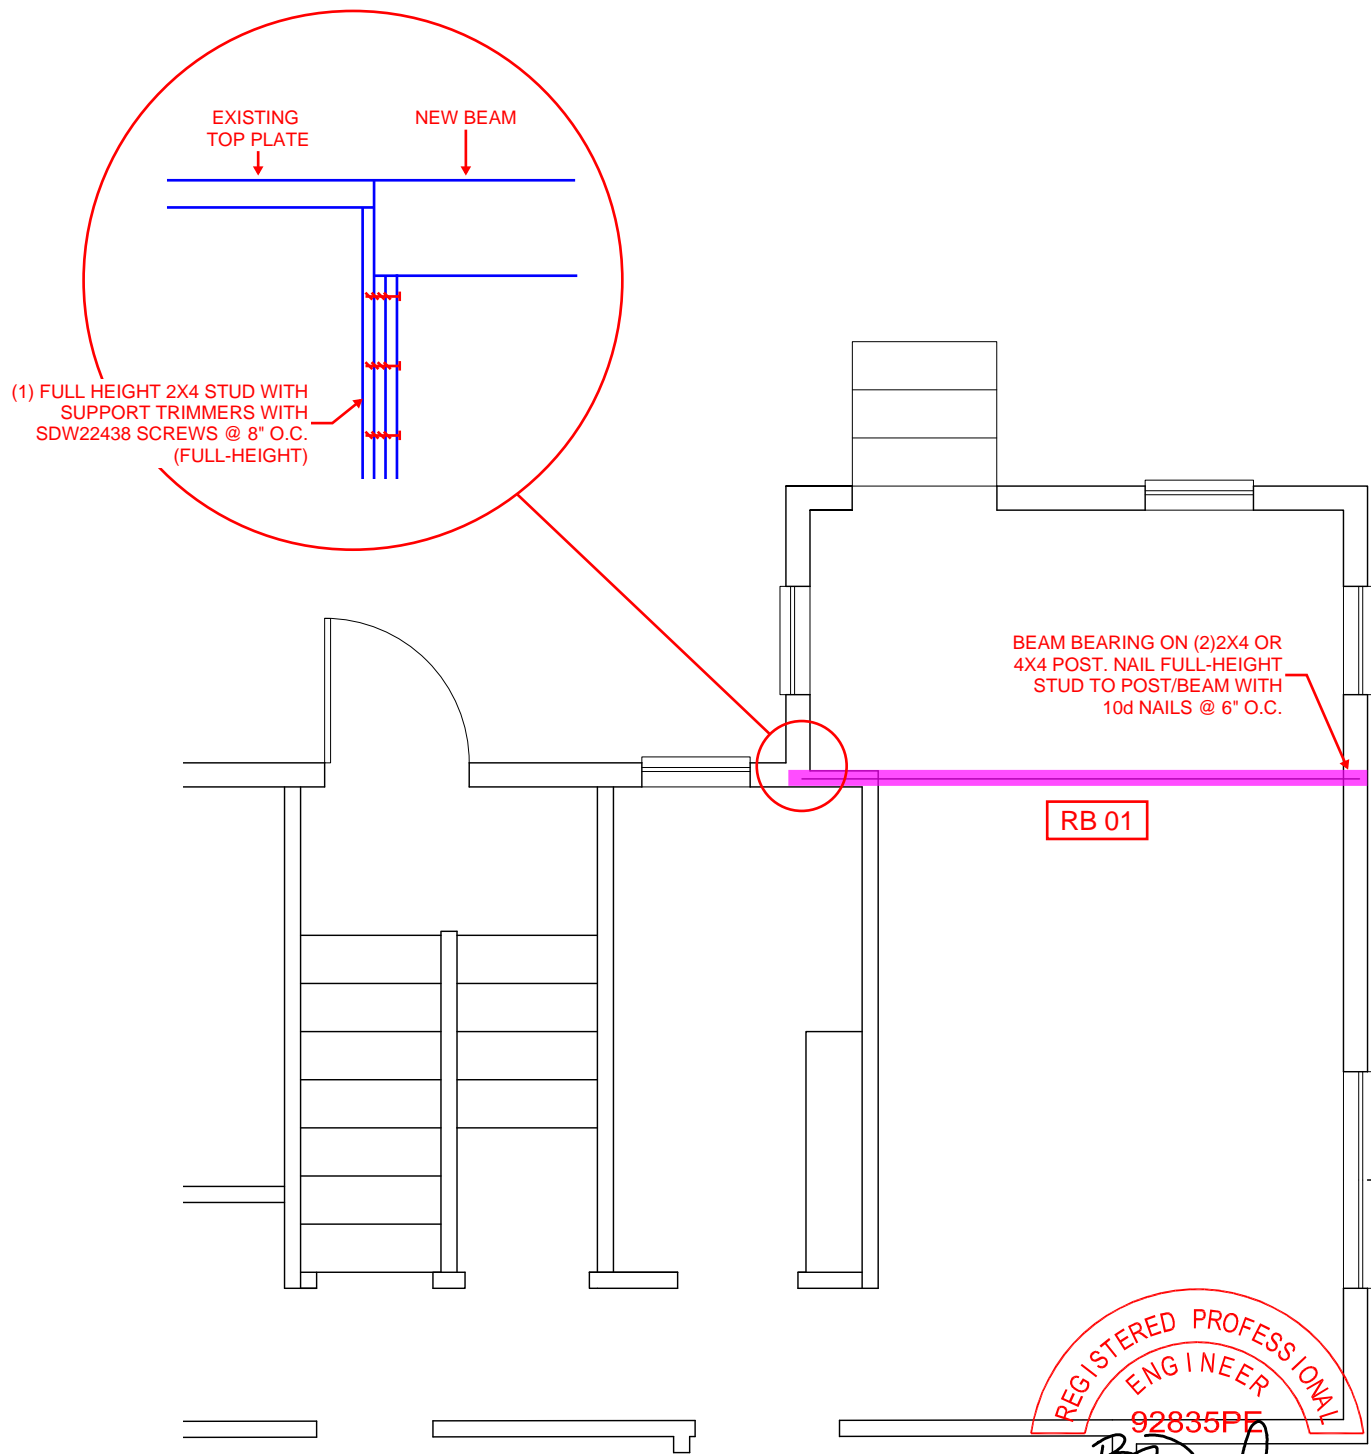
2nd FLOOR FRAMING PLAN

It was requested to verify the strength of a glulam beam that will replace the previous bearing wall.

- The new glulam beam will have enough sufficient strength to replace the bearing wall. See attached drawing for support clarification.

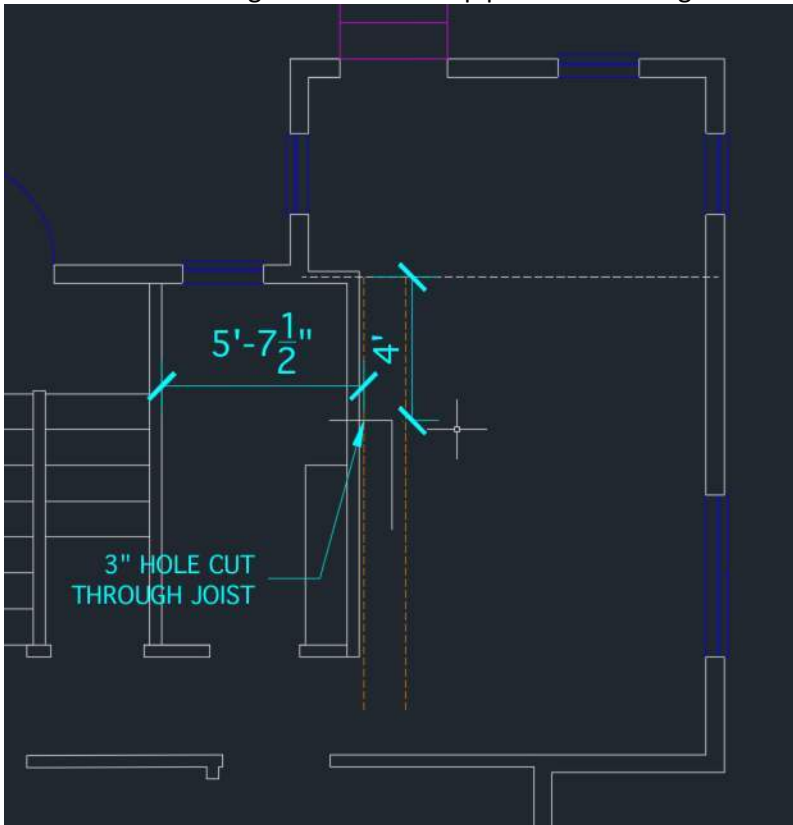
I think this is the rough location of the pipe from the images I have that what I am seeing

- The joist with the drilled plumbing needs to be addressed. Attach a 30" CS14 strap to the bottom of the damaged joist, centered below the hole.
 - Alternative option: Attach a 30" long 1/4" thick steel plate to the bottom of the joist. Plate to have same width and nailing as the CS14 strap.

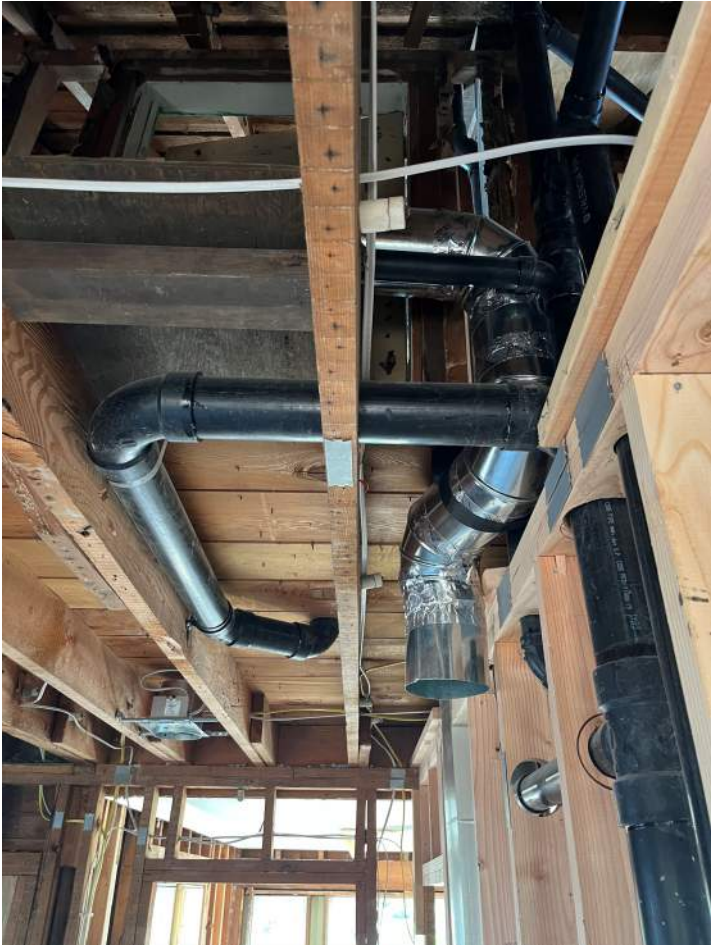
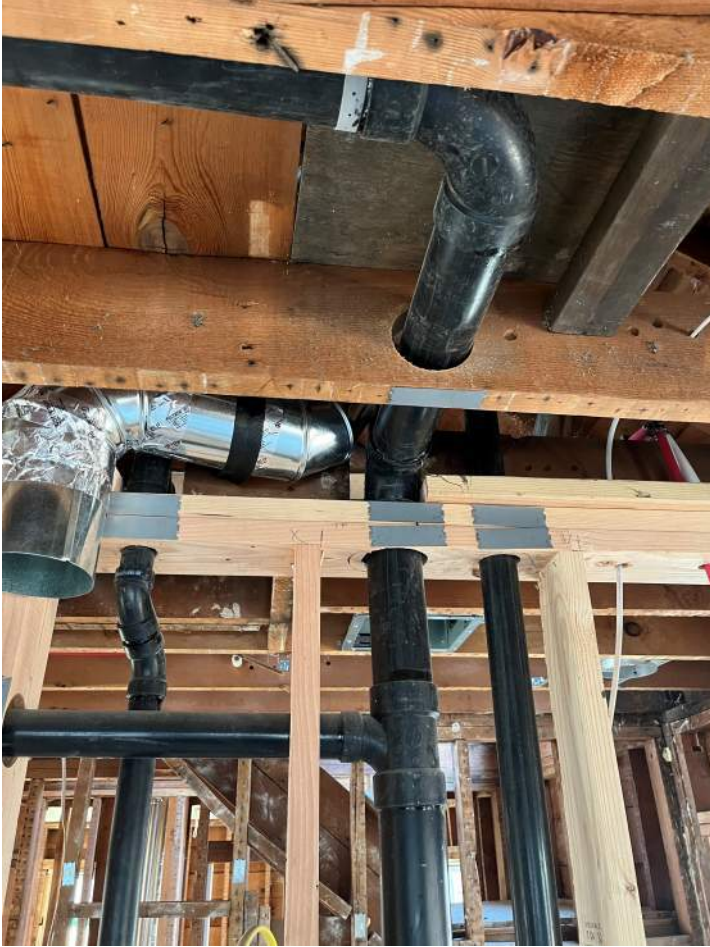
On Tue, May 9, 2023 at 3:15 PM Greg Carlson <gregcarlson1984@gmail.com> wrote:
If the bathroom wall (less than 2' away), then it's the wall in the 1st pic below which is less than 10' I'm out of town otherwise I could go there to

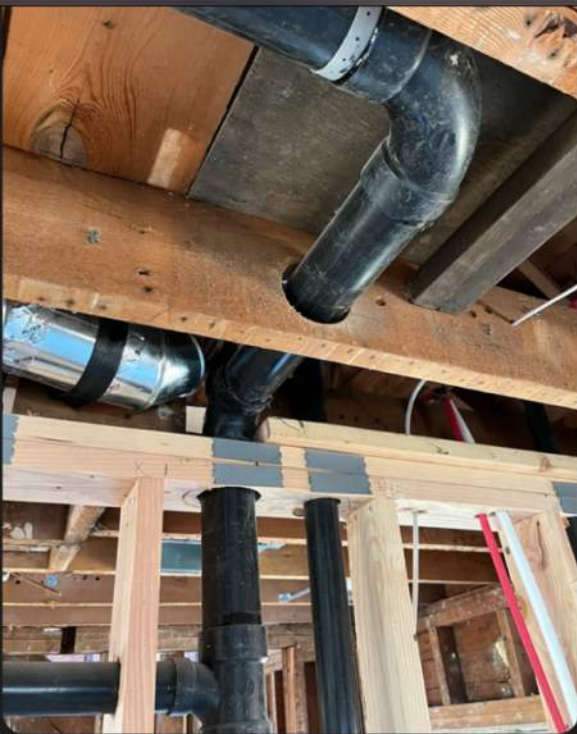
Hi Zac. Need to reinforce this joist per the inspector & wants a EOR letter with calcs. Joist is 2 x 7. Plumbing is 3". Can you have your engineer do this please? Let me know if he needs more info. It's always something.... Thx
