Johnson Creek Restoration Projects Effectiveness Monitoring

Reporting on data collected from 1997 through 2010

DECEMBER 2012

ENVIRONMENTAL SERVICES
CITY OF PORTLAND
working for clean rivers

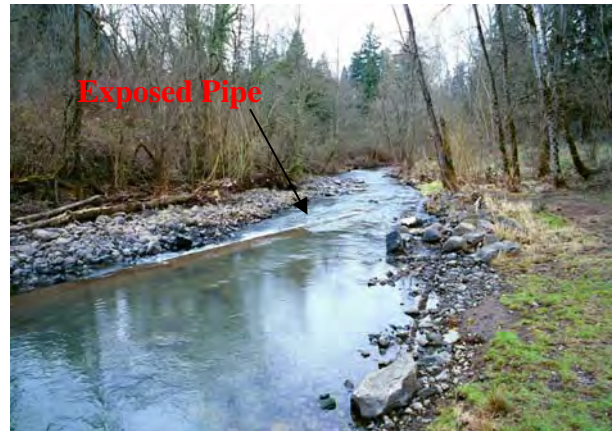
Environmental Services completed the Tideman Johnson Natural Area Restoration Project in November 2006 to repair the Lents Interceptor sewer. The Lents Interceptor is a 60" concrete pipe that conveys combined wastewater and stormwater from SE Portland to a pump station on McLoughlin Boulevard. The interceptor crosses under Johnson Creek in five locations, two of these crossings are within Tideman Johnson Natural Area. When it was built in 1922, the pipe was buried about five feet below the creek bed. Since that time, erosion of the streambed exposed the upstream section of the pipe leaving it vulnerable to damage (Photo 2a).

Photo 2a: Exposed sewer pipe crossing Johnson Creek at Tideman Johnson Park before restoration.

In Summer 2006, construction crews diverted 1,800 linear feet of the creek around the site, and encapsulated the Lents Interceptor with concrete. The streambed was raised by importing gravels and cobbles to re-bury the pipe and provide valuable salmonid spawning habitat. Engineered logjams (ELJ) were placed in multiple areas downstream of the pipe to prevent future erosion. Large wood and boulders stabilize stream banks, reduce stream velocity and provide habitat. High flow channels and wetlands were added to increase habitat and flood storage (Photo 2b).

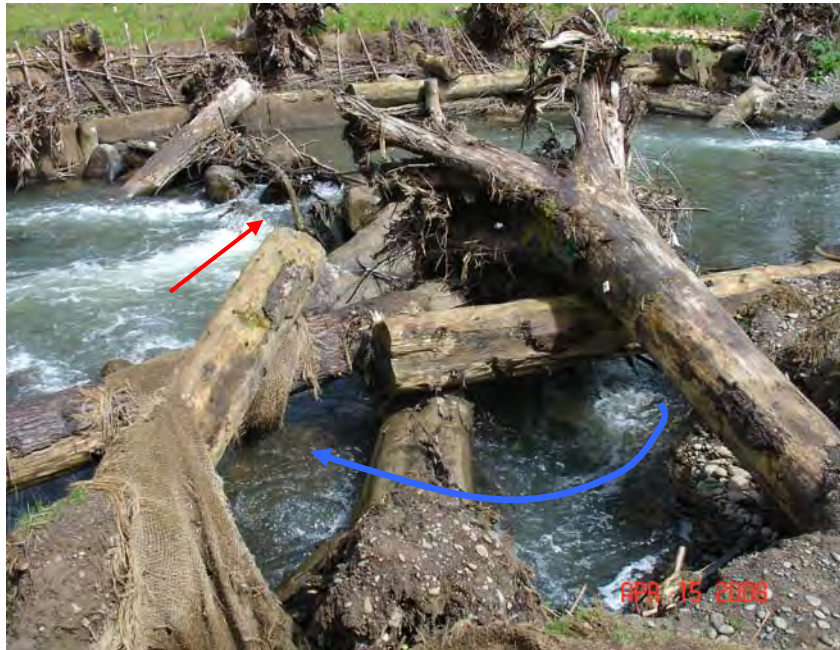
The ELJ capture typical urban debris (e.g. trash, tires, vegetation) blocking stream flow. In come cases, the stream diverted around the ELJ, causing significant bank erosion. To alleviate this problem, Environmental Services trimmed logs within the ELJ, reducing the capacity for debris to build up and returning the thalweg of the stream to its designed location (Photo 4).

Photo 4: The lower most engineered logjam at the Tideman Johnson Restoration site. The red arrow shows the center of the stream which is being blocked by debris. The increase in resistance diverted stream-flow, causing bank erosion and exposing buried logs (blue arrow).

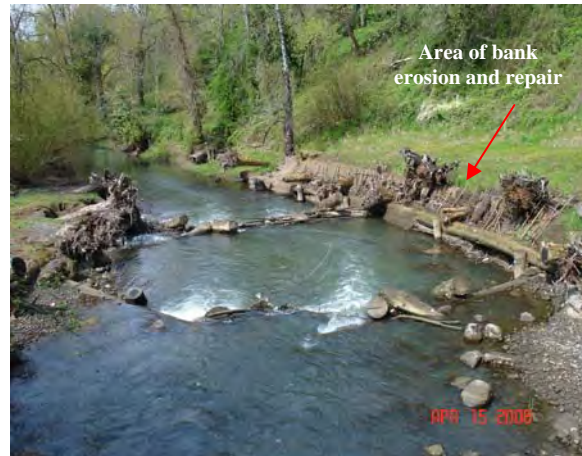
Photo 6: Tideman Johnson; erosion at lower extent of project began shortly after project completion on right bank. Willow stakes were place in the bank to prevent further erosion.

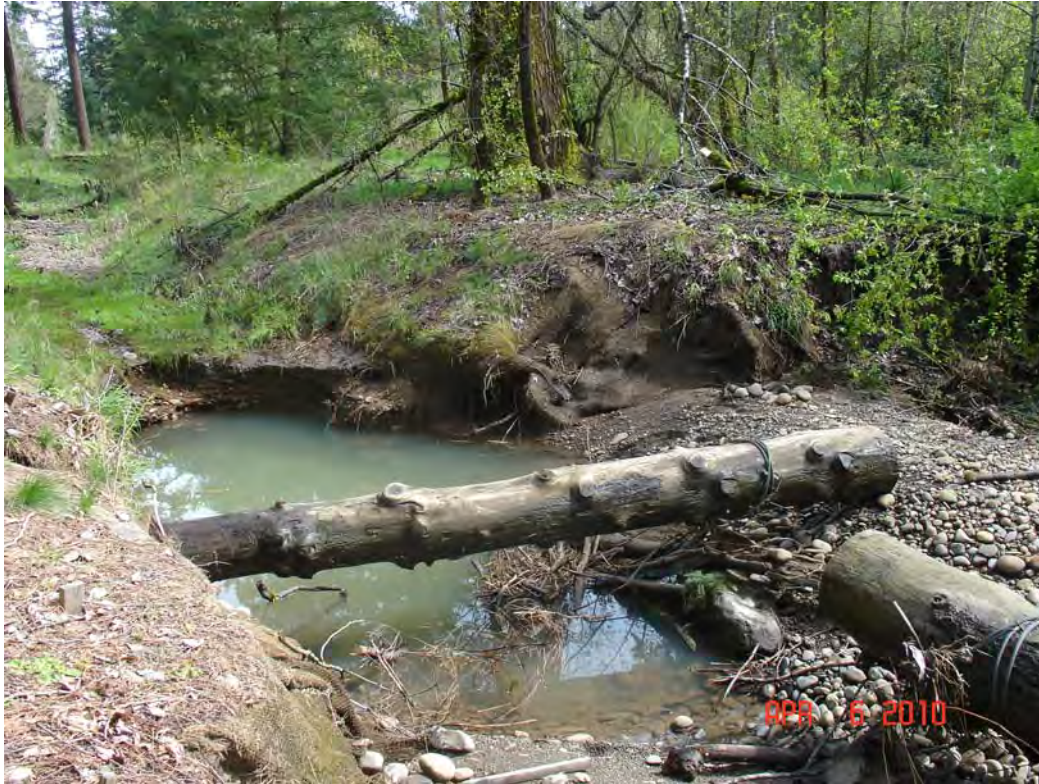
Photo 7: Scour hole at Tideman Johnson Park, in lower overflow channel.

In 2008, BES staff considered repairing the scour holes in the lower overflow channel. Oregon Department of State Lands (DSL) deemed the repairs to be below the 50 cubic yard threshold and therefore, not within the DSL jurisdiction. U.S. Army Corp of Engineers (USACE) determined the work could proceed through a minor modification to the original permit. The City of Portland’s Bureau of Development Services (BDS) regulations require the proposed repair to be in substantial conformance with the original permit application before the repair could be approved. It was determined that the repairs did not meet the substantial conformance criteria and would require a new City permit. BES Engineering Services determined the repair to be non-critical in its current state. Since then, scour continues to occur during annual high flow events. Continued monitoring will determine whether the scour threatens re-exposure of the upstream sewer pipe. Should repairs be required to stabilize the area, necessary permits will be obtained to restore the site as needed.

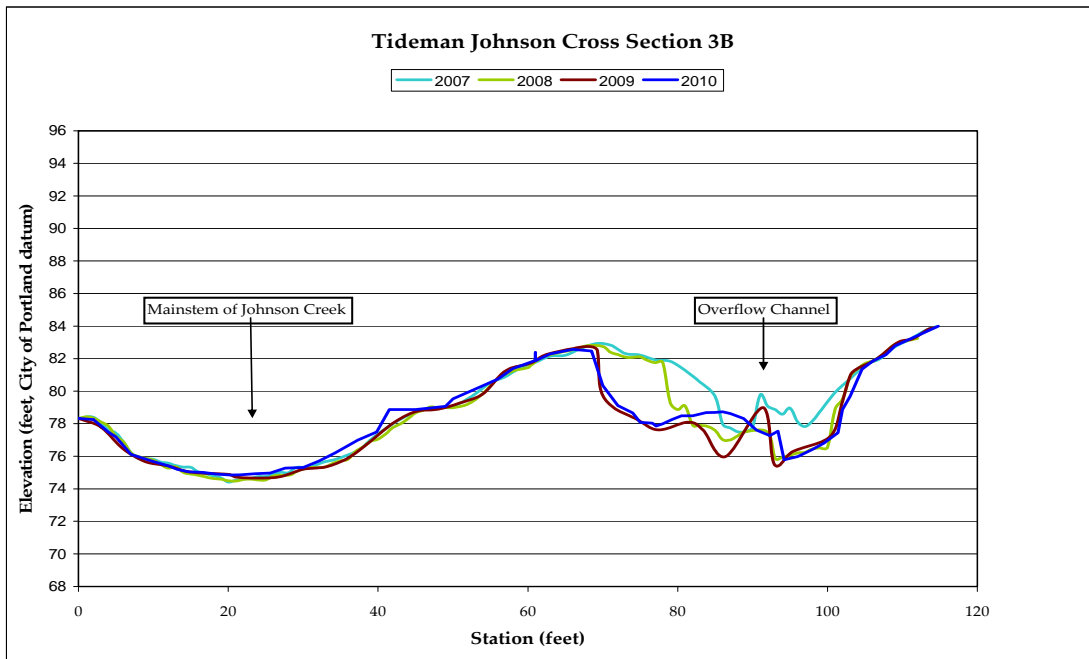
Figure 7: Cross-section 3B showing the erosion occurring within the overflow channel in the Tideman Johnson Restoration Project from 2007 to 2010.

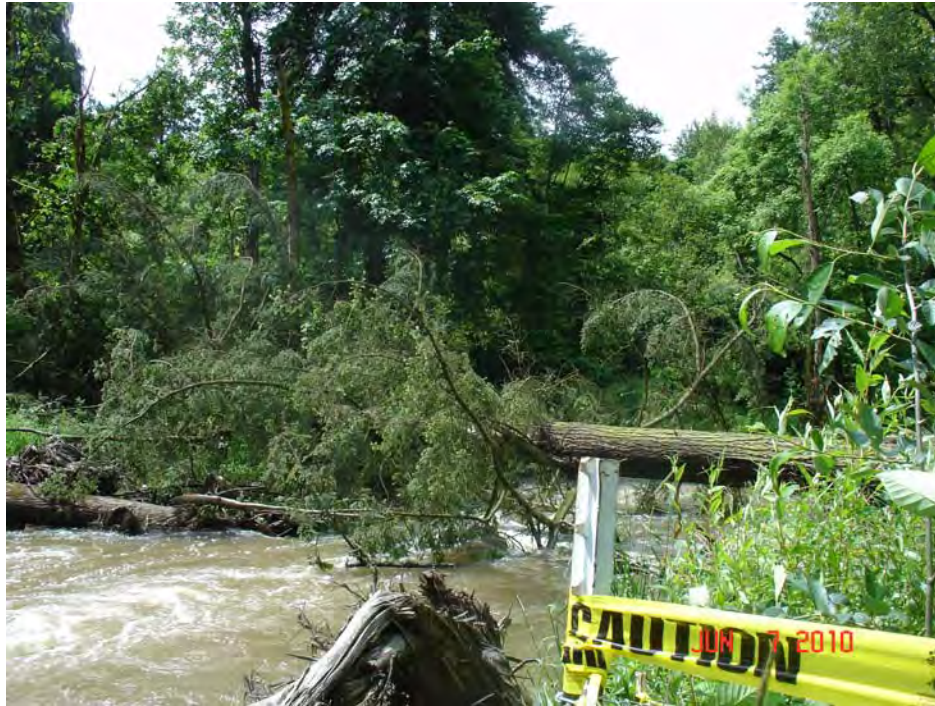
Erosion has occurred in multiple areas throughout this site. The restoration project area is significantly constrained by the Springwater Corridor Trail and utility towers and pipes to the north and private property to the south, limiting the degree to which high flows can be dispersed laterally. Erosion on the right bank compromised the root structure of a mature Douglas fir tree, causing it to fall across the creek and onto private property (Photo 8). To reduce potential of further erosion to the site caused by debris collecting on the channel-spanning log,

Photo 8: Tideman Johnson Restoration Project. Bank scour around root zone resulted in Doug fir falling across Johnson Creek.

a portion of the tree was cut and moved to the left bank while the rootwad remains on the right bank.

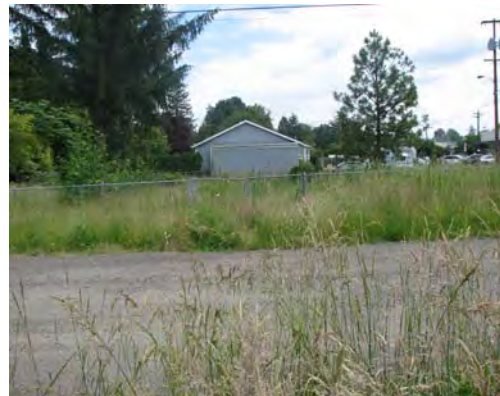
Photo 9a: Errol Creek runs under SE 44th. The culvert is a barrier to fish passage.

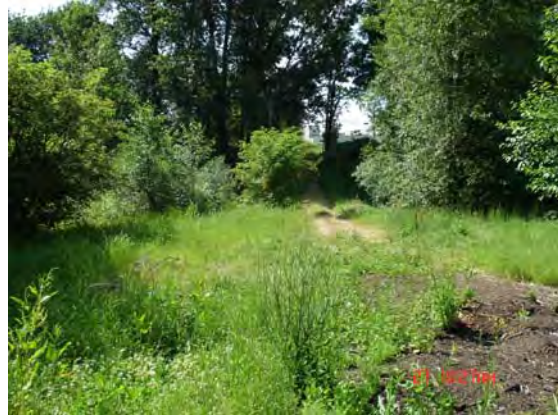
Photo 12a: Prior to restoration, private drive over stream creates fish passage barrier at Errol Heights Wetlands.

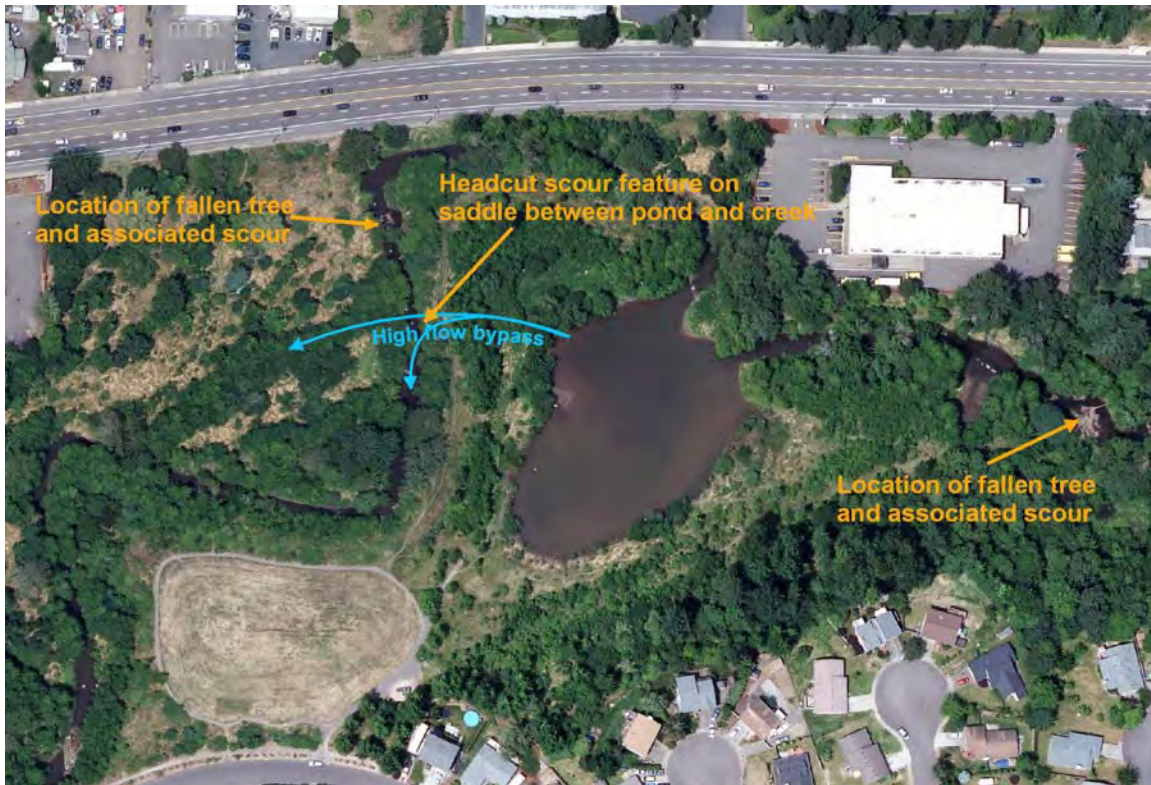
In addition to the bank scour directly associated with the fallen trees, bank scour was observed 80 feet downstream of the debris jam. This scour appears to be a head-cut created by high flows overtopping a saddle-shaped depression between the pond and a downstream section of the creek (see Photo 15). This saddle shaped high-flow bypass feature mimics a meander scar and was designed as part of the Brookside Wetland Restoration Project.

Photo 15: Brookside Wetland, large wood recruitment and scour locations.

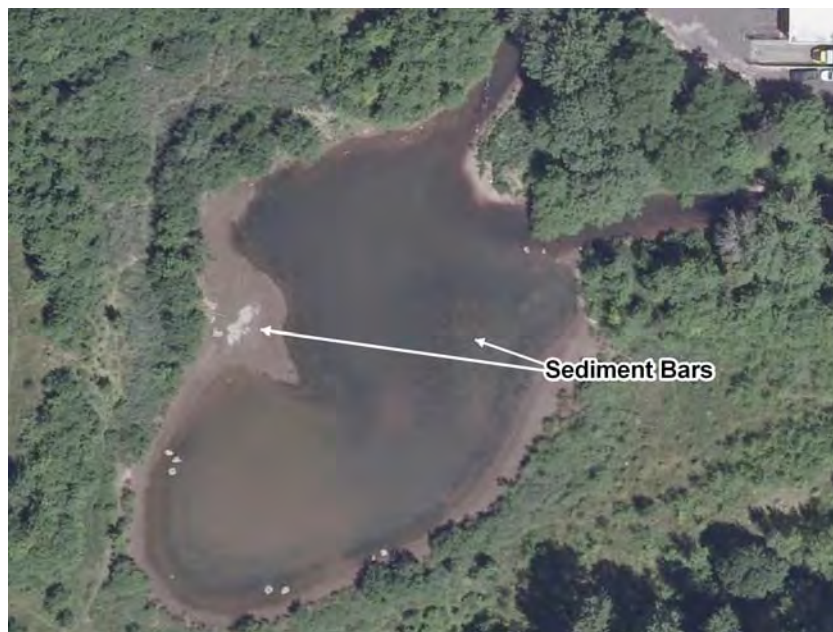
Visual inspections and photo documentation discovered sediment bars forming within the pond. Vegetation has been planted in these bars to encourage more sedimentation with the expectation of cutting off the pond from the stream channel during summer low-flow (Photo 17). The vegetation will also shade the stream and pond, reducing solar heat gain and enhancing amphibian and turtle habitat.

Photo 17: Sediment bars forming in Brookside embayment pond, 2008 aerial.

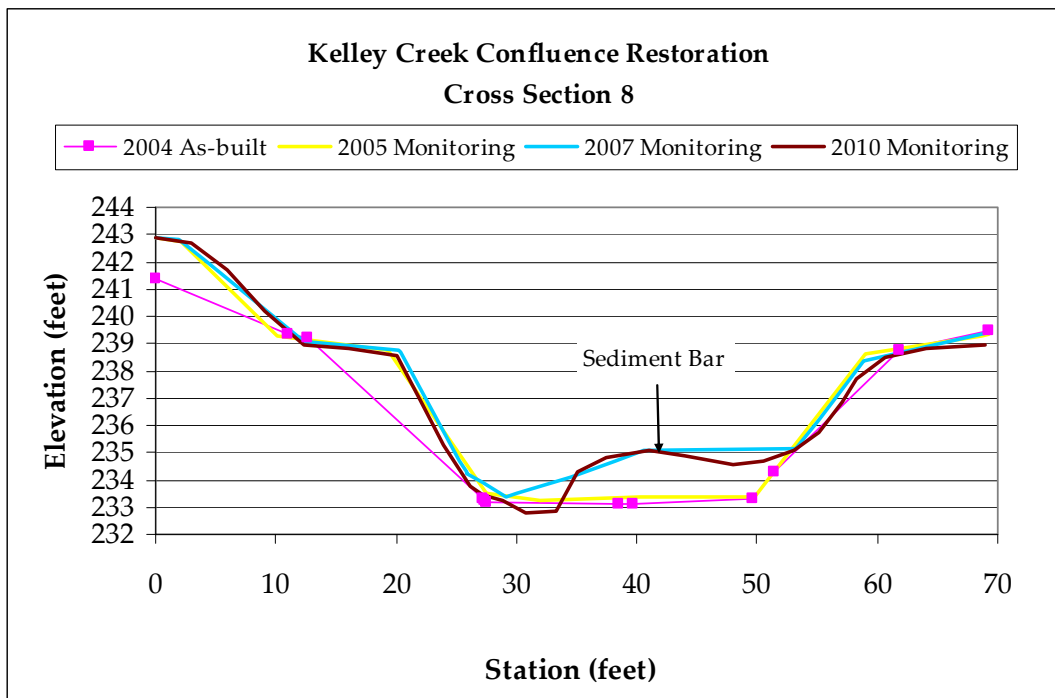
Figure 11: Cross-sectional data for Kelley Creek Confluence, survey is conducted closest to the confluence of Kelley and Johnson Creeks. A sediment bar has formed on the right bank as shown in the graph.

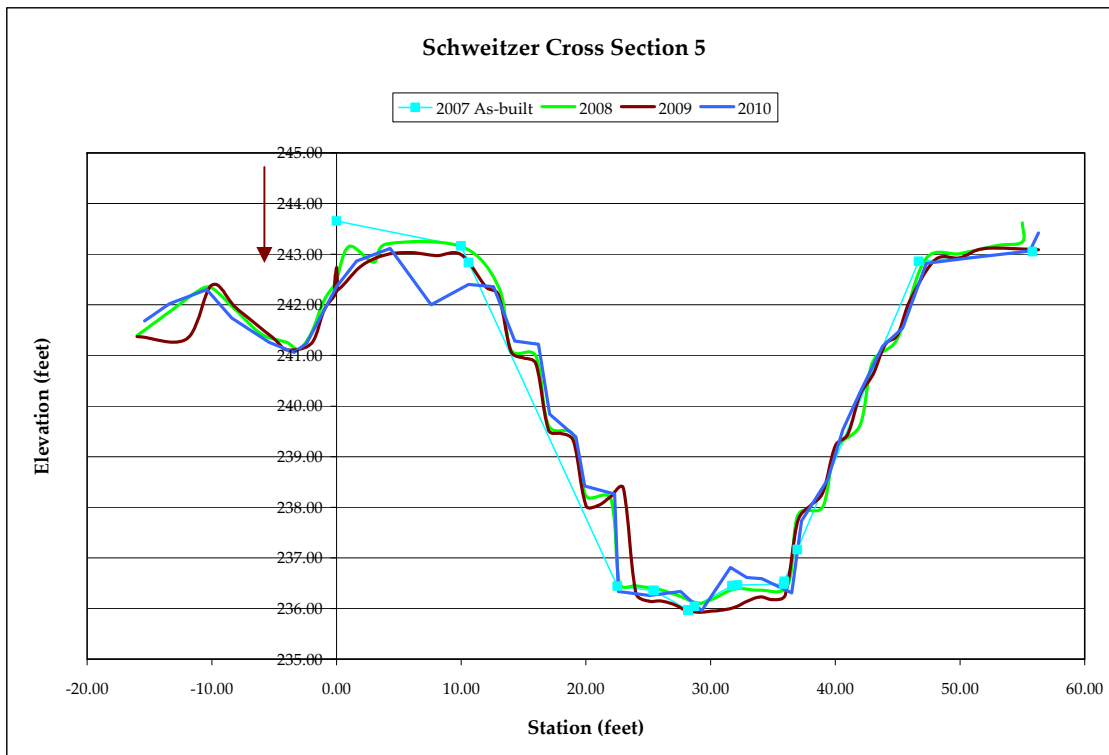
Cross-sectional surveys have been conducted annually since the project was completed in 2007 (Photo 23). Cross-sectional data shows little change within the stream channel. Some sediment deposition occurred on portions of the banks in the middle of the project area. In 2008, scouring was noted beyond the top of bank on the south side of the channel at cross-section 5. This scour is occurring around the large wood structures on the floodplain. The cross-sectional survey area was extended to include this portion of the floodplain to monitor any increase in scour. Cross-sectional data shows scour is slowly increasing. Further monitoring is necessary to determine if adaptive management measures are required (Figure 14).

Figure 14: Schweitzer Natural Area cross-sectional survey data for Section 5, shows scour occurring around large wood structure on the left bank floodplain (red arrow).

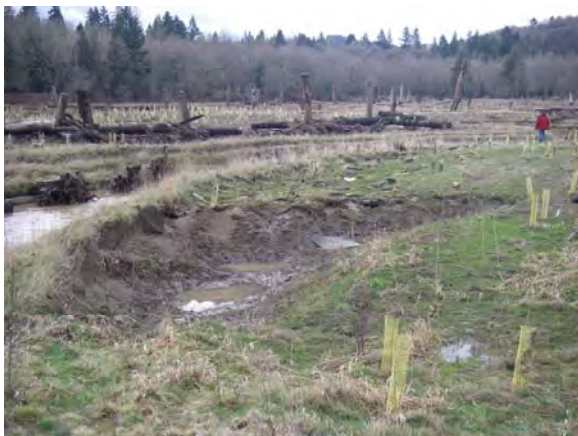
The Schweitzer Restoration Project has experienced two flood events since project completion. The first, approximately a 6-year event in 2007, just after construction completion, caused a scour hole in the floodplain at the uppermost extent of the project area. The second in 2009, of much greater magnitude (29-yr), caused further scouring (Photo 24a). It was determined that repair was necessary. Repairs were completed in Summer 2009. Large wood was incorporated into the repair to slow flows and reduce the likelihood of recurring scour (Photo 24b).

Photo 24a: Schweitzer Natural Area. Scour hole began to form at the upstream extent of project.

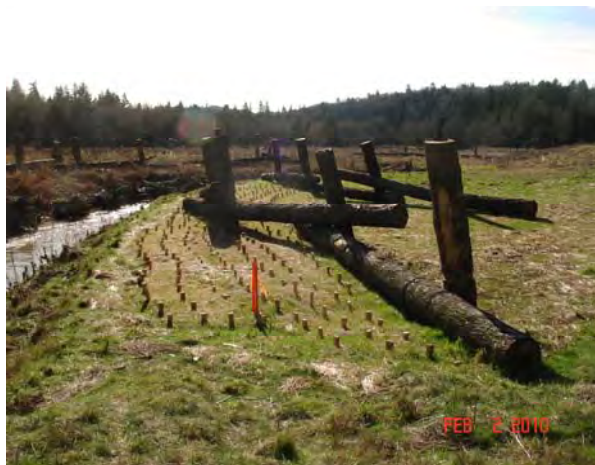
Photo 24b: Schweitzer Natural Area. Scour hole repair.
