WOODLAWN NEIGHBORHOOD DEVELOPMENT PROJECT

(PROGRAM A-5-1)

PROPERTY IDENTIFICATION

PARCEL NO	6-3	ADDRESS	1124 N.	Ε.	Oneon ta	Street	
LEGAL DESCRIF	TION Lot 3	, Block 6,	WOODLAWN				
BELL.	Harold W. & N	lorma J.				LOT	
OWNER BELL. Lewis B. & Marjorie R.						AREA_	5,000 sa.ft.
ONTRACT PURCH PROPERTY DESC		Billie and	d Minnie

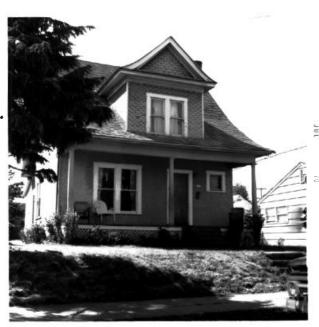
The subject is a 50' x 100' lot, concrete paved streets, concrete curbs and sidewalks, concrete steps, walks, concrete driveway in poor condition; level ground; no on-site improvements or drainage problems.

Improvements consist of a $1\frac{1}{2}$ -story frame building with composition siding, composition roof, fair condition; galvanized iron gutters and downspouts in good condition. Part of the rear addition has frame siding, some of which is on pier foundation, doesn't appear as though it is concrete.

Property was built in 1907. There is a large wood front porch; some of the skirting is in the dirt. Property has approximately 672 sq.ft. of living area on the main floor with an entry hall with hardwood floors, vinyl wainscoat; living room with lath and plaster walls, carpet over hardwood; hall to bath which has been finished with 3 white fixtures, linoleum floors, old medicine chest; kitchen finished with lineoleum floors, birch cabinets, needs formica counter top, has eating space and wired for range. The utility porch has been added on during past 10 years. There is extra storage area. It is finished with plywall and some sheetroc There is a fruit storage room. This part of the dwelling does not have crawl space vent. One bedroom is located off of the hallway.
