WOODLAWN NEIGHBORHOOD DEVELOPMENT PROJECT

PROPERTY IDENTIFICATION

PARCEL NO. 7-9 & 10 Lot 9: Vacant  
ADDRESS 1065 N. E. Woodlawn Street  
LEGAL DESCRIPTION Lots 9 and 10, Block 7, WOODLAWN

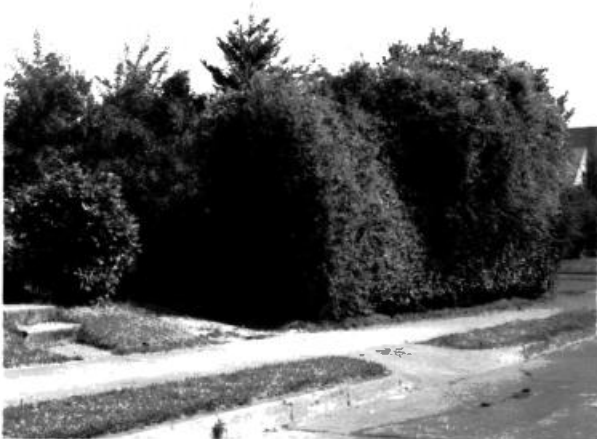
Improvements consist of a 1-story and attic frame dwelling built in 1926. It has a detached 18'x18' garage in poor condition with cedar siding, composition roof, used for storage.

The garage is almost deteriorated.

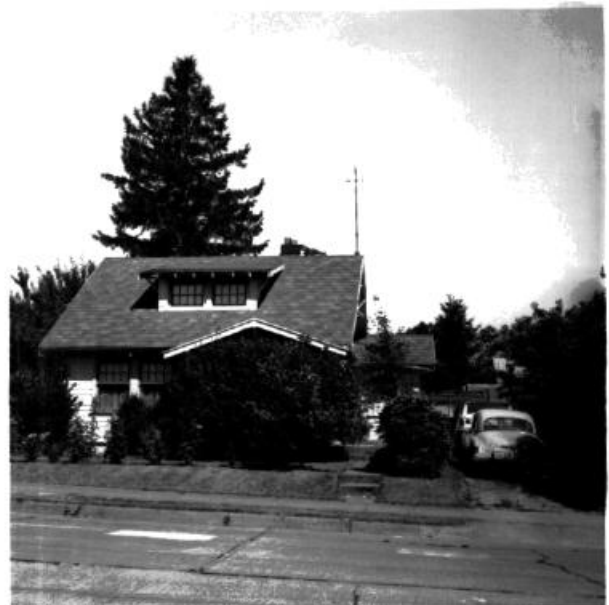
The dwelling is finished with cedar shingles and a composition roof in good repair. There is a covered wood front porch on adequate concrete foundations. The gutters in the front appear to be new. Some of window needs to be painted.
