## WOODLAWN NEIGHBORHOOD DEVELOPMENT PROJECT

(PROGRAM A-5-1)

## PROPERTY IDENTIFICATION

| PARCEL | NO14-7 | £ 8 | Lot 7:<br>ADDRESS | Vacant<br>1176 N. E. | Woodlawn Stre | eet |

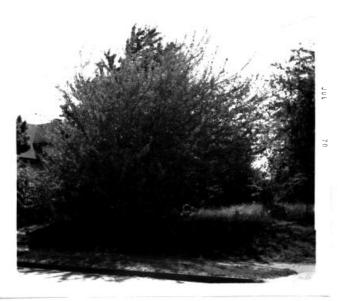
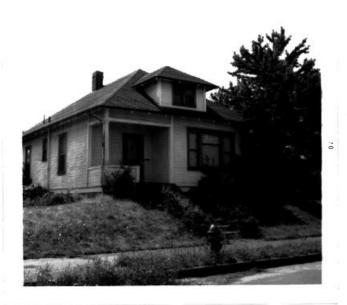
.3798

Improved with a 1-story and attic frame dwelling with full basement built during 1908. It has cedar siding in fair to poor condition; composition roof in good condition; gutters and downspouts in fair to poor condition. There is a covered wood front porch, wood steps in fair and poor condition. The property has a modern birch door.

There would be considerable work requirements to place the property in marketable condition. There is 960 sq.ft. of living area on the main floor.
