Burlingame Tanks Improvements Project

City Council Presentation

David Shaff
Administrator
July 13, 2011

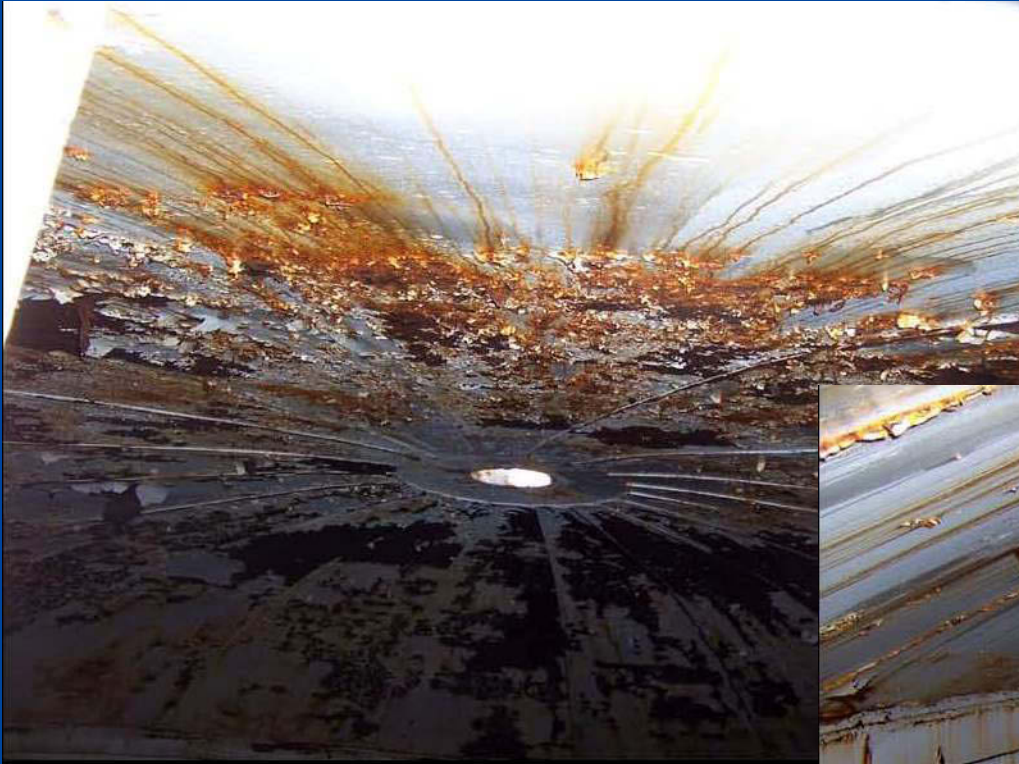
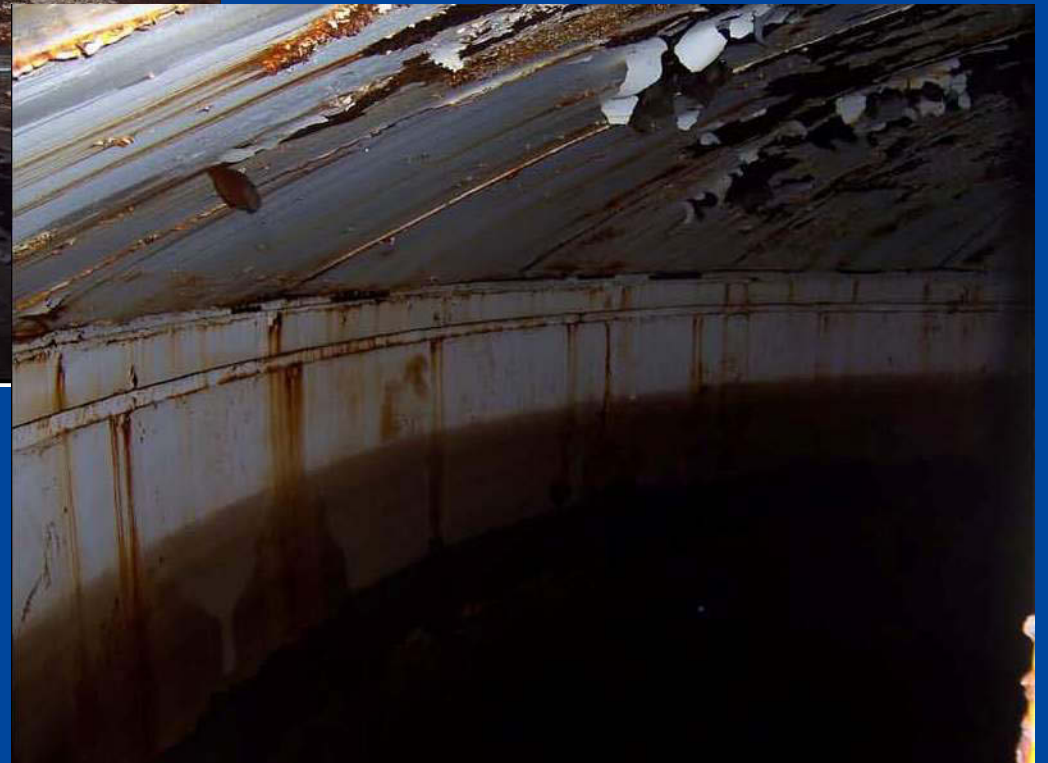
Interior Condition of Tank 4 During 2005 Evaluation – Paint is Failing

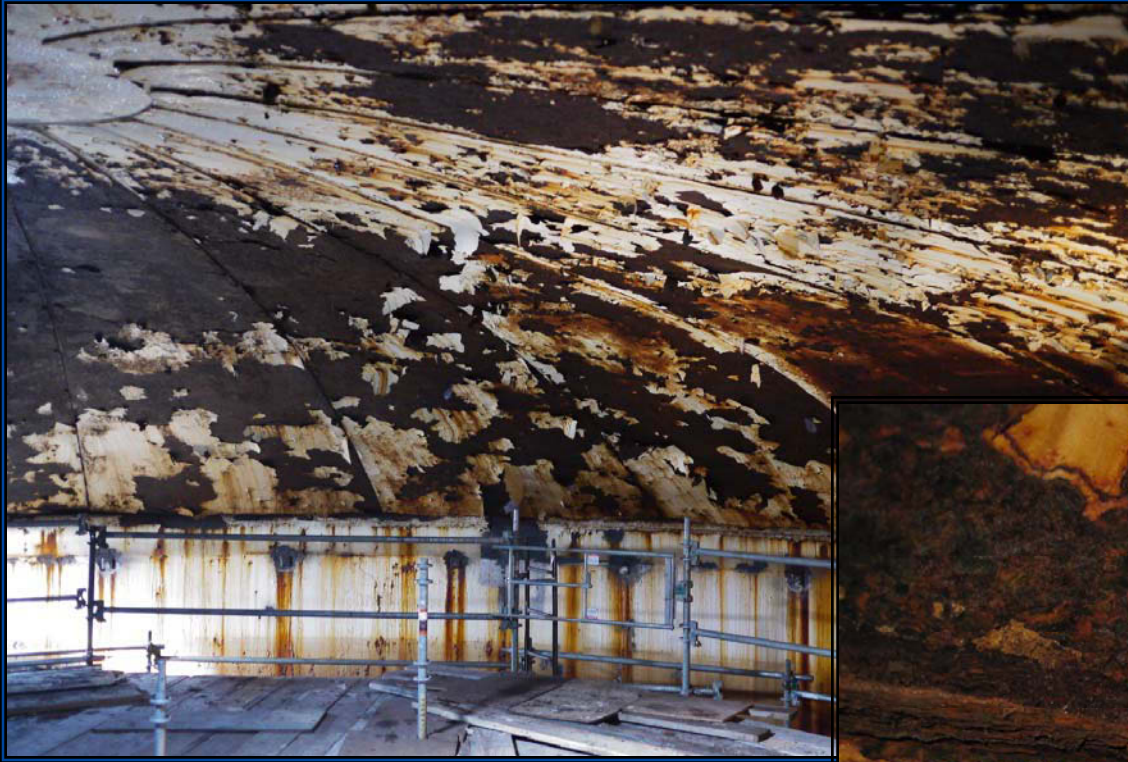
Interior Condition of Tank 4 During 2010 Construction

Paint failed and steel deteriorating

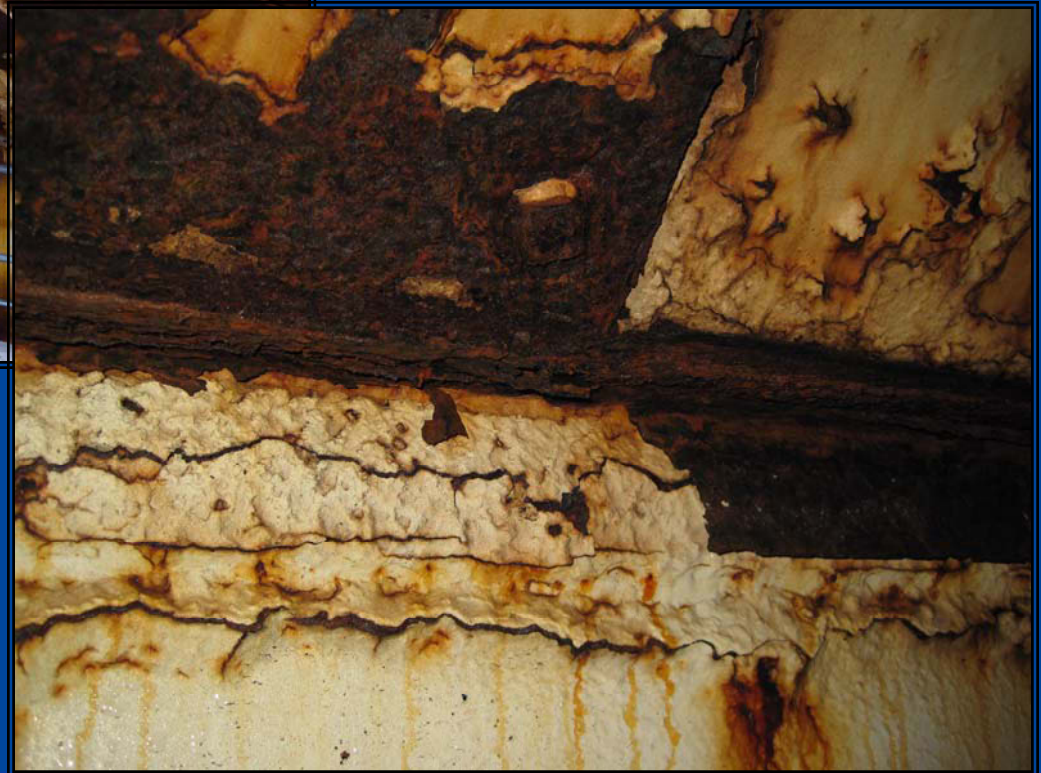
Steel at roof connection is corroded and unsound

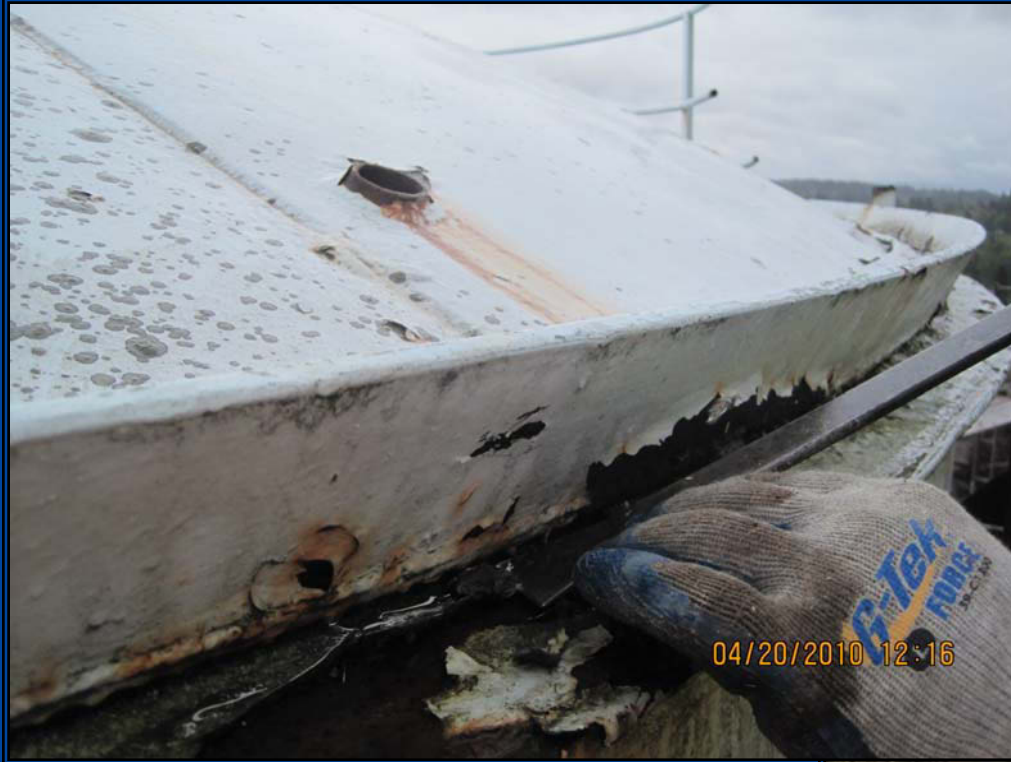
Exterior Condition of Tank 3 During 2010 Construction

***Steel at top connection
unsound***

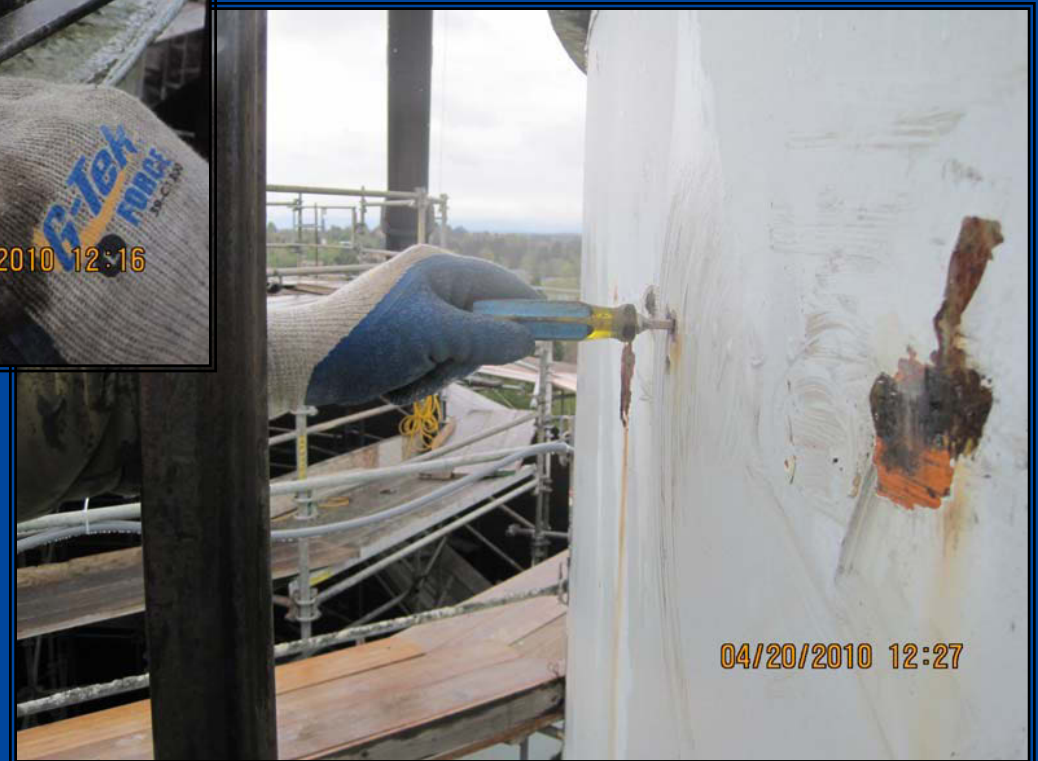
***Hole in sidewall with
screwdriver stuck through***

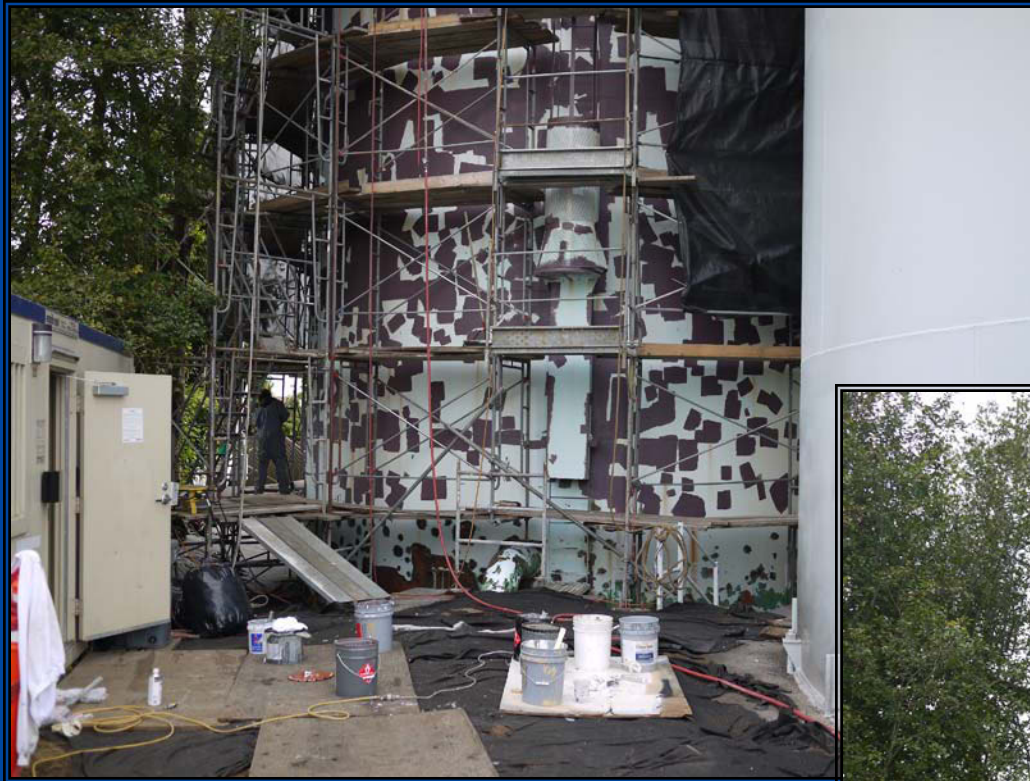
Exterior Spot Treatment

Purple areas are the spot treatment

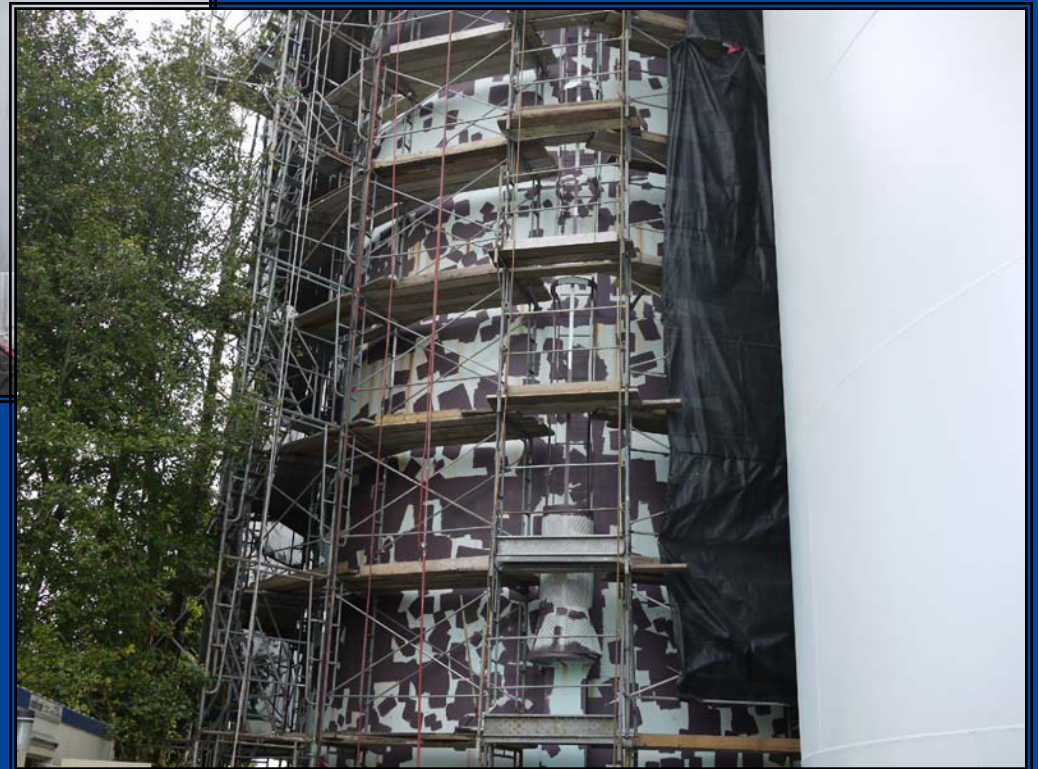
Spot treatment area is greater than 15%

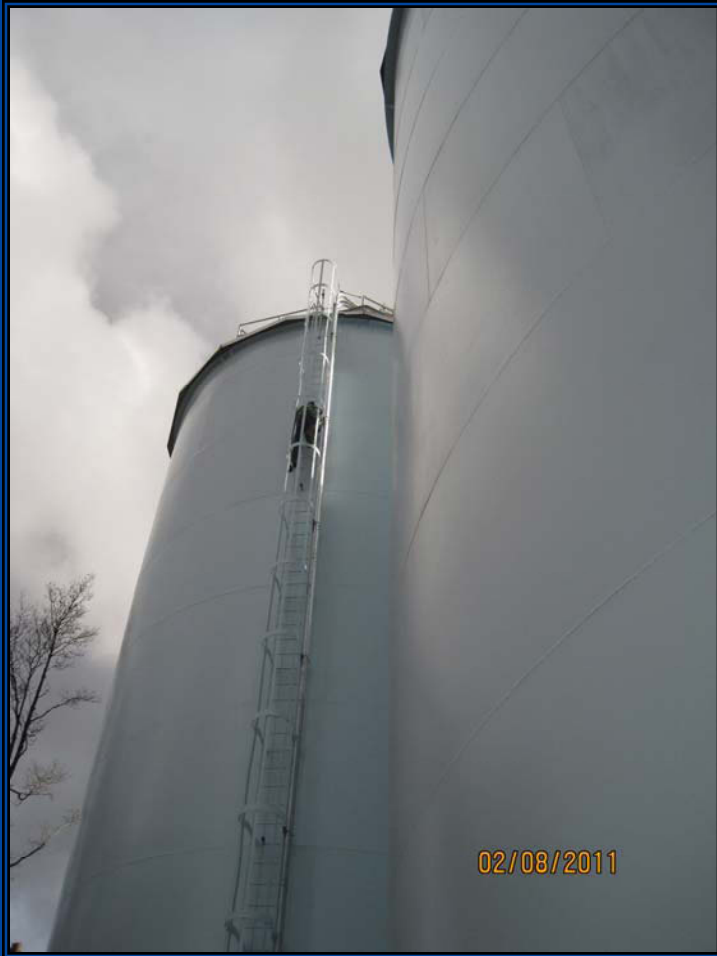
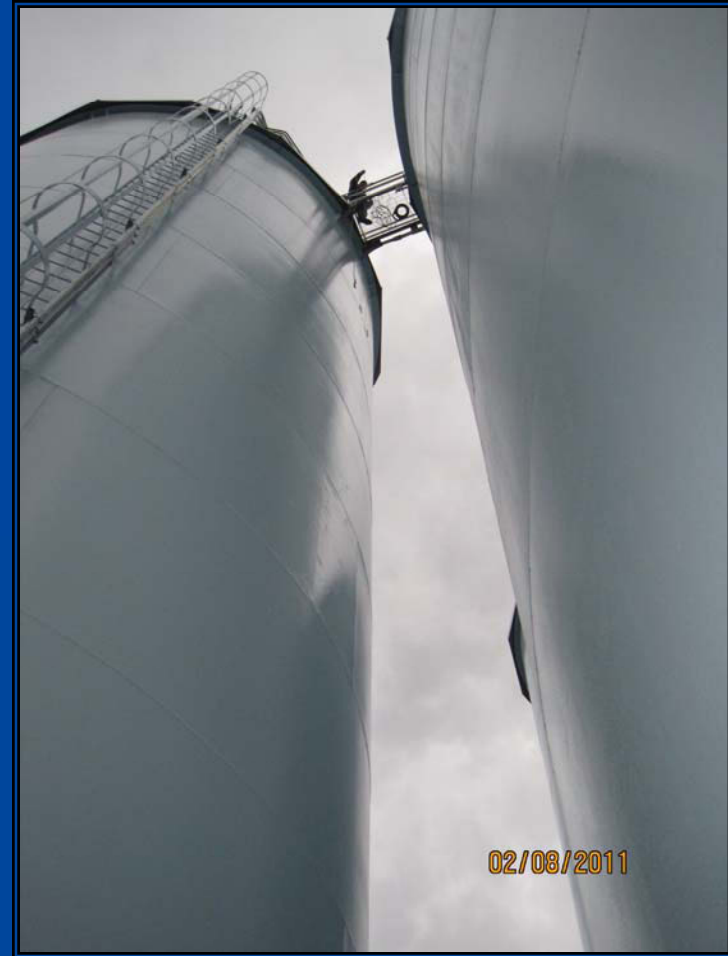
Final Condition of Tanks

Condition of tanks markedly improved
