**FUJITANI HILTS & ASSOCIATES, INC.**

June 19, 2001

PATIO DISTRESS
11100 SW RIVERWOOD ROAD
PORTLAND, OREGON

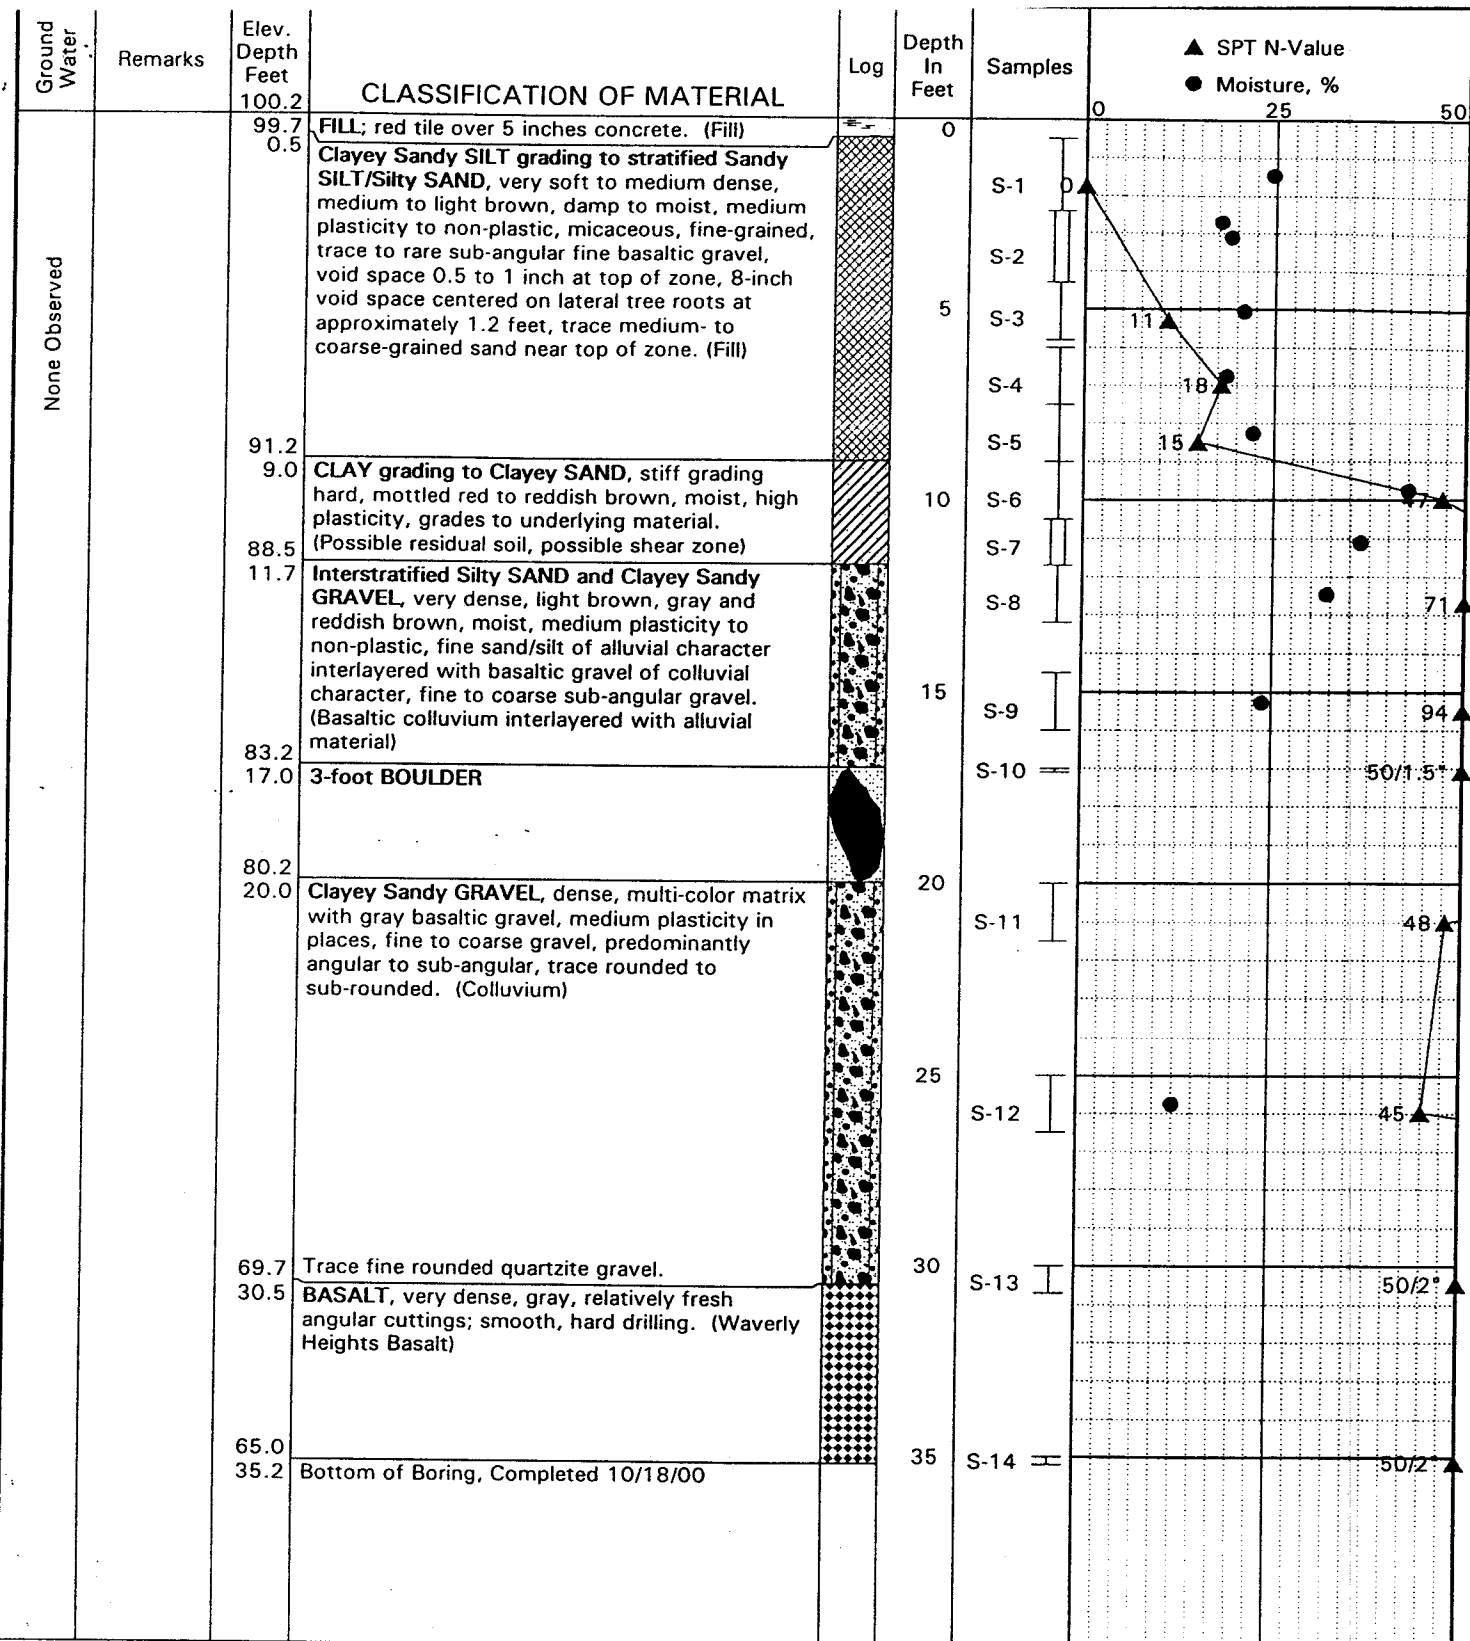
FIG. 3

The summary log of the boring is presented in Figure 3. Soil descriptions and interfaces on the log are interpretive, and actual changes may be gradual. The left-hand portion of the boring log presents groundwater information and gives our interpretation of the soils encountered during the field exploration program. The right-hand, graphic portion of the boring logs shows sample locations, the results of the SPT blow counts, and sample water contents.

The exploratory boring drilled for this study encountered ½-inch thick red tile overlying 5 inches of concrete forming the patio surface. A void space ranging from about ½- to 1-inch thick was observed immediately underneath the concrete pad. A standard split-spoon sample taken in the silty material at the base of this void at a depth of approximately 0.5 feet dropped under its own weight to approximately 2.4 feet, and a void space measuring at least 8 inches in thickness centered on a tree root was later observed in this interval. The soil recovered from this first sample is classified as very soft, light brown, medium plasticity, clayey sandy silt. Further sampling indicated this material grades to medium dense, low- to non-plastic, stratified sandy silt to silty sand at about 3 feet, extending to a depth of approximately 9 feet. A layer of gravelly silt/silty gravel was encountered at approximately 7.5 to 8 feet overlying additional silty sand as observed above. Stiff, red, high plasticity clay was encountered at a depth of 9 feet that grades to hard, sandy clay by 9.5 feet and then to medium dense, clayey sand with slight gravel by 10.5 feet, extending to a depth of 11.5 feet. From 11.5 feet, stratified, very dense, light brown silty sand and reddish clayey sandy gravel were encountered to a depth of 15 feet. A boulder was possibly present between 17 and 20 feet (the driller reported drilling alongside this boulder, not through it). Dense, multi-colored, clayey, sandy gravel with estimated maximum clast size of 2 inches was encountered from 20 to 30.5 feet overlying very dense, relatively fresh gray basalt in which the boring was terminated.

The red clay encountered at a depth of 9 feet is interpreted as a possible topsoil zone derived from the weathering of colluvium and may possibly indicate a shear zone. The materials from 9 to 20 feet in depth appear to be a graded bed of colluvium or landslide debris (bouldery base grading upwards to sand and then clay), but also show layers of alluvial deposition of light brown sand/silt above 15 feet. The very dense, gray, relatively fresh basalt encountered from 30.5 to 35.2 feet is interpreted as Waverly Heights Basalt.

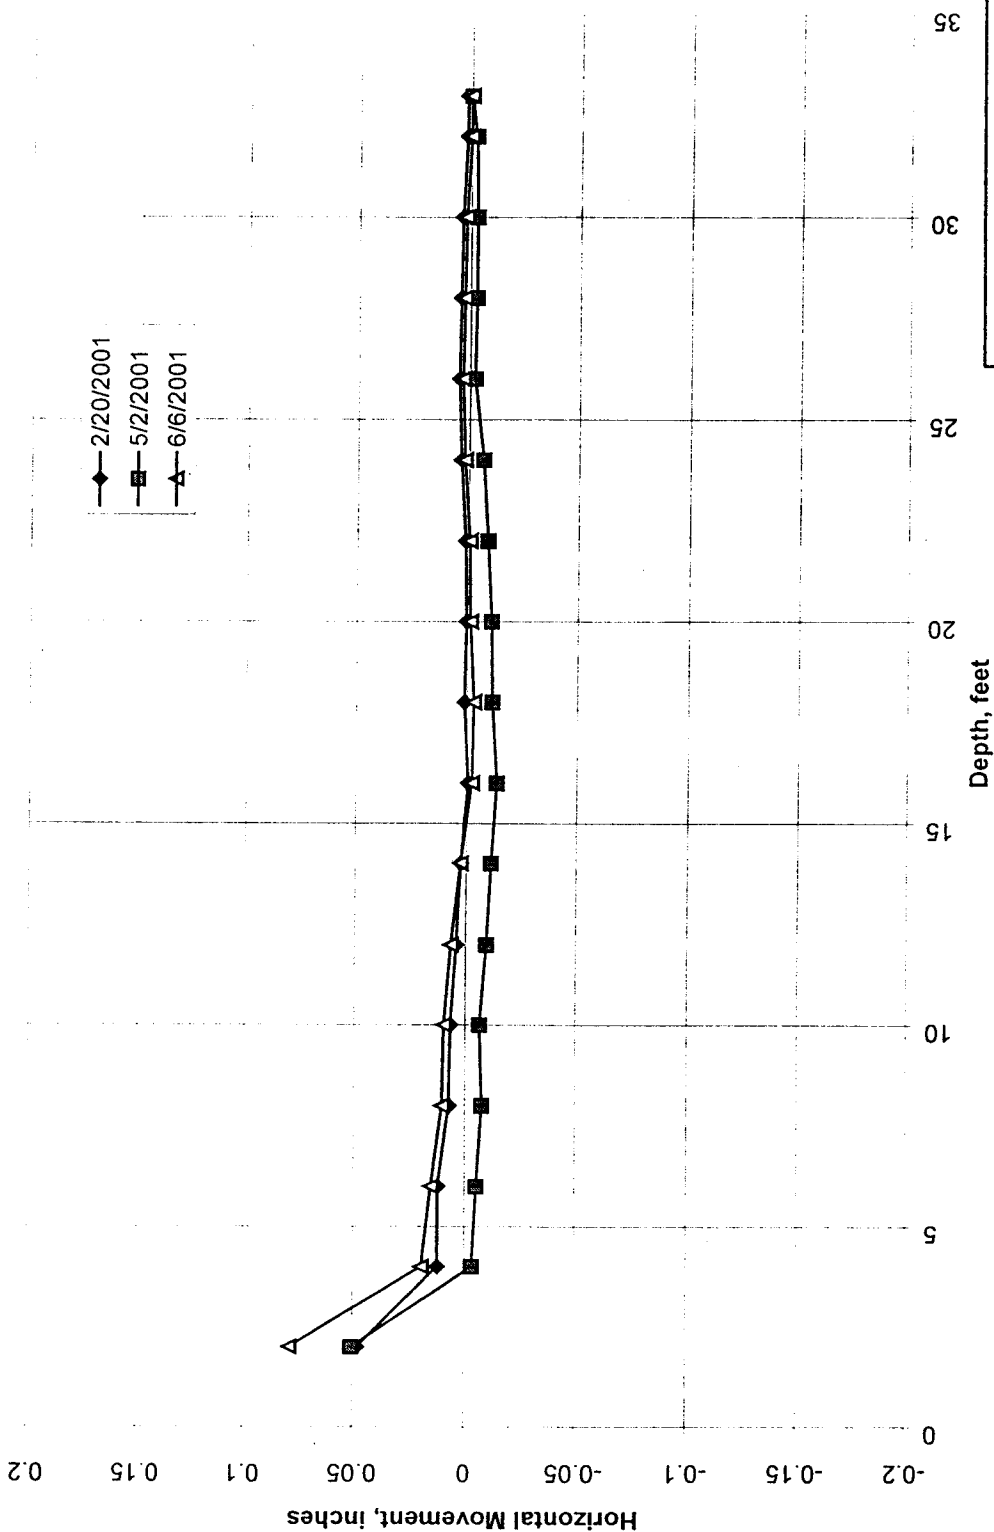
FIG. 4

The initial survey of the inclinometer casing was made on October 26, 2000, and subsequent readings were taken on February 20, May 2, and June 6, 2001. The results of the readings are shown plotted on Figures 4 (A-axis) and 5 (B-axis). The initial reading is the vertical line through zero on the movement scale. As can be seen from Figures 4 and 5, the readings do not indicate conclusively that movements occurred over the observation period, although the data may show the beginning of slight movement at a depth of 15 feet. The lack of good data is due, most likely, to the dry winter

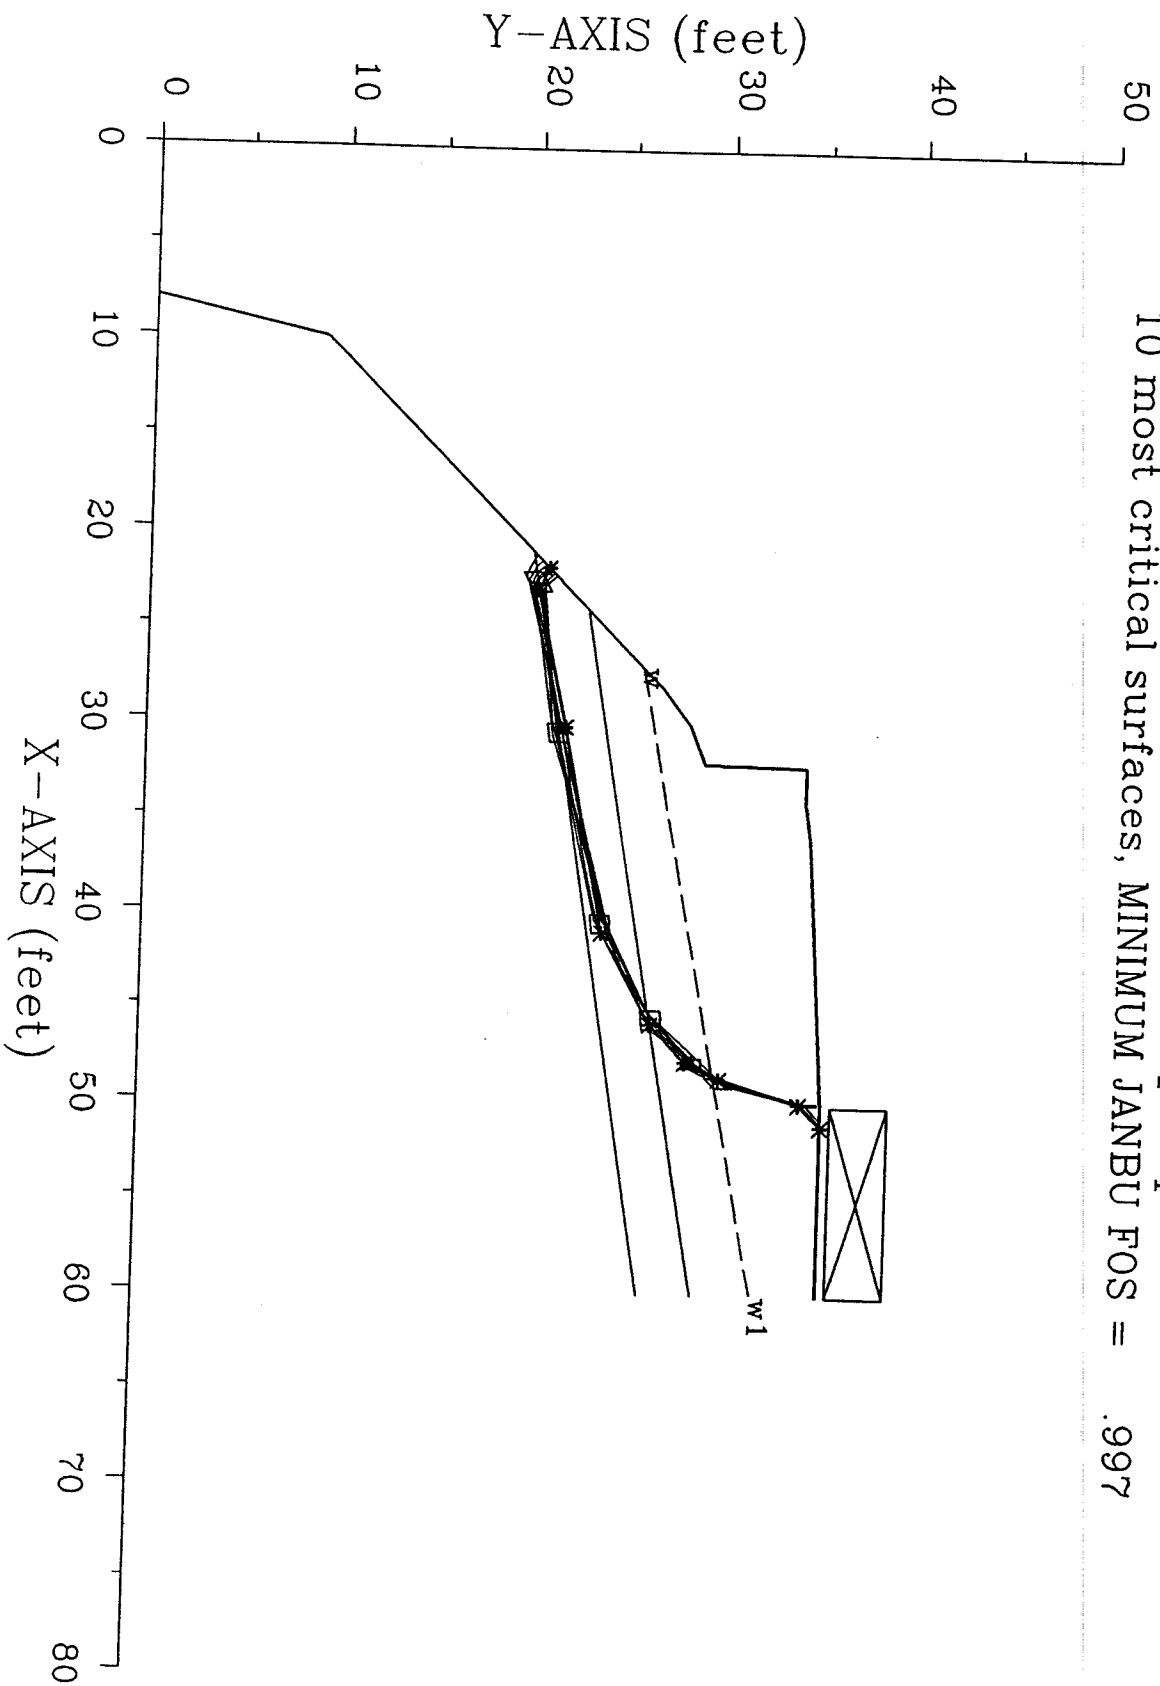
The results of the stability analysis indicates that the average shear strength required along the assumed failure surface is 220 pounds per cubic foot for a factor of safety of 1.0. The stability calculations for the existing conditions are included in the Appendix to this letter report.

Cummins Residence C=220 psf $\phi=0$
10 most critical surfaces, MINIMUM JANBU FOS = .997

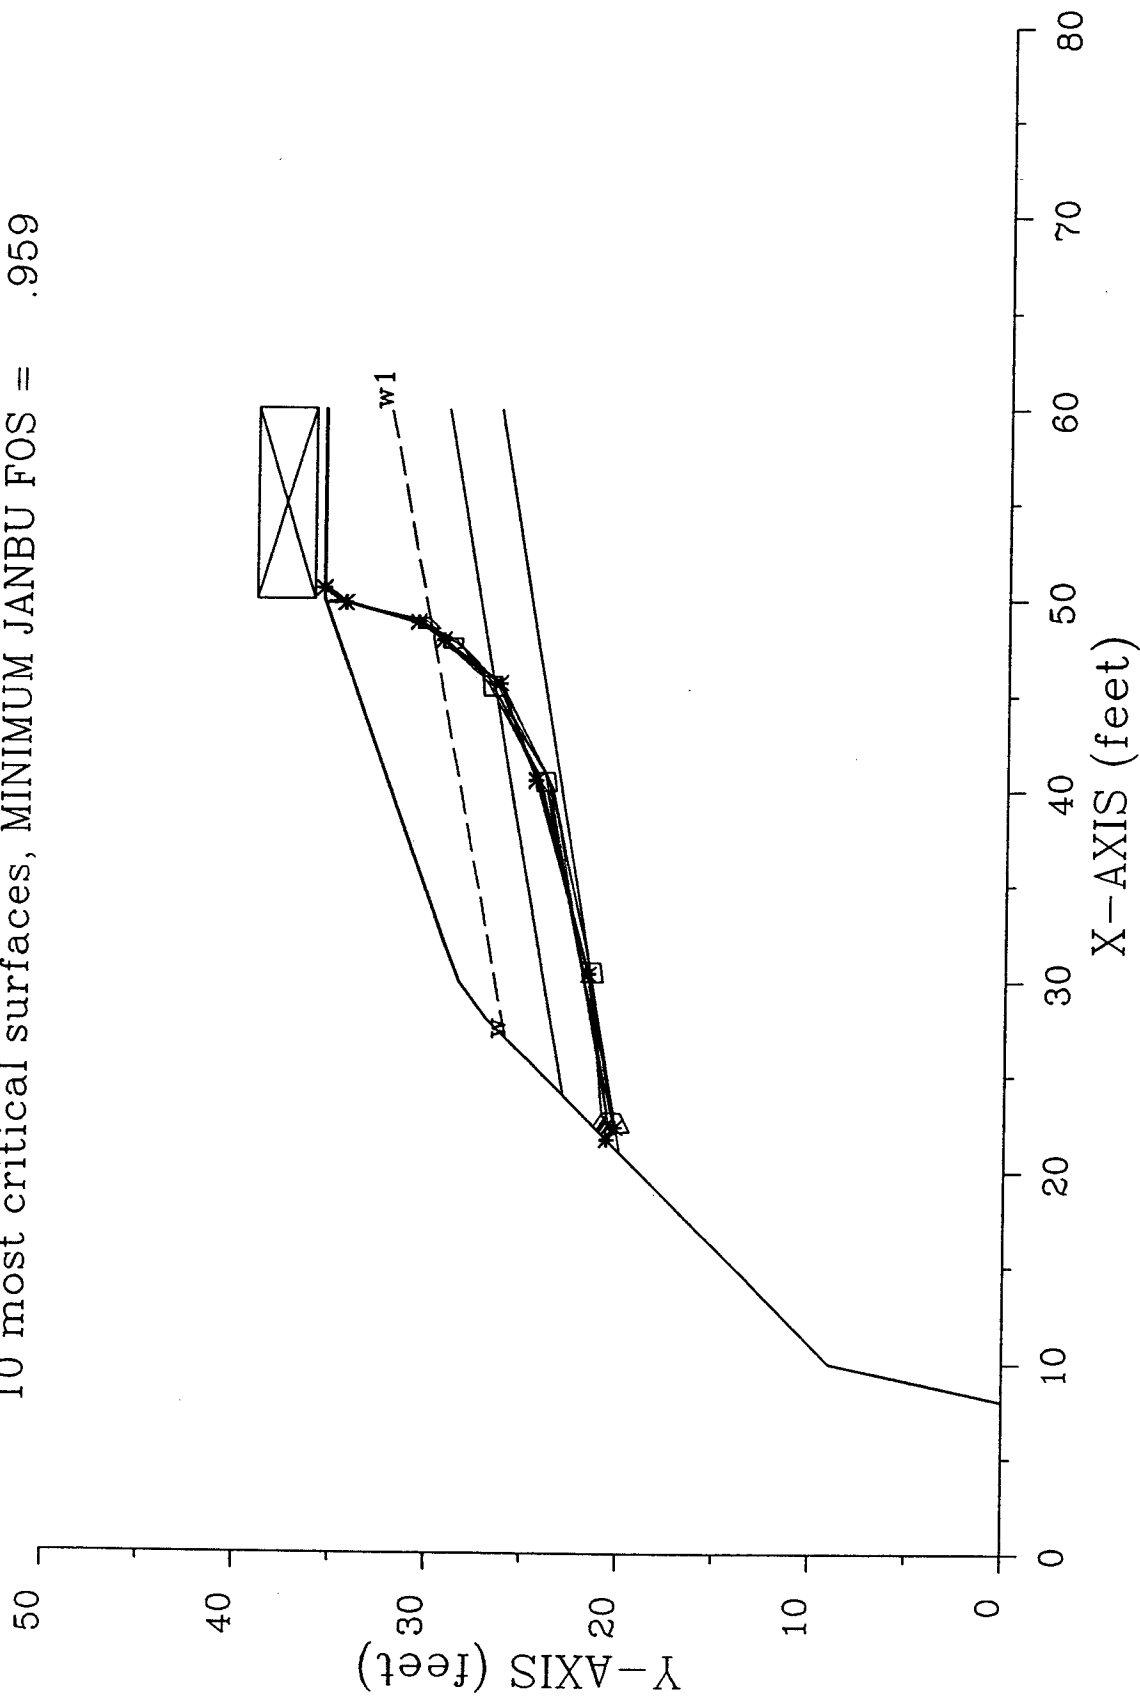
Cummins Residence $c=0$ $\phi = 22.5$
 10 most critical surfaces, MINIMUM JANBU FOS = .959

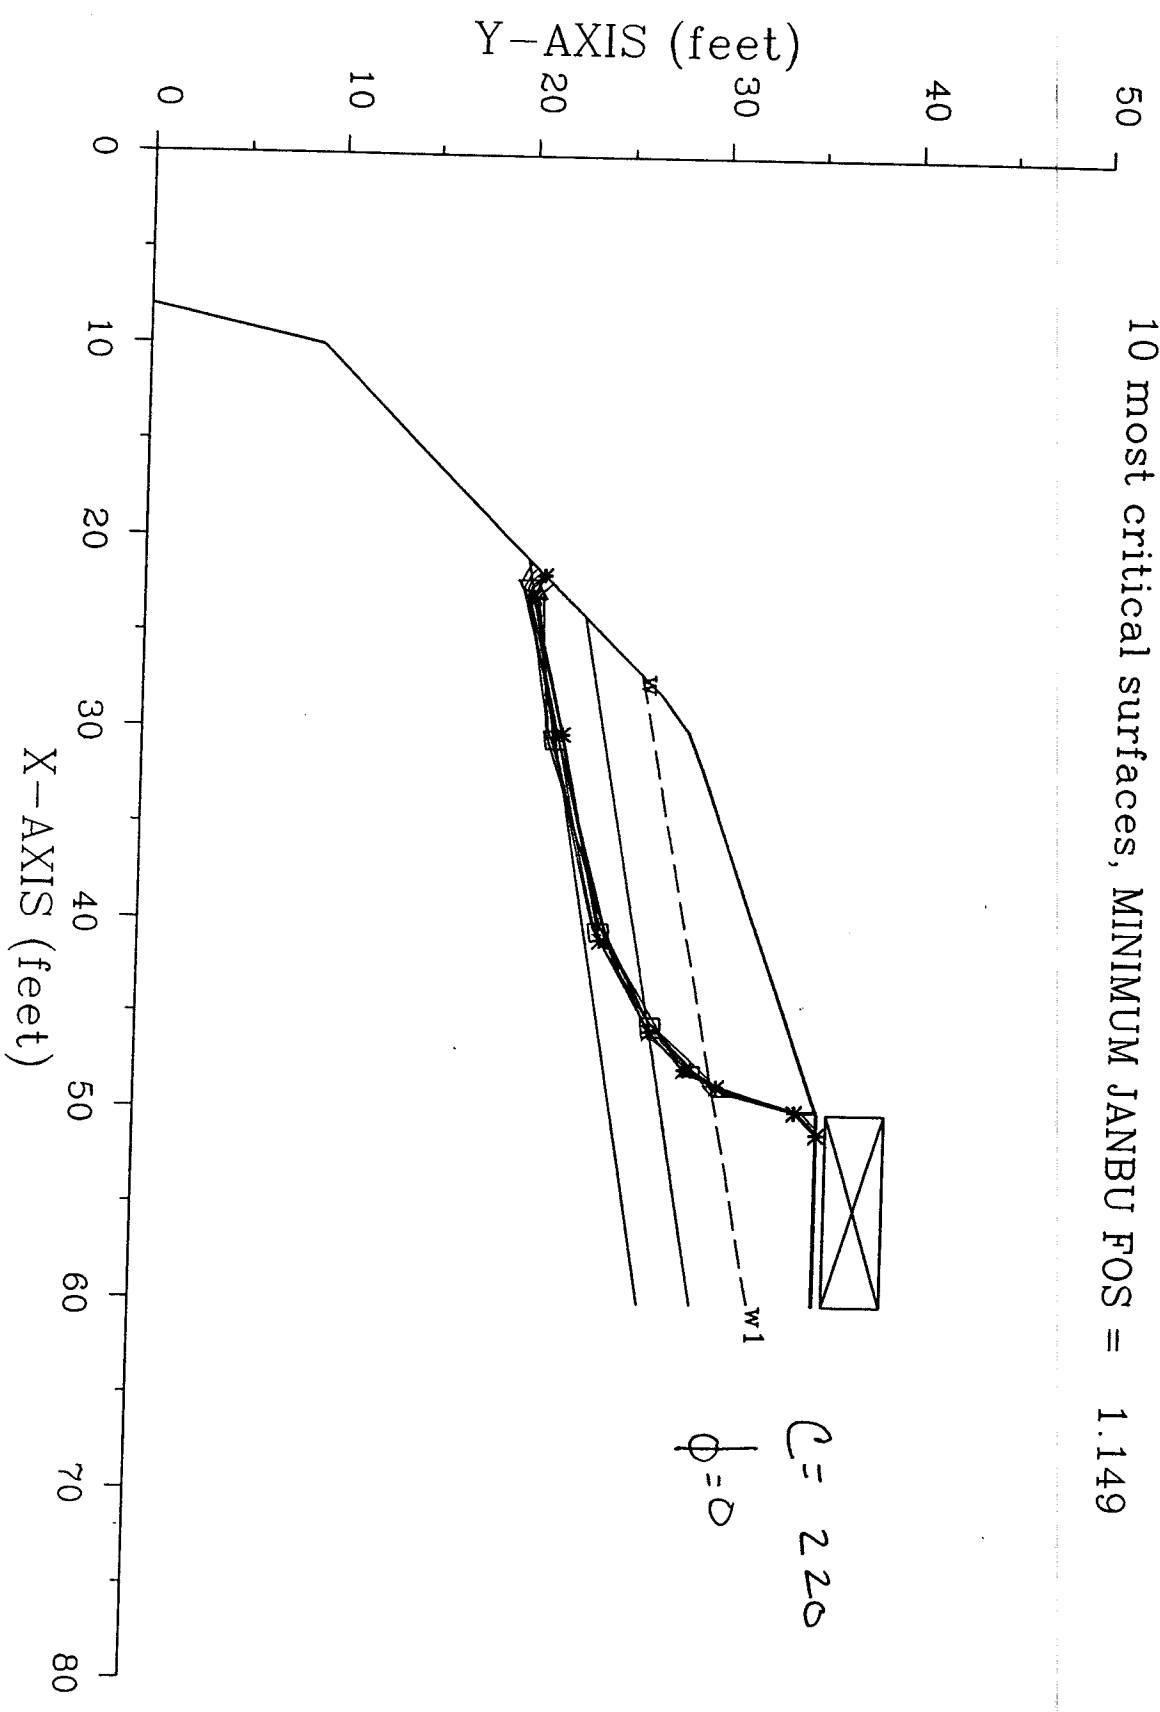
Cummins Residence Model E1

Fill Removal - Our analysis assumes that the fill material is removed to the base of the existing wall as measured on the downhill side. The analysis indicates that the removal of the fill increases the factor of safety from 1.0 to 1.15. In our opinion, the calculated improved factor of safety of 1.15 is not sufficient, and this solution should not be considered acceptable. Instead, a shorter retaining wall could be placed in the same location as the tied-back wall, and this smaller wall may not require tie backs to resist the loading.

10 most critical surfaces, MINIMUM JANBU FOS = 1.149
