QUALITY OF HOUSING

BROADWAY - STEEL AREA

QUALITY OF HOUSING REPORT
BROADWAY-STEEL BRIDGE AREA

July 1955

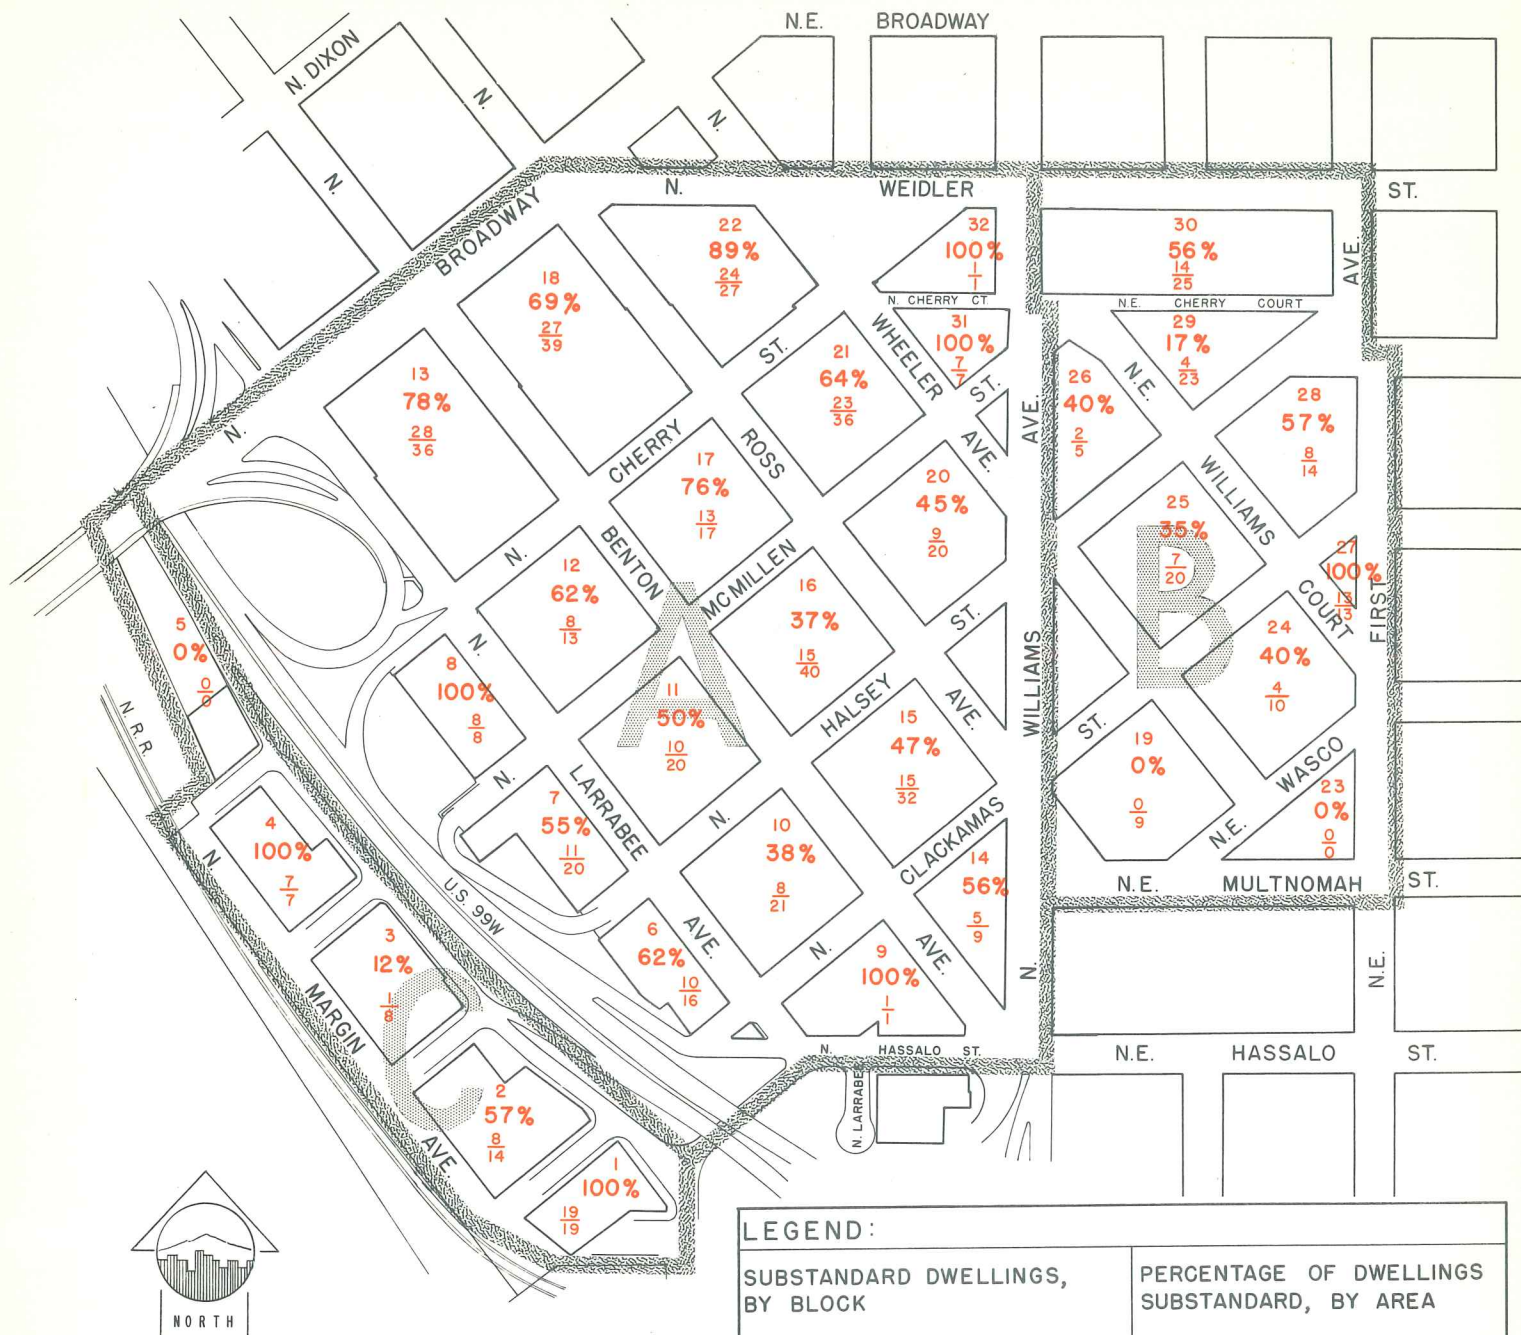
PLATE A

There were 530 dwelling and rooming units surveyed and 58.5% of them were found to be substandard. Some blocks were reported as high as 100% substandard.

SUBSTANDARD DWELLINGS

Plate A breaks the data on substandard dwellings down into blocks. The percentage of substandardness varies from 0% to 100% on the individual blocks with the median of the block percentages 56%.
