Date: February 2, 2015
To: Portland Historic Landmarks Commission
From: Hillary Adam, Land Use Services, 503-823-3581
Stacey Castleberry, Land Use Services, 503-823-7586
Re: 14-218444 HR EN – Mt. Tabor Reservoirs Disconnection
Type III Historic Resource Review & Type II Environmental Review

Reservoir Nos. 1, 5, 6 and 7

City of Portland Water Bureau

May 2009

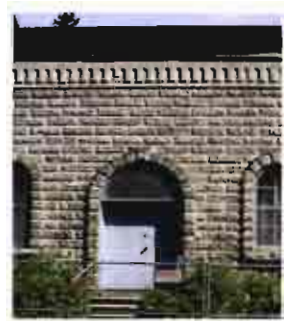
Condition/Observations: The non-original paired hollow metal main entry doors and frame are in fair condition, and need repainting. This opening is not scheduled for revision under Water Bureau Project No. 3366. The reservoir-side door and its hardware are weathered and are non-historic replacements.

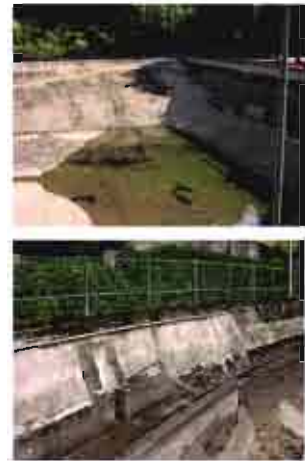
Reservoir Structure, Reservoir 1

Condition/Observations: There are numerous breaks and spalls showing in the patched concrete, giving a mottled appearance. Weeds are growing out of cracks. The reservoir has had leakage issues over time. The bituminous water proofing coating remains in portions. The valve platform is not sound and is being replaced under Water Bureau Project No. 3366. A new wash down pipe system is desired.

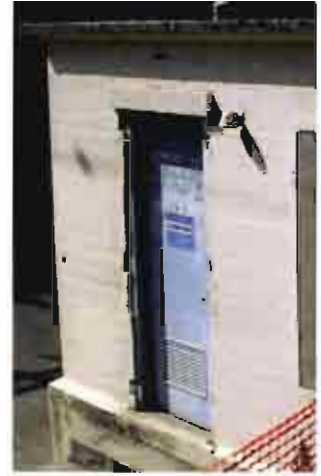
Condition/Observations: The structure is outside of the vehicle controlled area, and appears to receive vandalism as a result. The entry door frame is damaged at the head member, and there are damaged concrete edges around that opening.

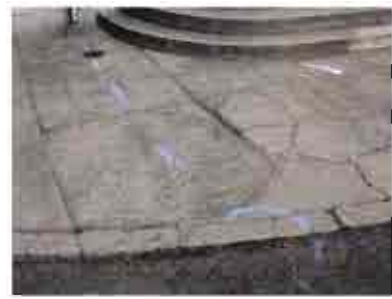
Condition/Observations: The walkway has some damaged areas, including broken slabs, corners, spalls, roughened surfaces and settlement. There does not appear to be much of a base remaining for the concrete slabs. The walkway is in better condition than at the other reservoirs.

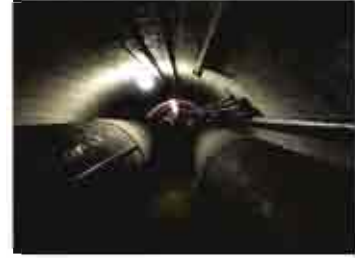
Condition/Observations: The concrete roof/ceiling appears to be in good condition. No evidence of leakage or serious concrete deterioration was observed. The floor was dry. The painted ceiling has peeled in some areas, and there is evidence of concrete patching. New conduit has been installed on the south wall in conjunction with Water Bureau Project No. 3366.

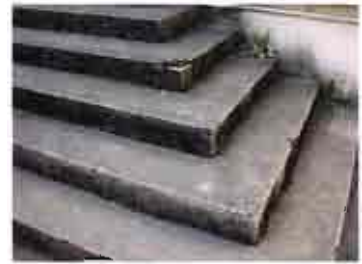
Condition/Observations: There is spalling at the steps. It appears that the steps have been recoated in the past, or were originally poured rough and finished with a topping coat, and that this topping is breaking up.

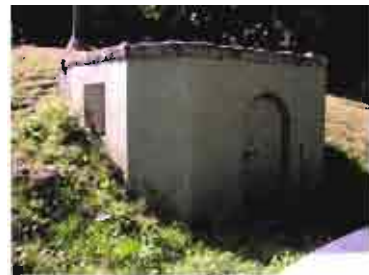
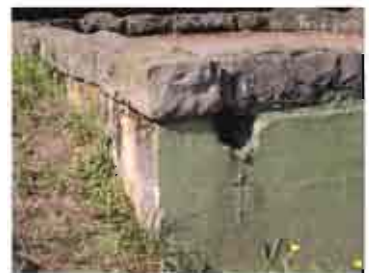
Reservoir 7 Building

Condition/Observations: The building is in fair condition. The drainage system is prone to clogging from tree debris. There is water damage evident (cracks and deposits) at the upper wall at the height of the roof deck. The stone roof curb has many deteriorated joints. The access door has non-historic hardware and intrusive security provisions. Part of the frame molding is missing. The wood louver vents are badly deteriorated.

Option A.1: Preserve and Repair – Repair wood door and frame, suitable hardware; repair wood louver vents where venting required; where not required provide protective overlay; repair stone and crack damage at roof and upper wall; remedy roof drainage
