Application for Type IV Demolition Review for the Garage at 1609 SE 16th Avenue

CUSTOMER: Shannon and Ryan Buchanan

PROPERTY INSPECTED: 1609 S.E. 16th Ave., Portland, Oregon 97214

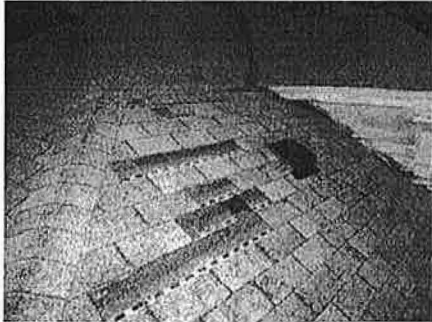
Missing shingles throughout:

- G. All roof areas should be cleaned of debris and then have a roofing contractor inspect them and repair them to a point where he does not think they will leak this rainy season.**
- H. Some examples of roof repairs needed now:**

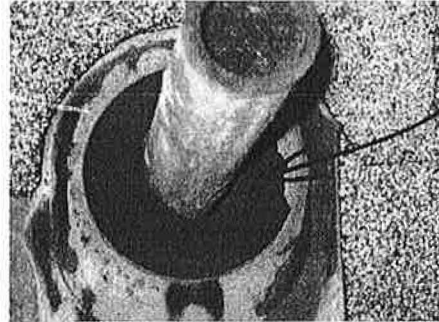
Gap at the sewer vent gasket near the furnace chimney:

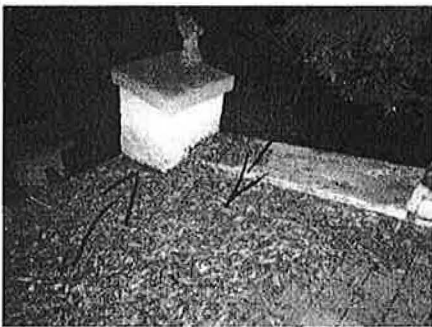
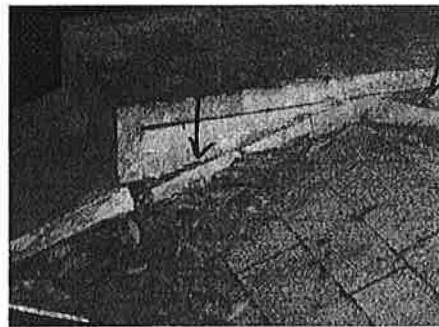
Front porch debris: Vertical wall joints will need patching at this point:

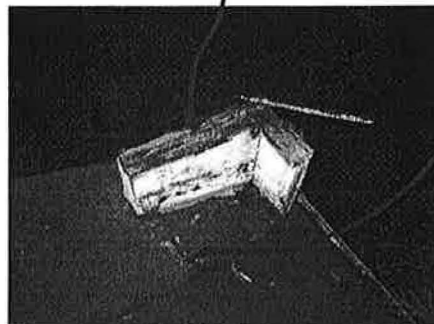
Example of the eastern penetration in the garage roof that will be difficult to maintain and keep water tight. Plan on removing them or completely rebuilding them:

Cap flashing is rusted. Replace it when the roof and penetrations are replaced.

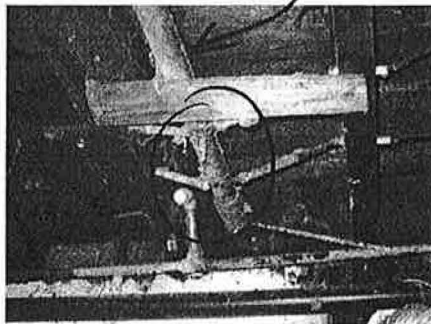
- F. Remove the steel pipe on top of the knob and tube wiring in the ceiling of the laundry area.

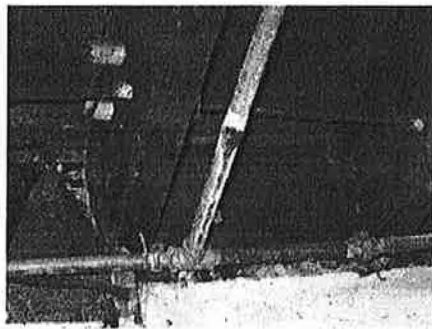
- E. Pin hole type rust spots noted on the galvanized water piping. This is not uncommon in an older galvanized water pipe system and is a sign of old age. It is not uncommon for these small pin hole "leaks" to rust themselves closed and basically fix themselves. We recommend that you: monitor the pipes and replace any piping where pin hole leaks are larger and do not fix themselves, replace water pipes as you remodel, and plan on replacing them all someday. An example is shown below:**

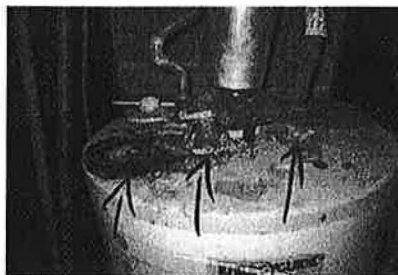
- D. The water heater is leaking from penetrations in the top of the tank. I could not tell if this was a repairable condition or if the tank should be replaced. The tank is older and considered near the end of its useful life. Have a plumbing contractor figure out what is leaking and advise you on your options. Repair as needed or replace the tank so leaks do not exist.
