Seismic Retrofit Cost Estimate for Garage Building at  
730 SW 10<sup>th</sup> Ave, Portland, Oregon

Franz Rad, PhD, PE

June 22, 2016

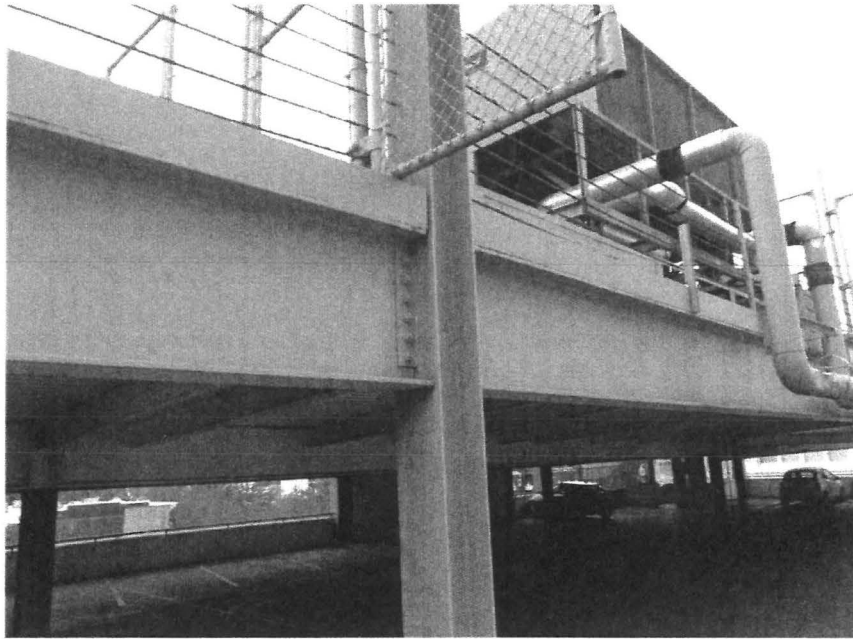
Figure 2, Steel framing in the upper floors

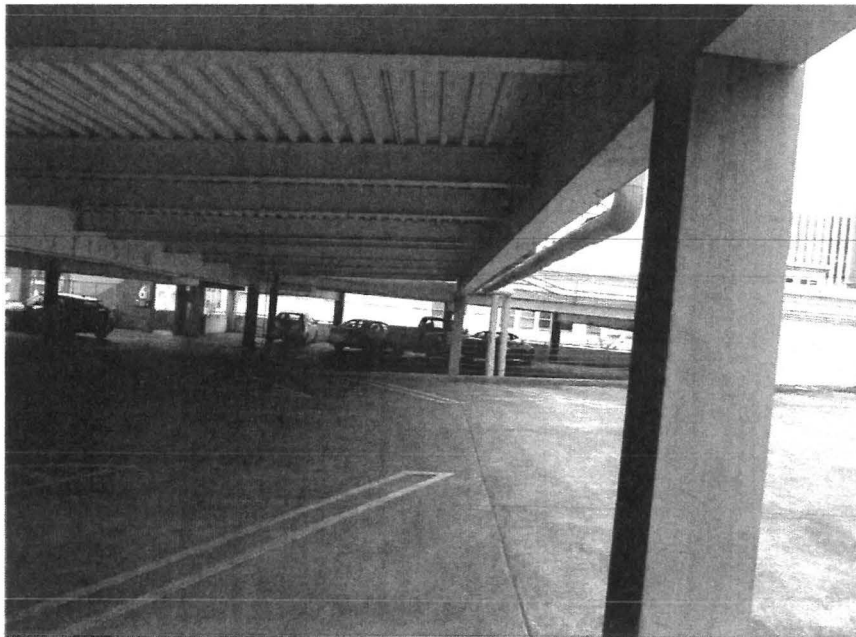
Figure 3, Composite floor construction, upper floors

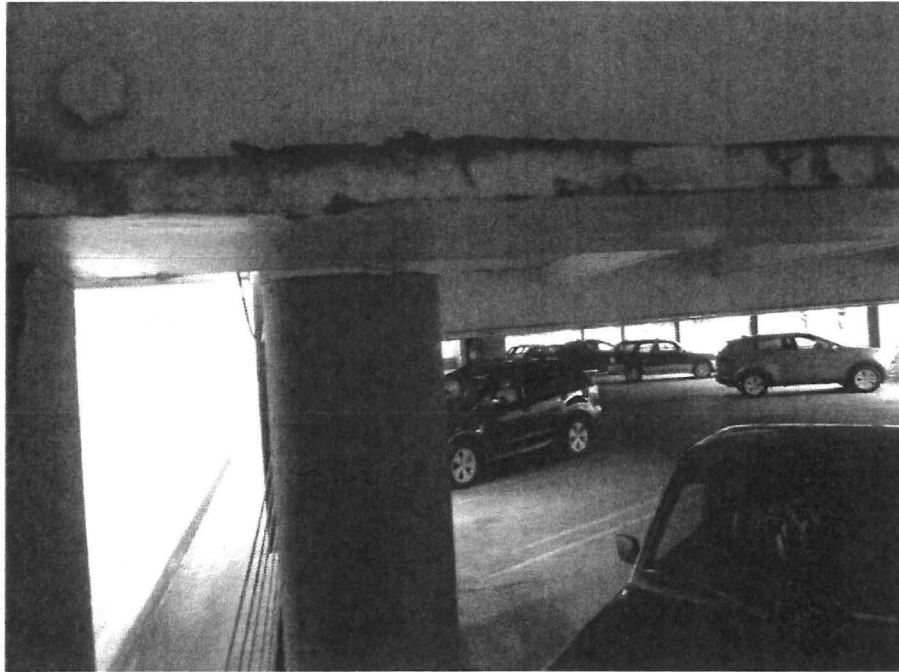
Figure 4, Evidence of rust in some steel sections

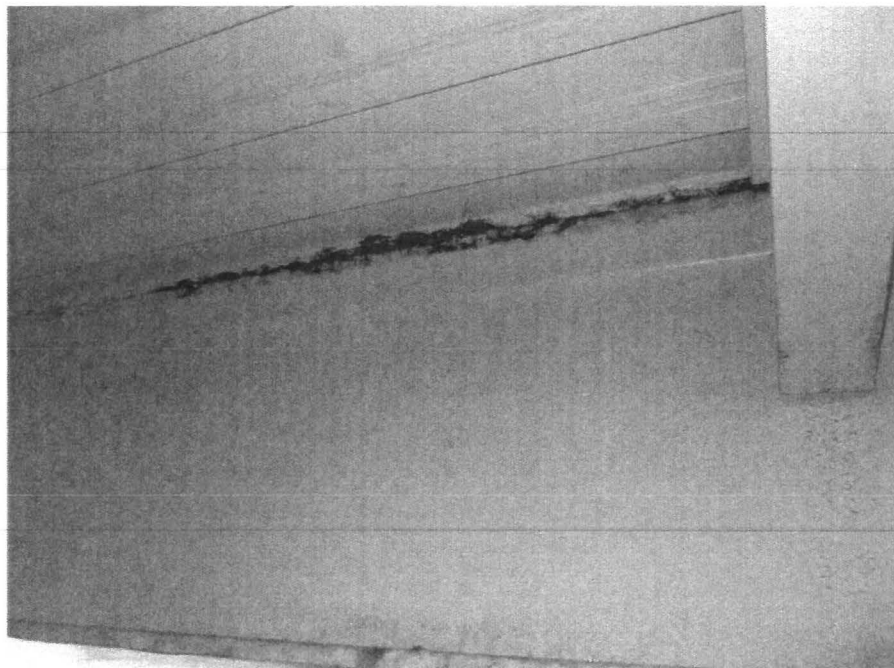
Figure 5, Evidence of rust in some steel sections

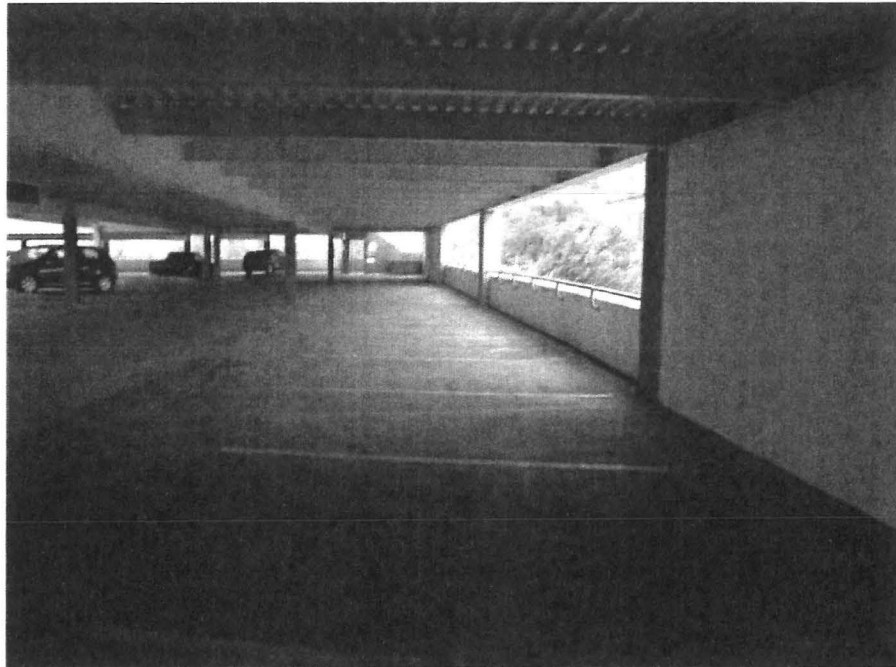
Figure 6, Shear walls in the N-S direction

- Add new shear walls to reduce the seismic shear forces in the existing shear walls and in the floor diaphragms.
- Add new boundary elements to existing shear walls to increase strength and ductility.
- Use CFRP overlay (wrap) to increase the shear capacity of the existing shear walls.

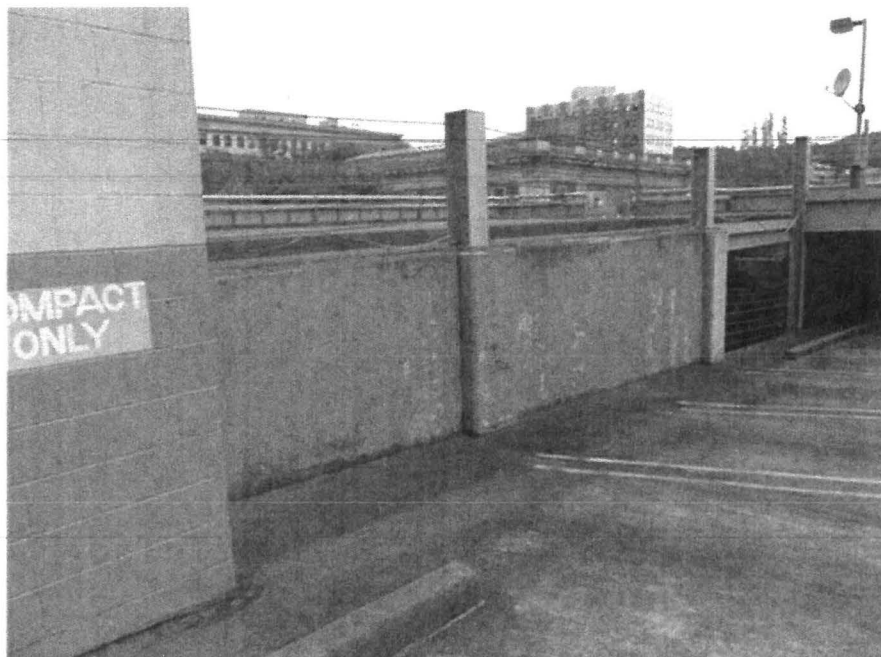
Figure 7, Shear walls in the E-W direction

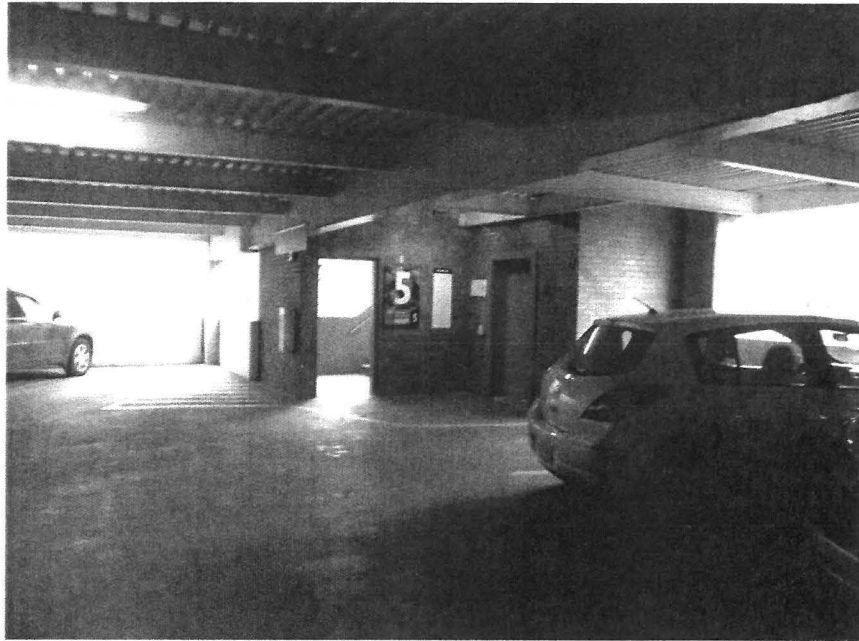
Figure 8, Framing system in the 5<sup>th</sup> floor

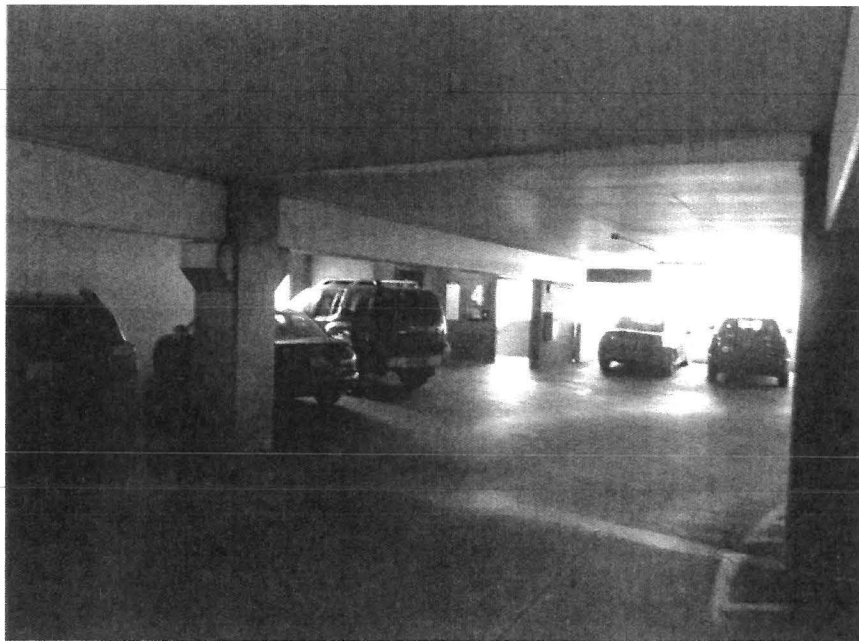
Figure 9, Concrete framing system in the 4<sup>th</sup> floor

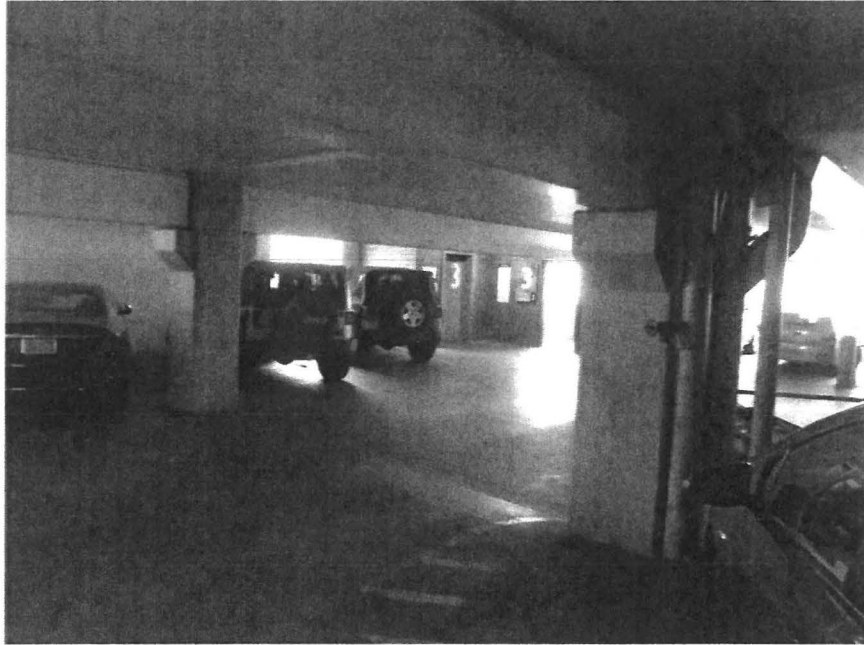
Figure 10, Concrete framing system in the 3<sup>rd</sup> floor

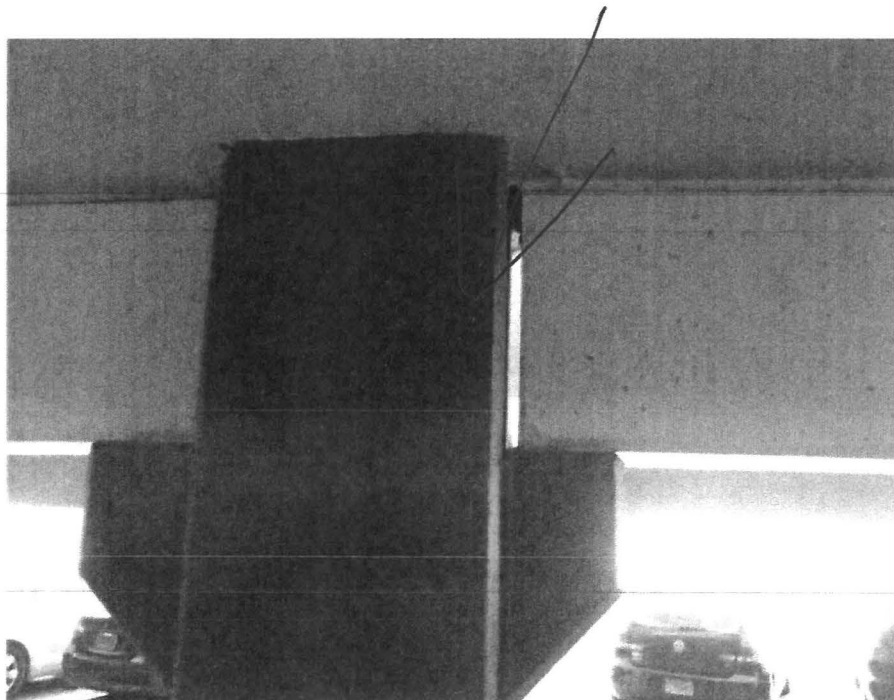
The first five stories of Garage Building (GB), the vertical-load-carrying members are precast-prestressed beams of rectangular cross-sections. The beams are seated on brackets (corbels) that protrude from columns. As such, the beams are “simply supported” and their function is to carry gravity loads. They do not contribute to the lateral load carrying capacity of the building.

Figure 11, Beams on corbels

- Add epoxied shear dowels through the corbel to increase vertical shear and/or bending strength.
- Add structural steel bolster under the corbels.
- Add new steel column or reinforced concrete column.
- CFRP wrap.

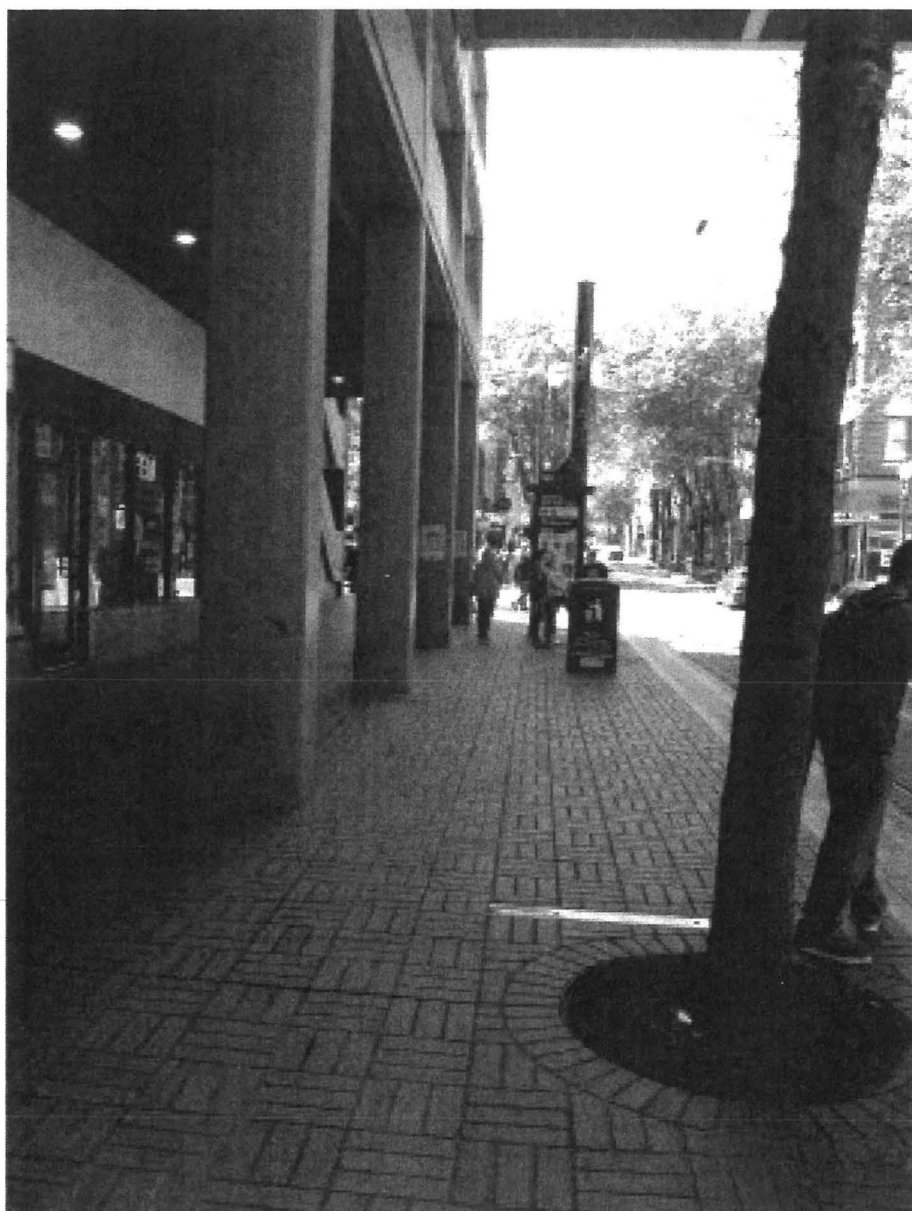
In this structure, more reliance is placed on the shear walls to carry the seismic forces. However, a portion of the seismic forces will be transferred to the columns. The columns in this building were not designed based on the modern “seismic detailing” requirements of the recent ACI codes, hence will not have ductility comparable to columns in a new structure.

Figure 12, Longer Exterior Columns

If a future “Seismic Structural Analysis” for this building finds that the columns may be overstressed, then a structural retrofit technique such as CFRP wrap may be considered to increase the strength and ductility of the columns.
