## SITE OBSERVATION REPORT

SUBJECT: Inverness Force Main Site Visit

PROJECT NUMBER: 276-2177-032

PROJECT NAME: Inverness 30-Inch Force Main Repair

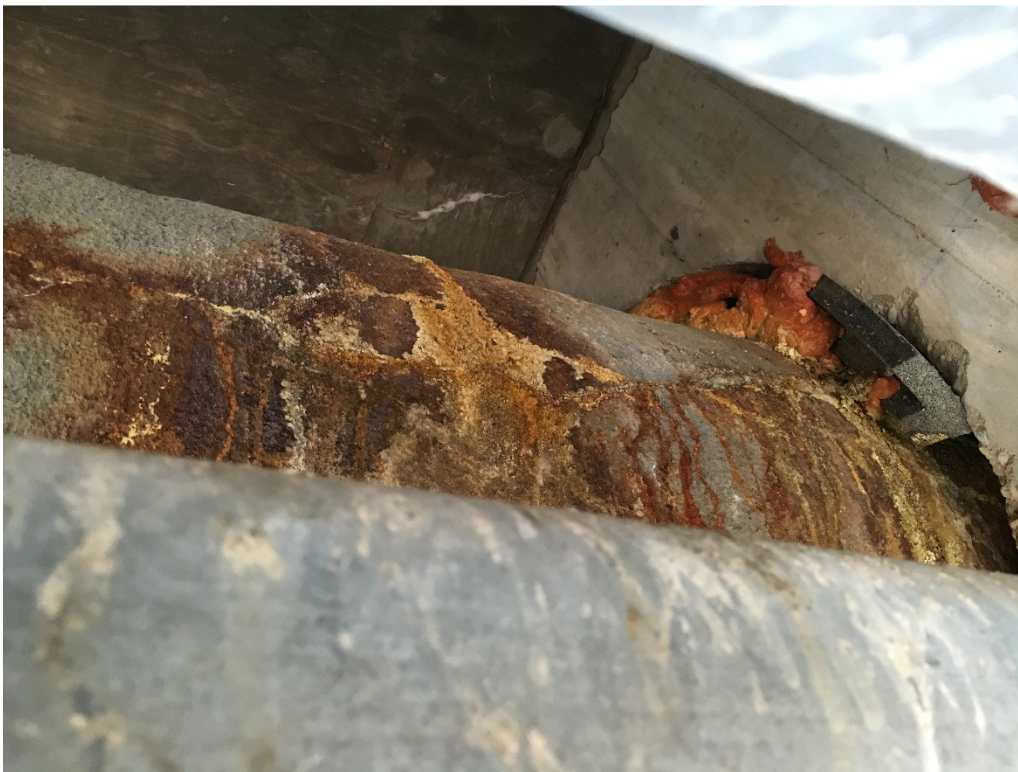
The pipe insulation had been removed from approximately Sta. 22+12 to Sta. 23+35 per the contract documents. There was insulation partially remaining where the pipe passes through Bent 2 (Sta. 23+10, Photo 1) and some of the concrete diaphragms between Bent 1 and Bent 2.

Photo 1 – Insulation and spray foam around CCP at bent 2.

- Remove approximately an additional 30 feet of pipe insulation to the north in order to determine the extent of damage and north end limits for the external pipe repair.
- Remove all insulation where the pipe passes through the intermediate concrete diaphragms and the diaphragm at bent 2.

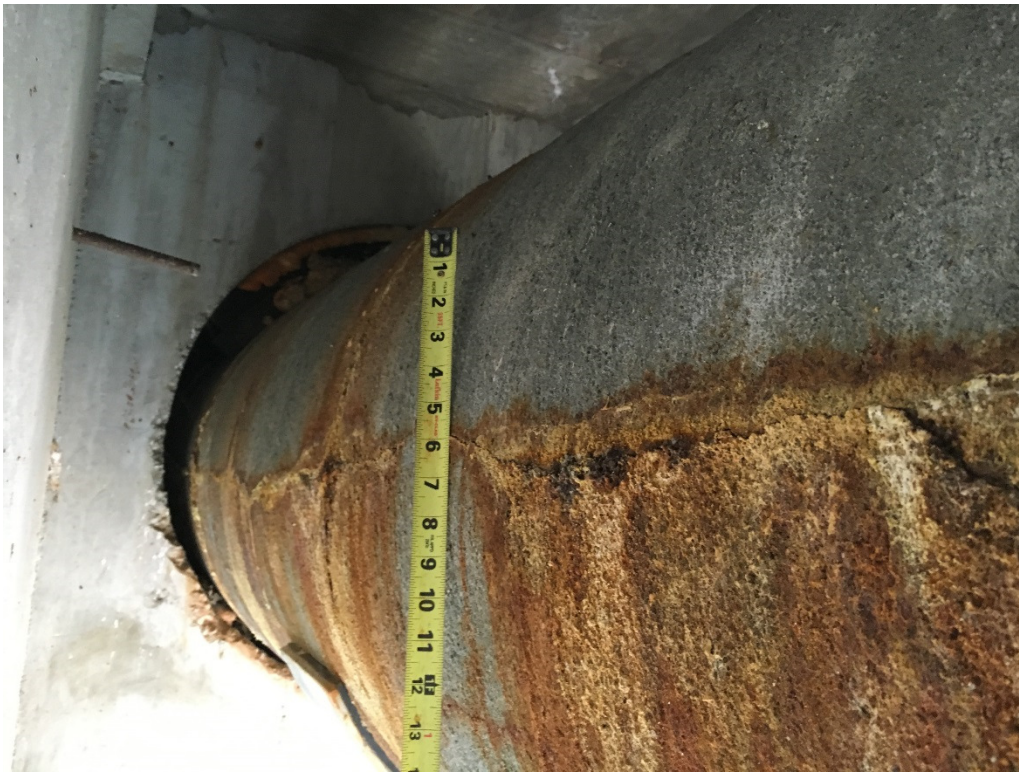
The exterior of the 30-inch CCP pipe was examined at the exposed areas. Longitudinal cracking and evidence of seepage was observed at approximately the 9:00 and 3:00 positions (Photos 2 & 3), along with cracking on the bottom at the 6:00 position. Sounding with a hammer revealed several areas that are delaminated or beginning to spall away from the exterior pipe spiral reinforcement. The worst area appeared to be between pipe supports #7 and #9 on the south side of bent 2.

Photo 2 – Horizontal cracking on west side of CCP near bent 2.

- Begin the exterior pipe repair just north of the roller on support beam #5 at approximate Sta. 22+59. The repair does not need to go under the roller and can start within 2 inches of the pipe shield.
- The north extents of the exterior pipe repair should be determined after the additional insulation is removed.
- Confirm with Fibwrap that the repair will function as intended and provide the required strength for CIPP installation in the areas where the existing CCP is cracked and delaminating.
- Confirm with Fibwrap that the repair material will perform as intended at flanged connections. The submittal did not contain any details or language about how the repair was to be installed at these locations.

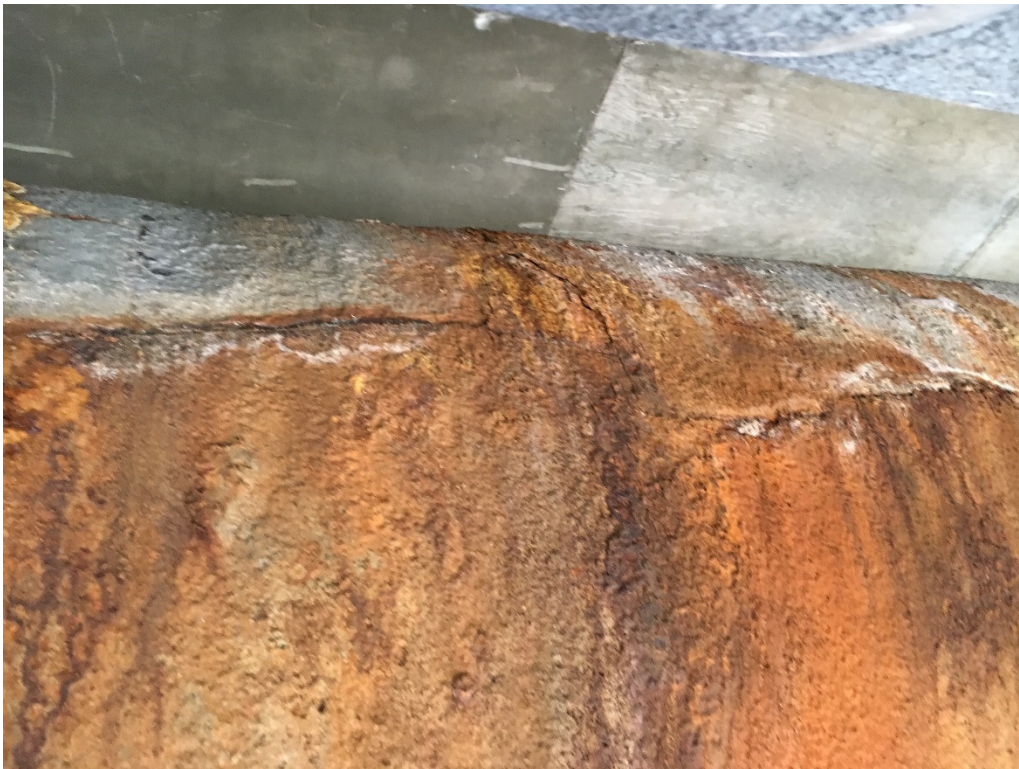
Photo 3 – Horizontal cracking and areas of concrete beginning to delaminate on the east side of CCP near bent 2

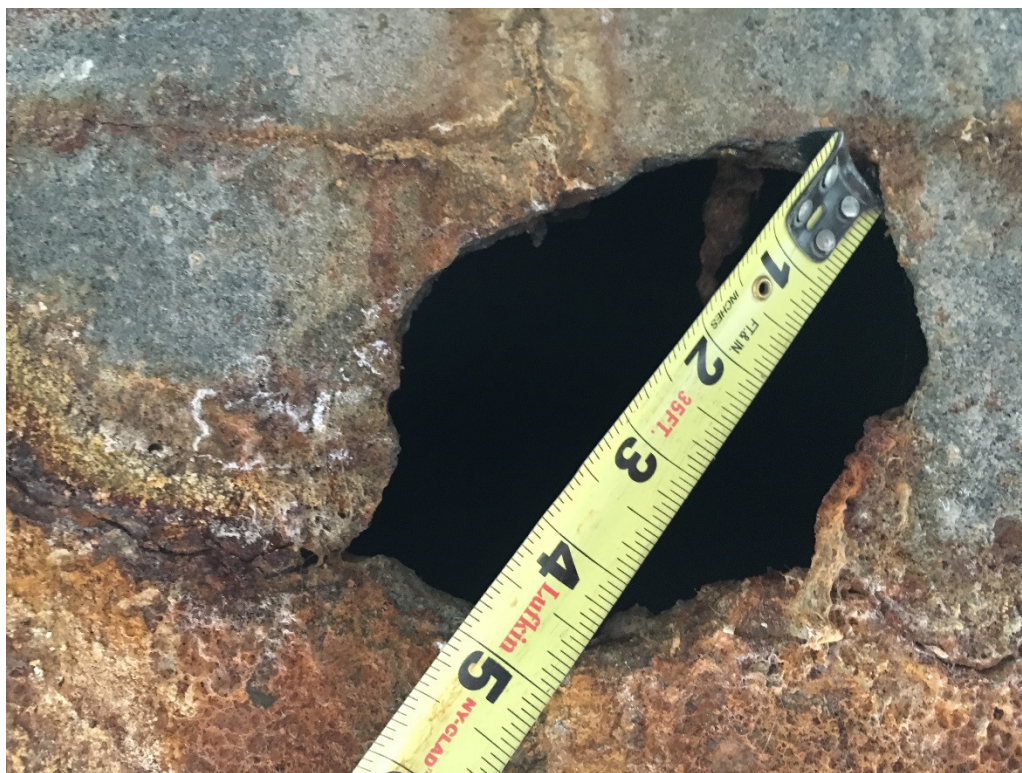
On the west side of the pipe between supports #8 and #9, a 2" diameter hole discovered after insulation was removed was enlarged to 4" by the contractor to view inside the pipe (Photo 4). The interior concrete and metal lining has disintegrated and the exterior spiral reinforcement is visible (Photo 5).

Photo 4 – Enlarged hole on west side of CCP between roller supports #8 and #9.

- For all holes greater than 2 inches in diameter, a two part epoxy should be used for repair. A stay-in-place form will likely be required on the pipe interior, and should be constructed as to not obstruct the

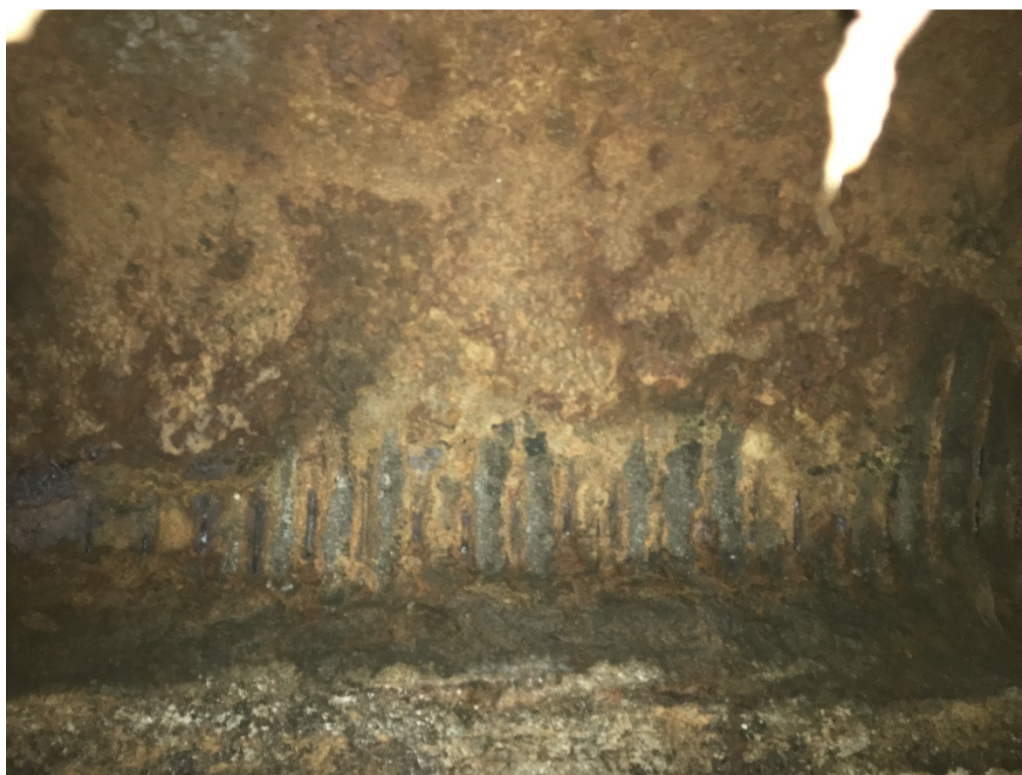
Photo 5 – Exposed exterior spiral reinforcement.

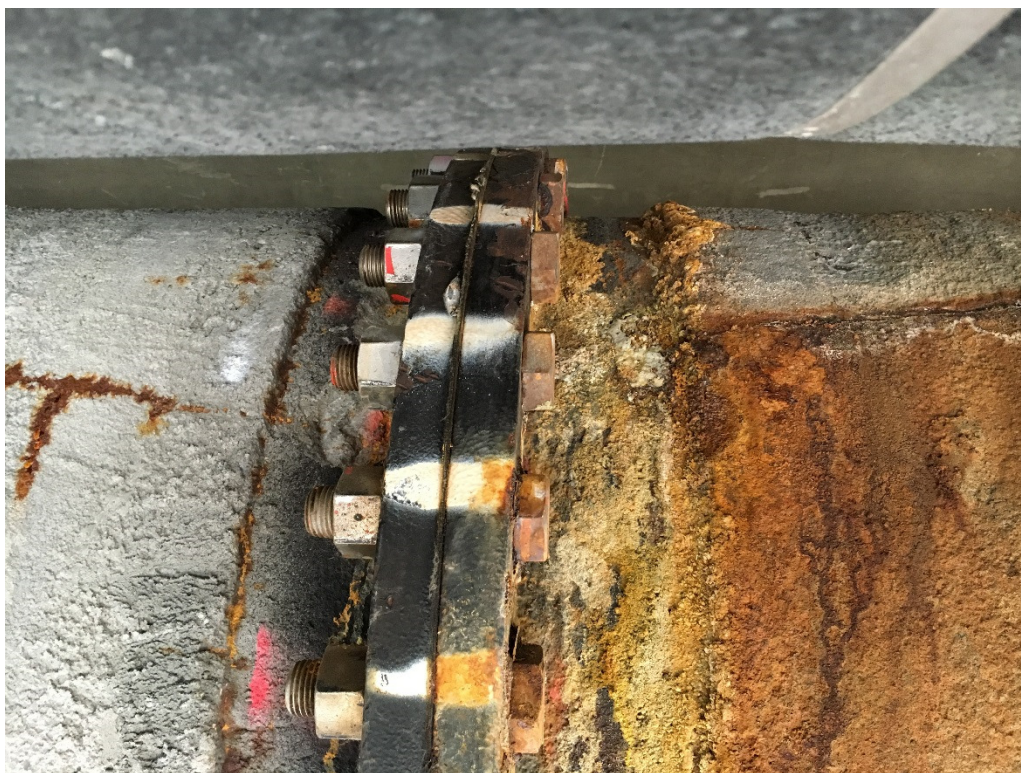
Between pipe supports #7 and #8 there is a flanged connection on the 30-inch CCP (Photo 6). Exterior damage is also evident south of support #7, but the level of damage decreases as the pipe gets closer to the south end of the bridge. On the north end there were signs of leaking on the roller supports where the pipe insulation was still intact.

Photo 6 – Flanged connection between support #7 and #8.

- At multiple locations there are flanged connections of the existing CIP pipe, including one that is approximately centered between the roller supports. Given the deteriorated condition of the CIP pipe, and the assumption that the Fibrwrap repair will not be continuous over the flanged connection, will the Fibrwrap repair perform as intended to provide the strength required for the CIPP installation, water cure, and long term service loads? The typical repair sections provided by Fyfe in submittal 12.01 do not contain any details of the repair at the flanged CIP connections.

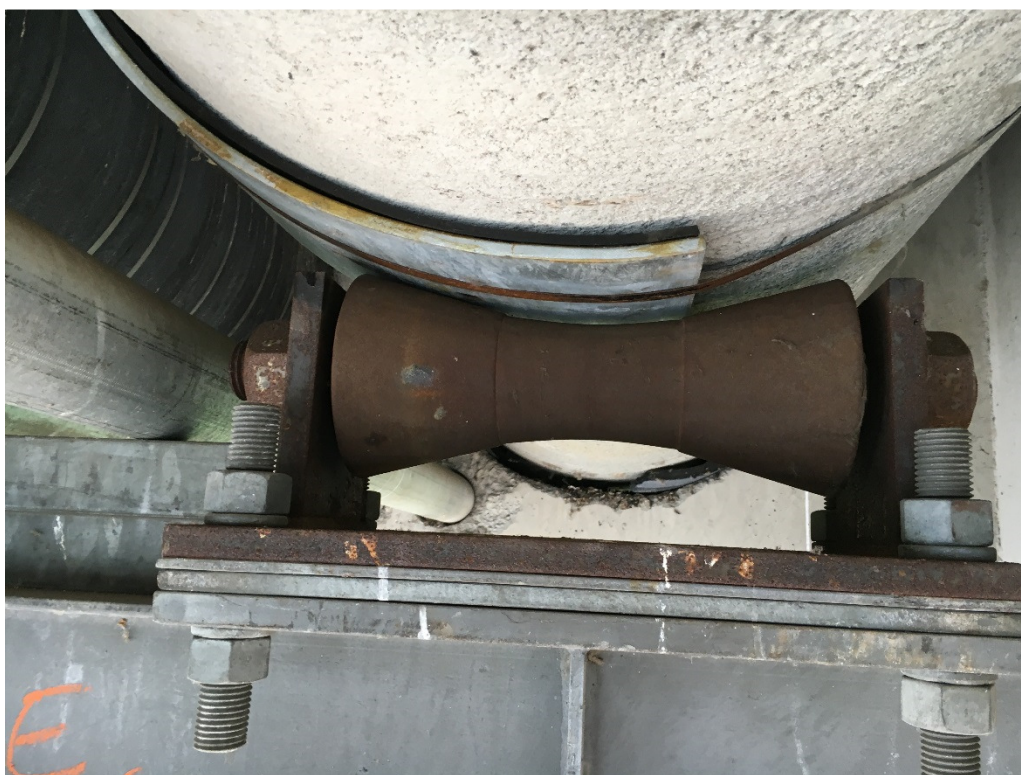
The pipe shields on supports #4 and #6 have rotated approximately 90 degrees, and as such the rollers are free to spin and are currently not supporting any weight of the 30-inch CCP pipe (Photo 7).

Photo 7 – Rotated pipe shield at support #4.

- Pipe shields should be inspected at all roller support locations to determine if they have shifted, and to confirm that the roller is supporting the pipe under the shield.

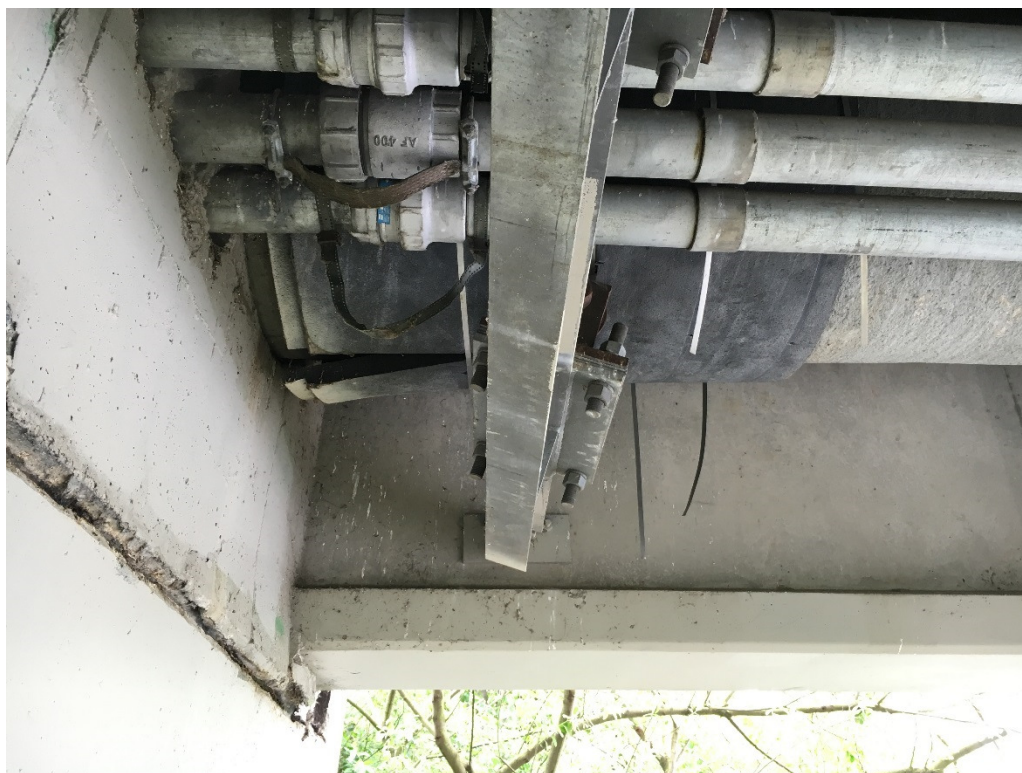
Several pipe support beams have rotated out of position, with support #1 rotating the most (Photos 8 & 9). Several bolts at the girder to support beam connections do not have full bearing of the bolt head or nut shoulder. One of the bolts observed was less than hand tight and able to wiggle back and forth. Several of the girder to support beam connection brackets exhibit signs of rotation and vertical displacement. The weld on the girder to support beam connection bracket on the west end of support beam #5 has failed and is showing excessive vertical displacement (Photo 10).

Photo 8 – Rotated pipe support beam at roller #1

- All pipe support connections should be investigated for damage, including but not limited to rotation, vertical displacement, weld failure, and connection bolt diameter discrepancies.
- **Any and all work involving loading of the existing pipe support beams should be delayed until all connections can be assessed and any needed repairs performed.**

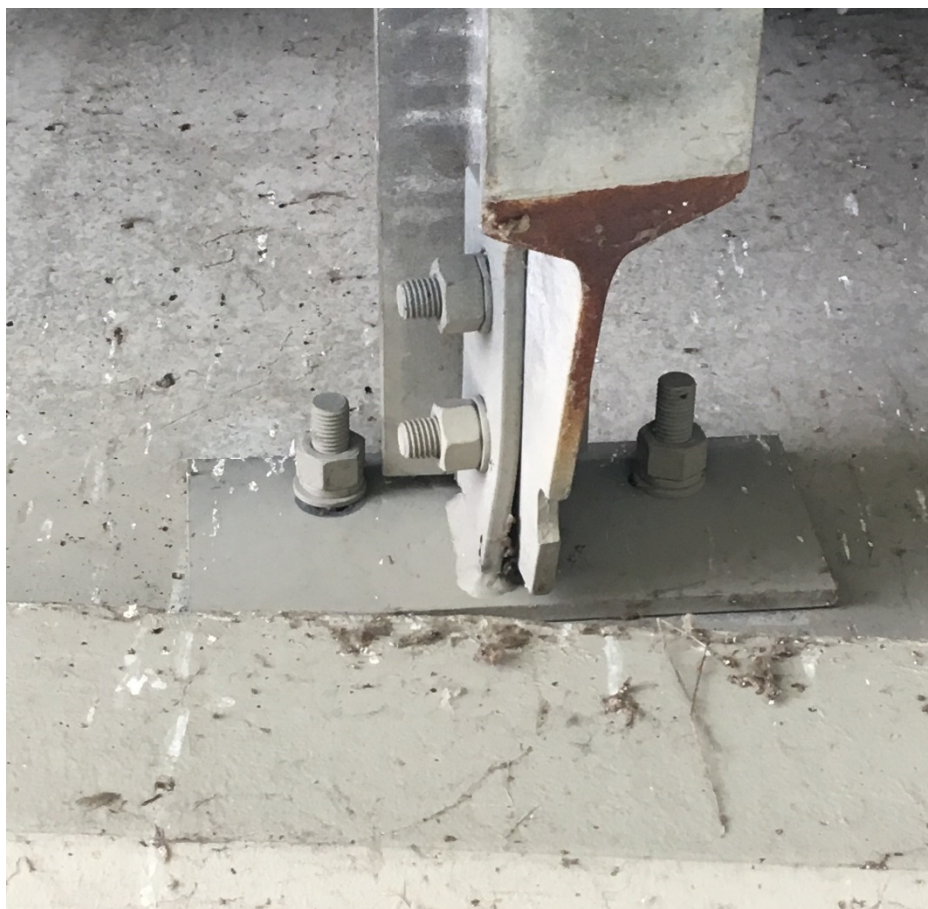
Photo 9 – Rotated girder to support beam connection plate at

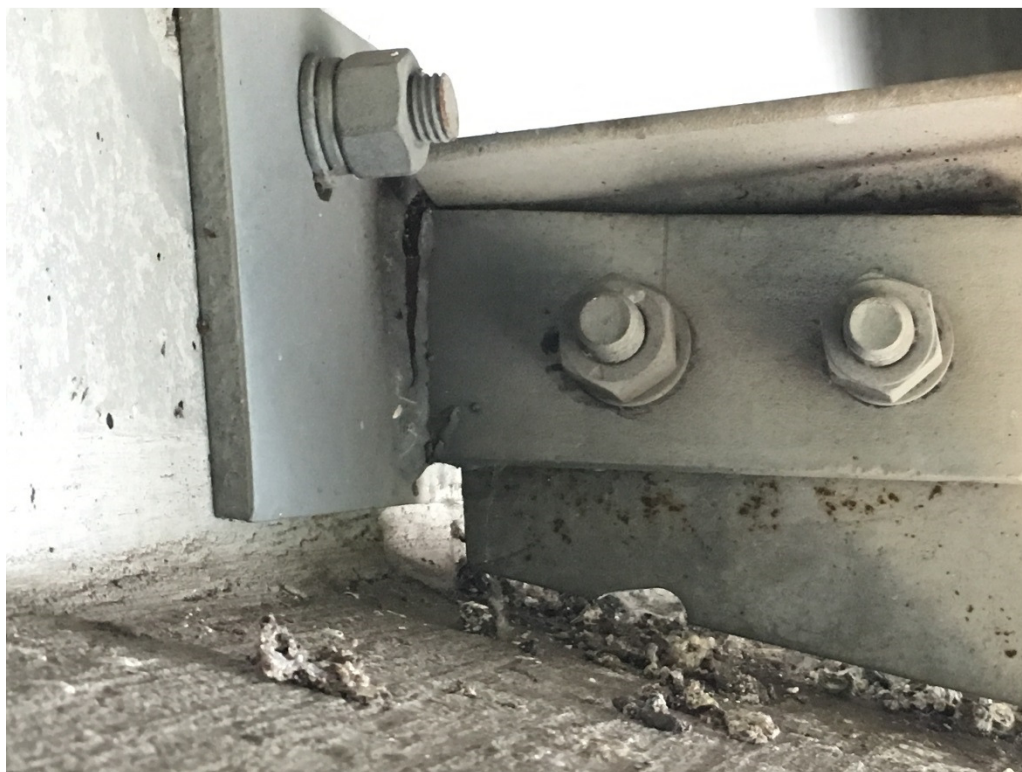
Photo 10 – Failed weld on support beam #5

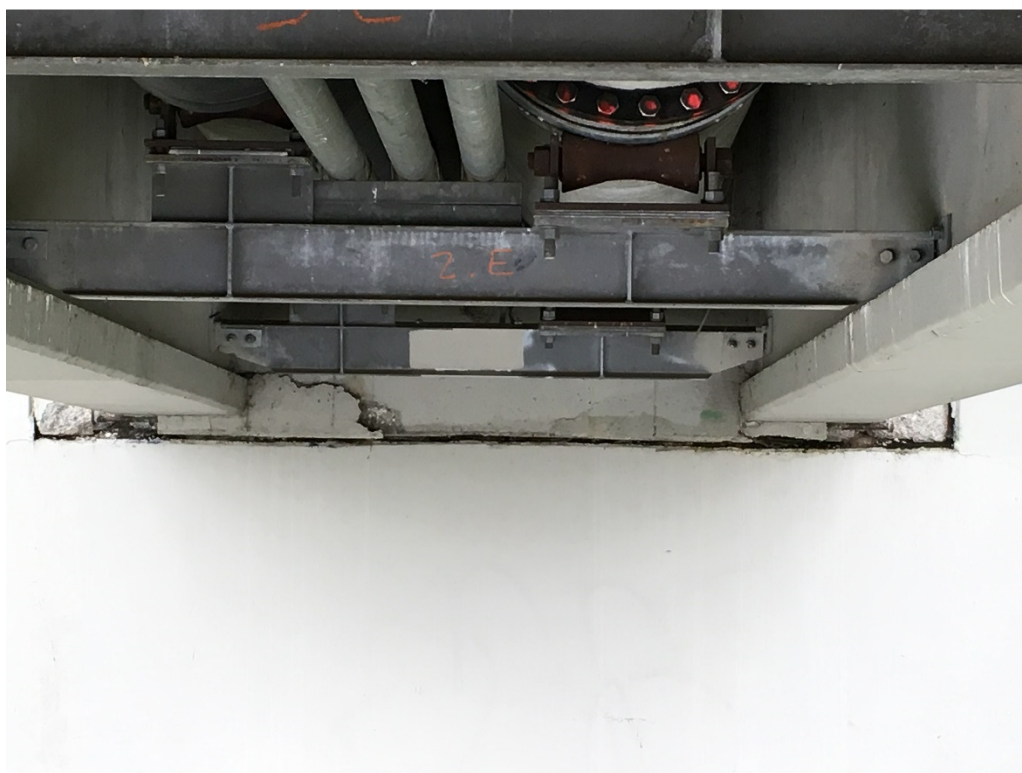
The concrete diaphragm between the bridge girders at the sound end of the bridge (bent 1) has extensive cracking and dislodged concrete under and adjacent to the girders (Photo 11). Steel reinforcement is visible and has surface rust (Photos 12 & 13).

Photo 11 – Cracked concrete under girders at bent 1.

- The cracking under and near the girders should be further investigated to determine the extent of the cracking and potential repairs.

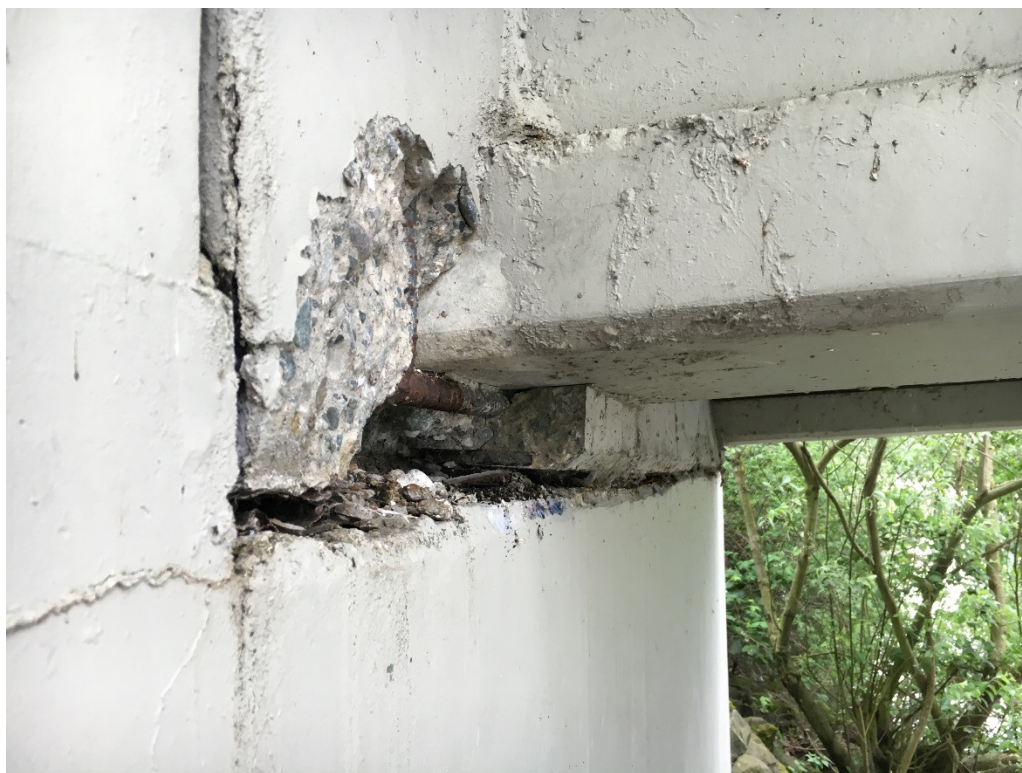
Photo 12 – Cracked concrete under east girder at bent 1.

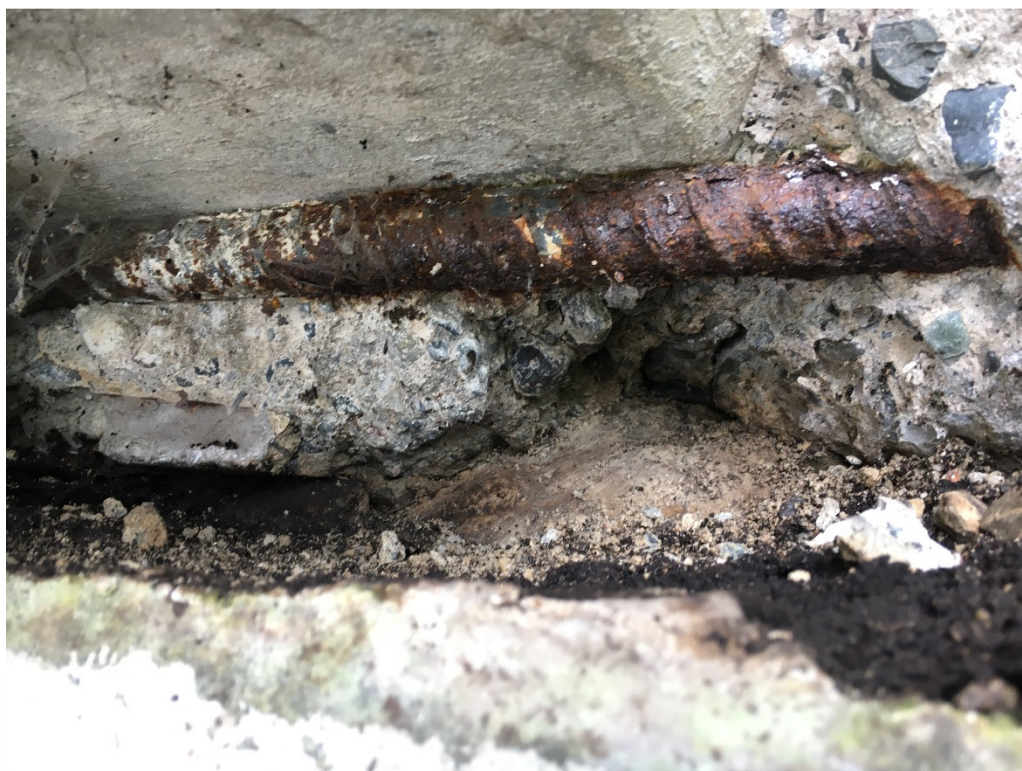
Photo 13 – Exposed and rusted diaphragm reinforcement under west girder at bent 1.

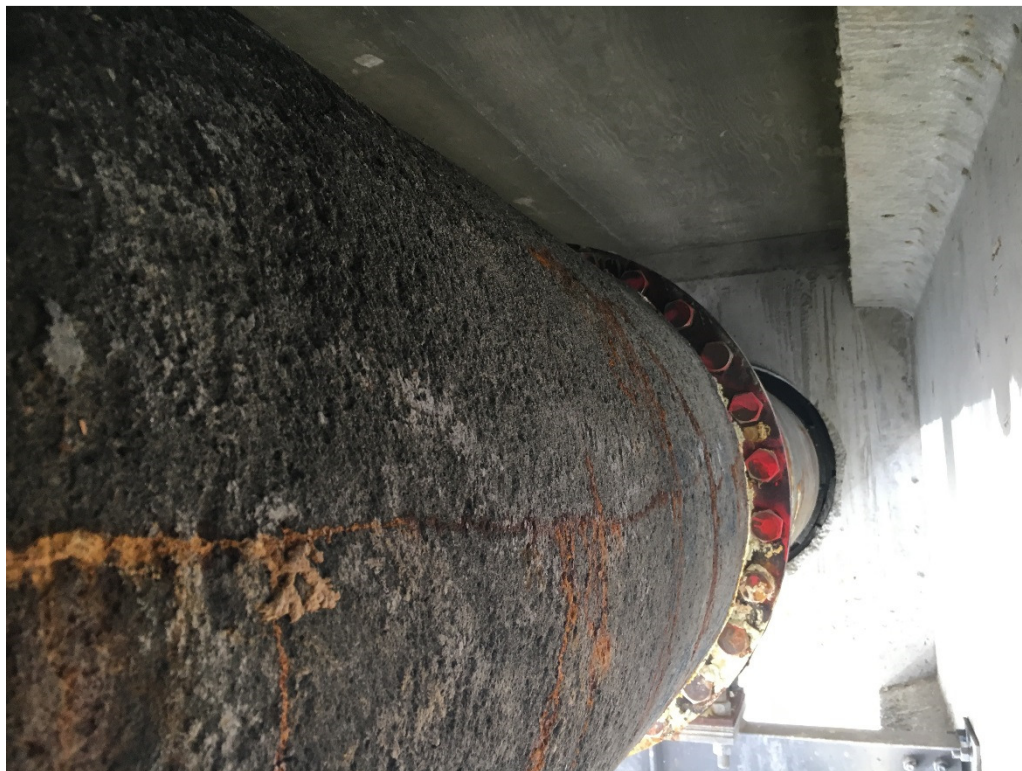
The exterior of the 30-inch CCP pipe was examined at the exposed areas. Longitudinal cracking and minor evidence of seepage was observed at approximately the 3:00 position on the west side of the pipe (Photo 14). Additional transverse hoop cracks with little or no staining were evident along bottom half of the pipe (Photo 15). Sounding with a hammer indicated very little, if any delamination near the cracks.

Photo 14 – Longitudinal cracking and minor staining on the west side of the pipe at approximate Sta. 23+50.

- Terminate the exterior pipe repair just south of the Harnessed Mechanical Coupling near support beam #14. The revised limits of the exterior pipe repair are from approximate Sta. 22+58 to Sta. 23+55, or roughly 97 feet in total.

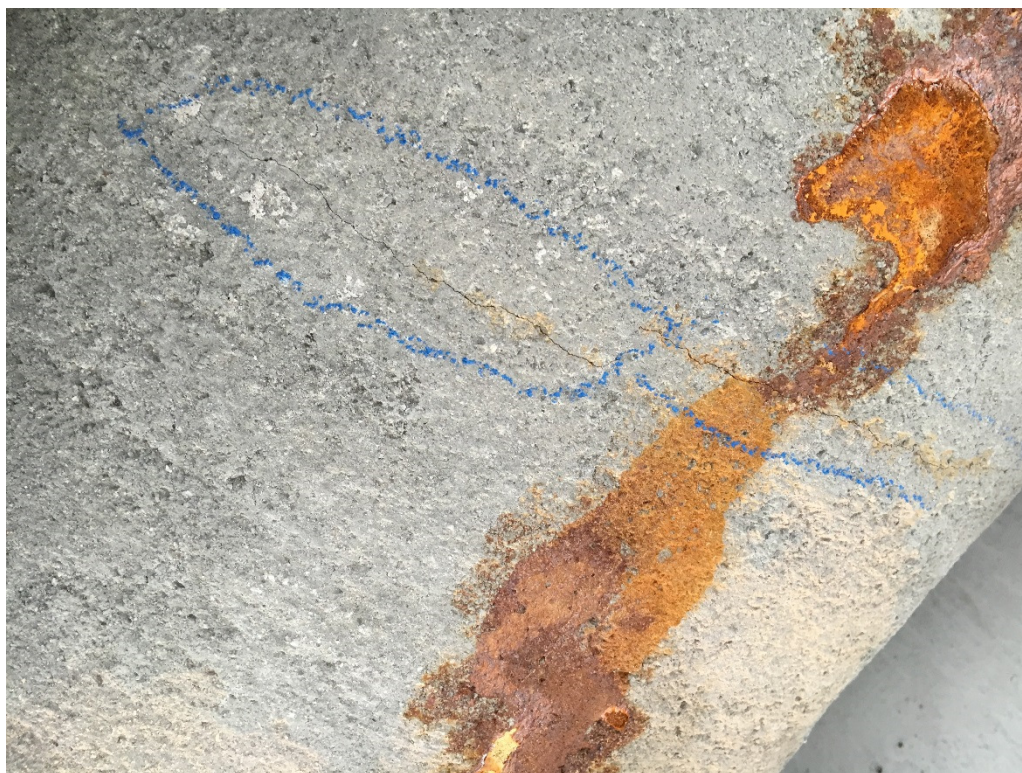
Photo 15 – Hoop cracking on the bottom of the pipe at approximate Sta. 23.50.

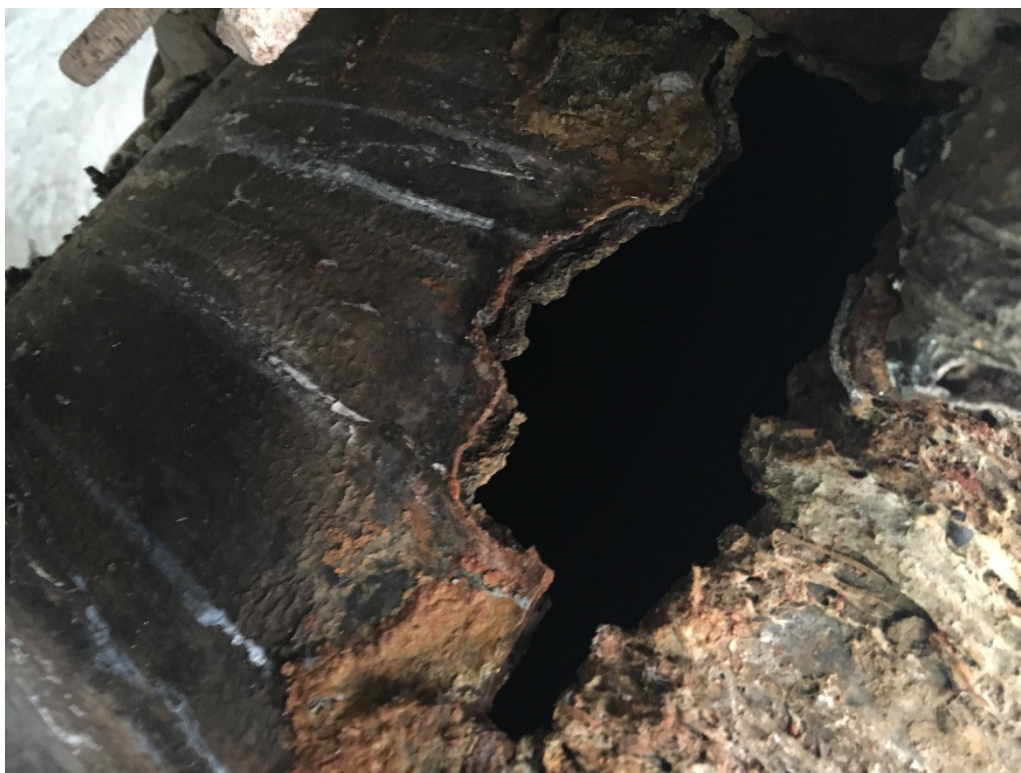
There is a Harnessed Mechanical Coupling at Sta. 23+58 with an approximate 2" by 3" hole on the north end of the pipe within the coupling, at 2:00 on the east side (Photo 16). The pipe on the north side of the coupling does not exhibit any exterior signs of leaking or cracking. Noticeable staining and cracking begins on the south side of the coupling and extends south through bent 2 to the area previously determined as needing exterior repair.

Photo 16 – 2" by 3" hole in east side of Harnessed Mechanical Coupling at Sta. 23+58.

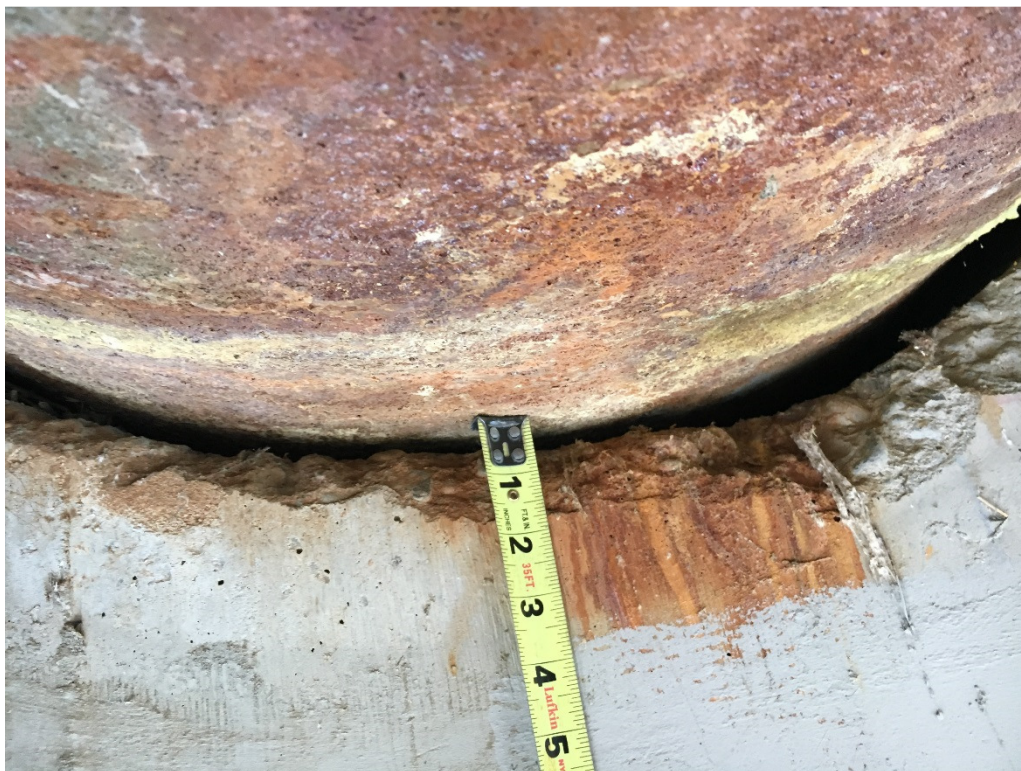
Where the 30-inch CIP passes through bent 2, the pipe is not centered in the hole in the concrete diaphragm between the girders. The pipe is not resting on the concrete, but minimum clearance at the bottom is estimated to be less than 1/4" (Photo 17).

Photo 17 – Reduced clearance at bent 2 where 30-inch CIP passes through concrete diaphragm.

- Given the reduced clearance at bent 2 where the CIP passes through the concrete diaphragm, external repair of the pipe with Fibrwrap will be difficult. The contractor discussed submitting alternate methods to the repair/ support the pipe at this location, one of which was to grout the void between the pipe and concrete diaphragm. Any grout or method used to fill the void and support the pipe should include a bond break around the pipe to allow for thermal expansion and contraction of the pipe.

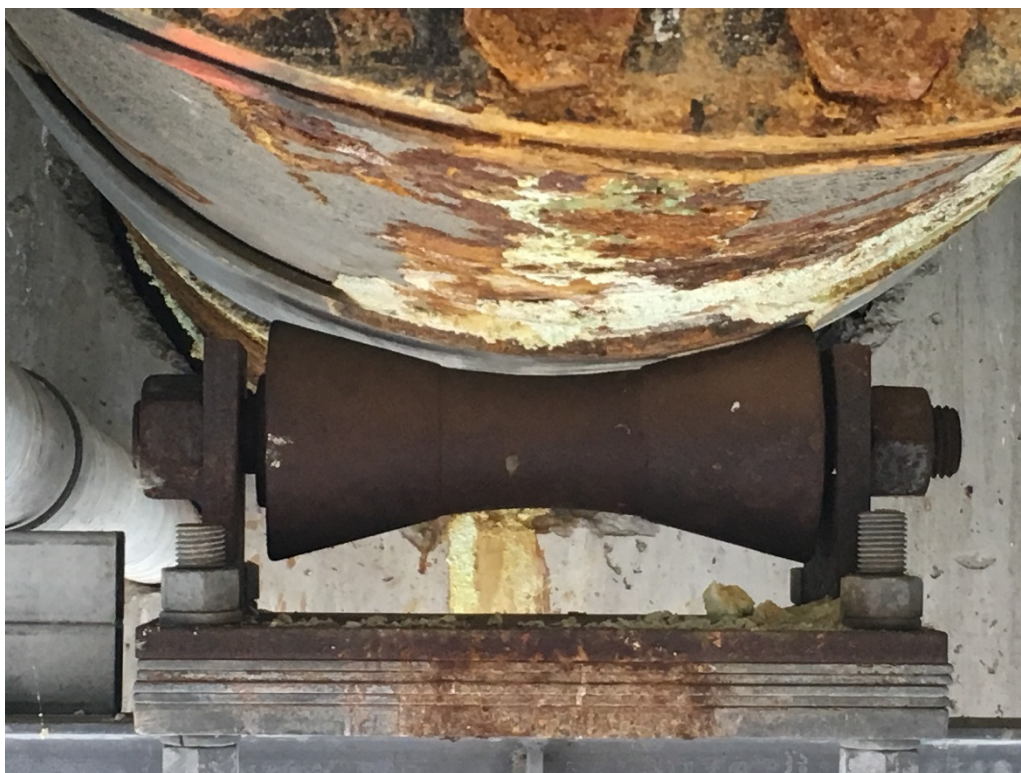
The pipe shields appear to be in place per original design, however, the pipe roller support on support beam # 13 has minimal contact with the right side of the roller (Photo 18).

Photo 18 – Roller support at beam #13 with roller only in contact on the west side of the pipe shield.

- Pipe shields should be inspected at all roller support locations to determine if they have shifted, and to confirm that the roller is supporting the pipe under the shield.
