THE EARTH SLIDE ON ST. FRANCIS HILL

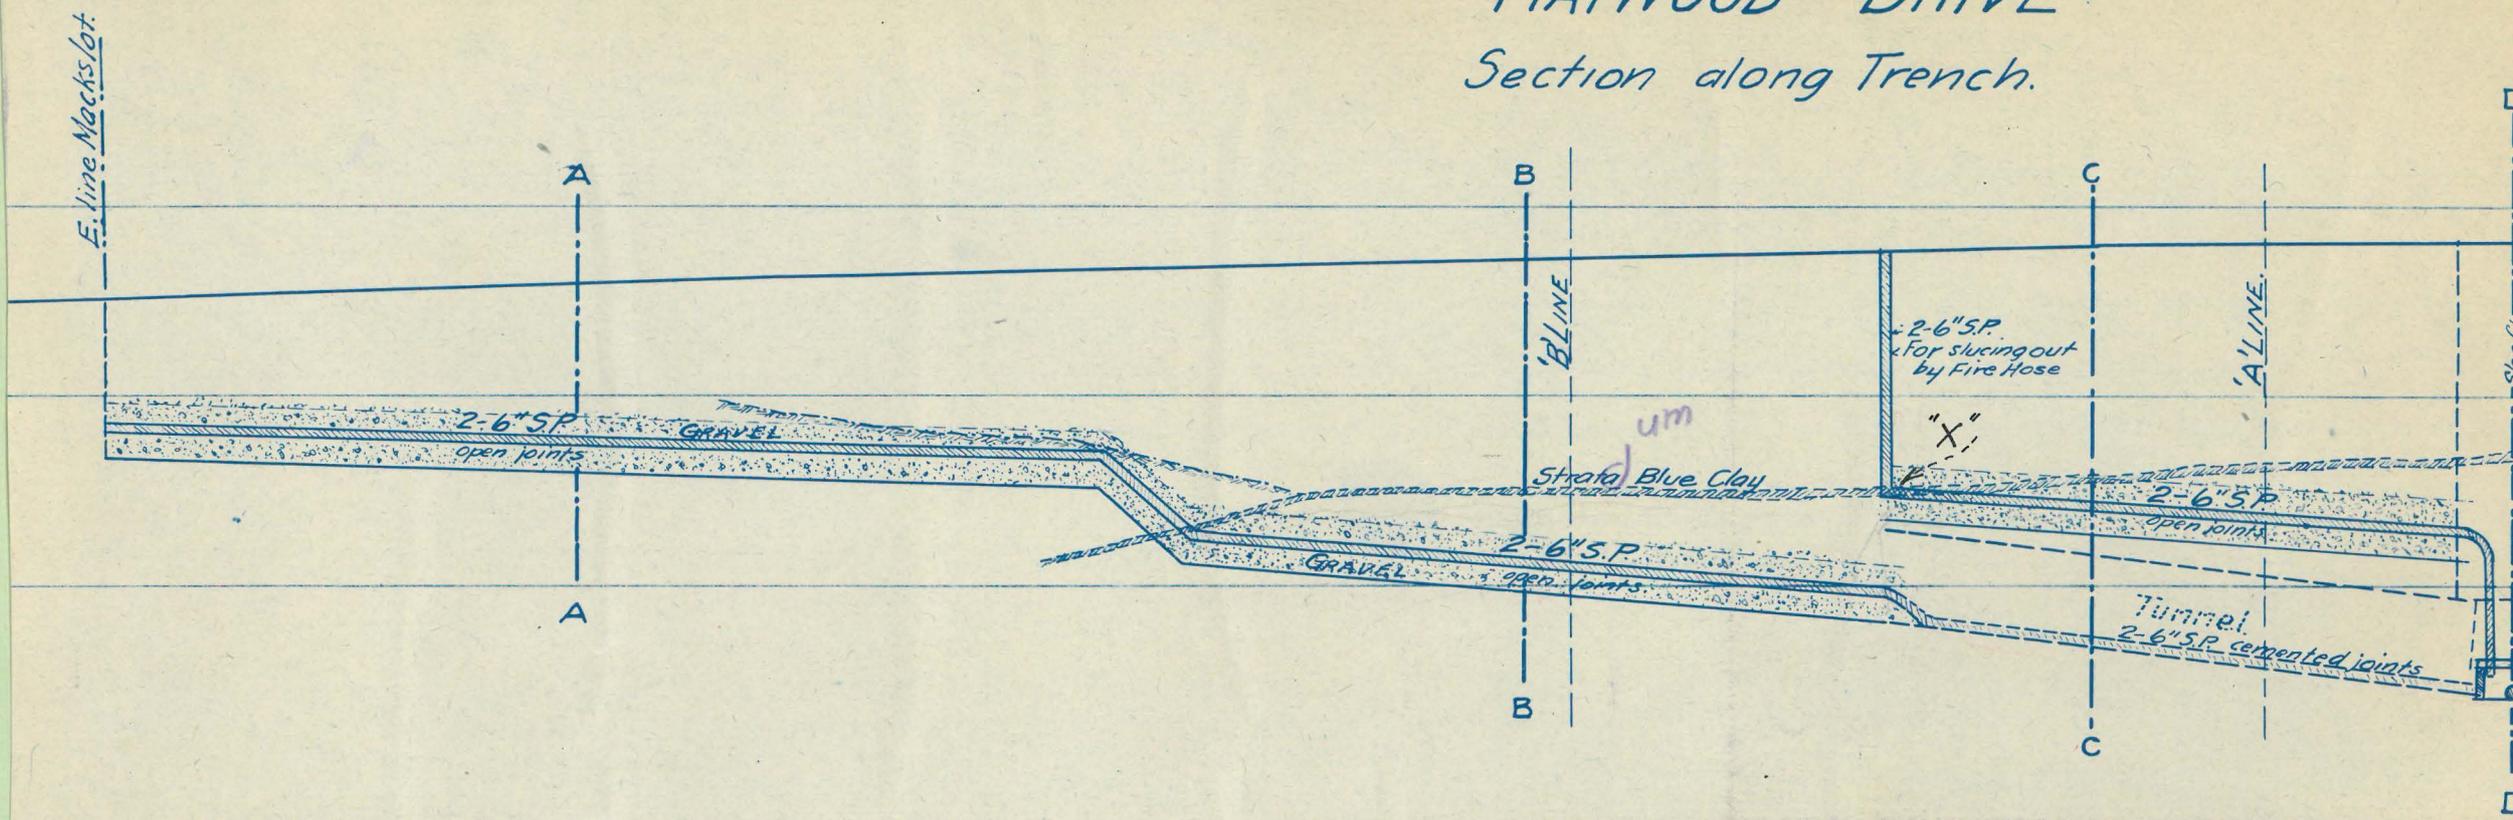
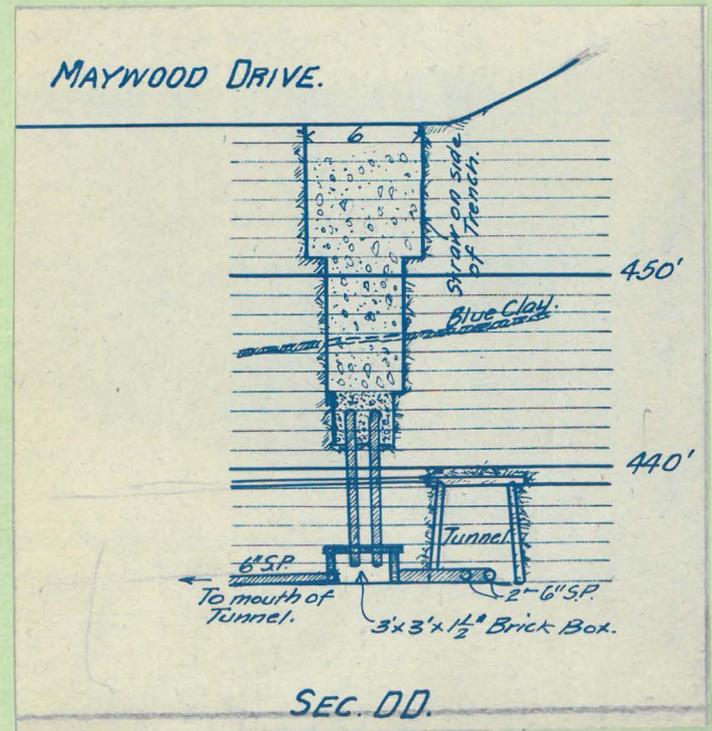
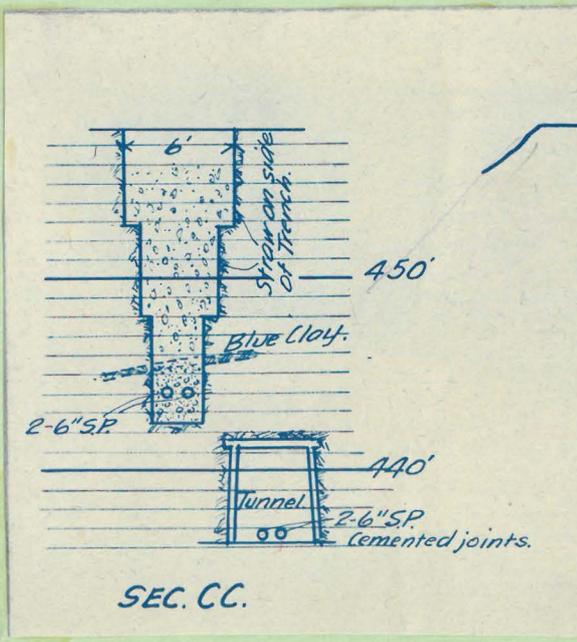
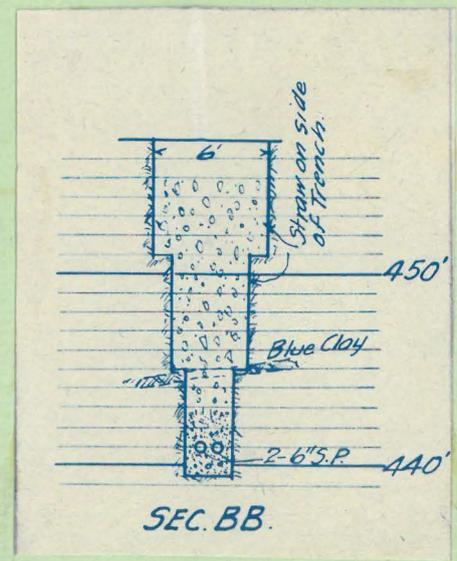
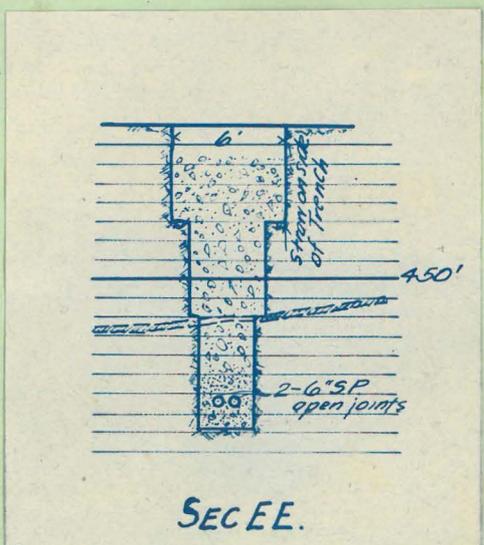
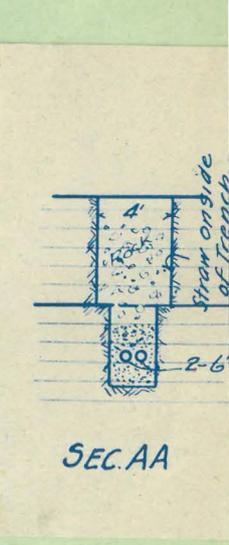
FIGURE 8
SECTION AND CROSS-SECTIONS OF TRENCH AS CONSTRUCTED.

Material was ordered and construction immediately begun. A careful survey was made and all points "tied-in" and stations established from which to observe the progress of the movement. These observations were made daily, the results of which are shown in table (Fig. 9). At the time construction was begun, the movement was averaging 1/4 of an inch per hour, causing the curb to work away from the pavement at the rate of 6 inches per day. The total movement up to the time the trench was constructed was nearly 5 feet. This caused considerable difficulty in excavating and holding the trench in line. Owing to this movement and treacherous character of the soil, heavy timbers were used in the trench, these consisting of 3-inch sheeting and 6" x 6" wales and shores. The trench was constructed in sections 6'6" long in two lifts, the first being 6' wide over all and 6' feet^{deep,} the second 4' wide with an average depth of 6'. The trench was started about 2 feet south of the tunnel, the idea being that the lateral movement would carry the new work approximately over the roof of the tunnel. This movement was greater than anticipated, however, and the trench was carried about 2 feet north of the tunnel during construction (See Sections Fig. 8). Excavation

near Shaft "A" was carried to a depth of about 5 feet below the hard stratum of blue clay, which, in its wetted condition, formed the plane upon which the superimposed material was sliding. The trench was constructed so as to afford a grade of 1 inch per foot ascending easterly. When a length of about 35 feet was reached the bottom of the trench intersected the blue clay stratum due to a downward pitch of the latter; this necessitated excavating to a greater depth (Point "X" Fig. 8). At this point, it was exceedingly difficult to hold the ground, owing to excessive over-burden and surcharge of the upper slopes and as the timbers were being strained to the utmost, we increased the number of cross-timbers and waling pieces and excavated to a depth of 7 feet below the stratum of blue clay and continued easterly on an ascending grade of 1 inch per foot. At a point 70 feet from Shaft "A", the clay stratum suddenly faulted and divided into two layers, one layer breaking downward and the other raising towards the surface. We continued about 6 feet easterly to the intersection of the bottom of the trench with the clay strata, raised and followed the upper strata to the east line of Lot 17. We followed the upper stratum for the reason that the movement was considerably less at this point and it did not seem advisable to attempt to excavate to the lower stratum on account of its very abrupt downward pitch. This would have considerably increased the cost of the work and in the event of its being necessary to resort to this latter, the work already done would not be lost, and furthermore, the movement now seemed to be under control. As the work progressed, two 6-inch sewer pipes were laid with open joints in the bottom of the trench, the pipes being well bedded in gravel, and the balance of the trench filled with crushed rock to within 2 feet of the surface; the timbers were not removed. Figs. 4 and 5 show the trench in its partially-filled condition. The up-hill side of the trench was first covered with a straw mat to resist the tendency of fine particles of clay and silt to percolate through the crushed rock and interfere with the drainage. At point "X", Fig. 8, the pipe in the lower trench was connected with two

similar pipes laid on the floor of the tunnel; these latter pipes were laid with cemented joints. These pipes, as well as the pipes in the upper trenches, were connected to a basin consisting of a 3' x 3' x 1½' brick box provided with a removable cover. From the box the water was conveyed through a single line of 6 inch pipe laid with cemented joints on the floor of the tunnel "Y" (Fig. 7) to a wooden flume carrying the water to the sewer in Marlborough Avenue. At the upper ends of the high level trenches two 6 inch pipes were carried vertically to the surface for the purpose of flushing out the drainage system, should this be necessary in the future. Fig. 8 shows a section and cross-sections of the system as constructed. The pavement has not been replaced at this date, as it was deemed advisable to wait until the effectiveness of the system was proved beyond a doubt. The movement, however, has been entirely checked and the writer does not anticipate further trouble in this immediate vicinity. Several surface drains were also constructed and connected to the sewers at different points. The total cost of this work was \$1520.00

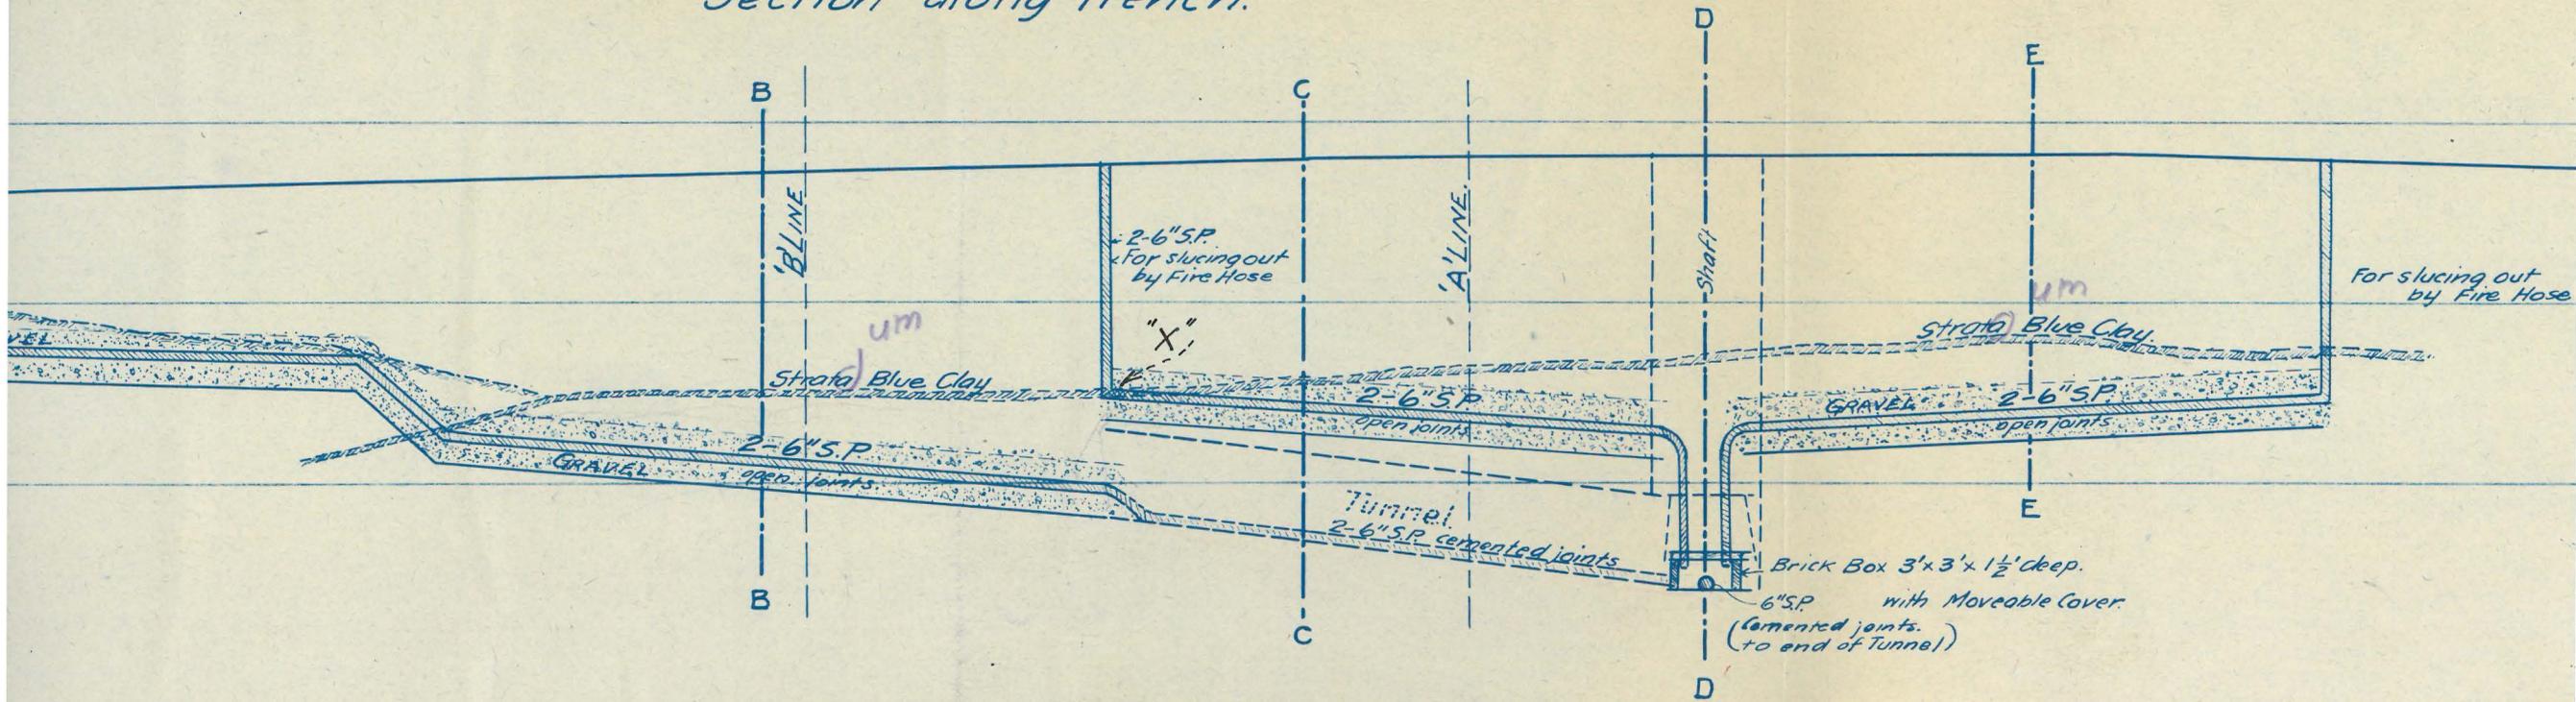
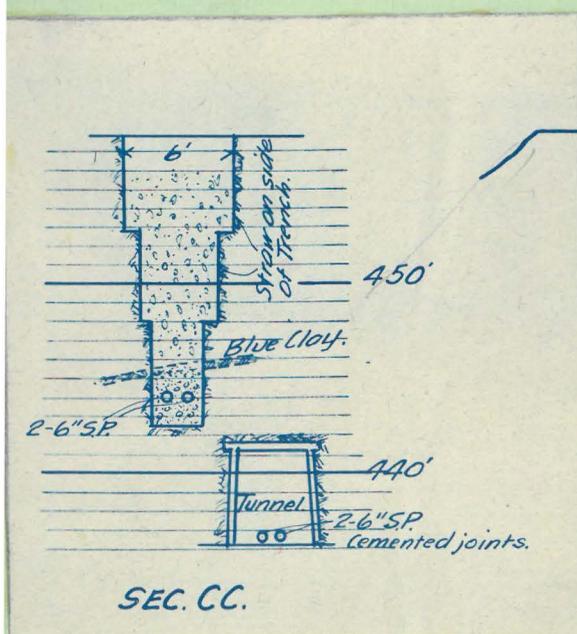
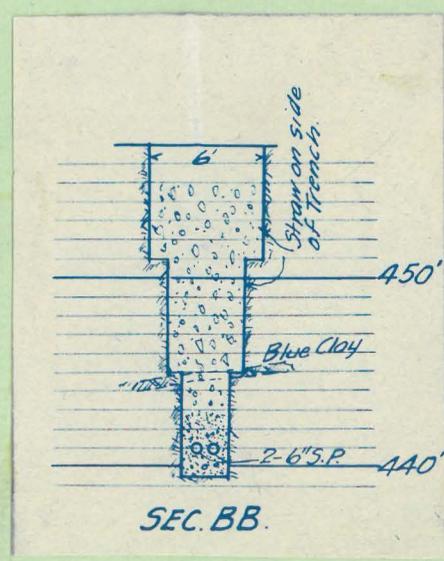
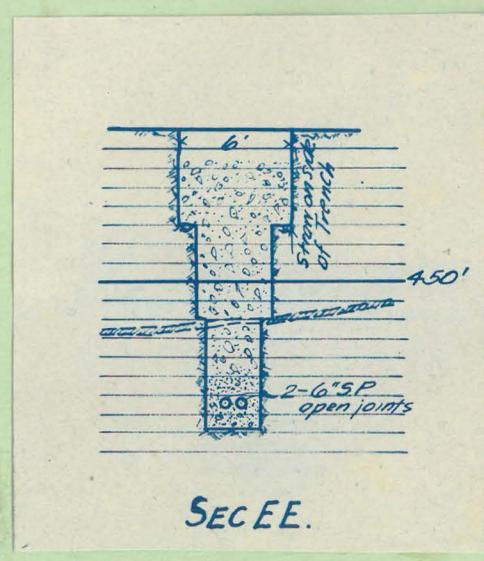
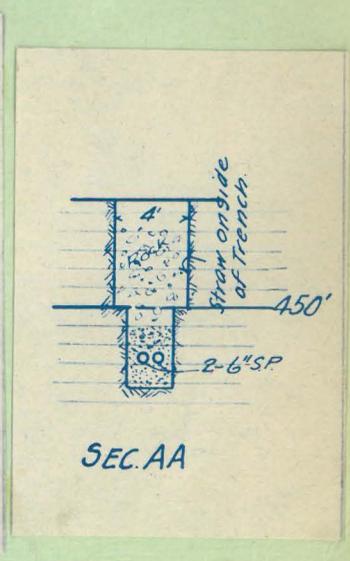
FIGURE 8

SECTION AND CROSS-SECTIONS OF TRENCH AS CONSTRUCTED.
