Subject: Response to City of Portland BDS Site Development Checksheet dated November 5, 2019
Prologis Development at NE 158th Avenue and NE Airport Way
Portland, Oregon
File No. 3626-071-00

FIELD REPORT

Development at NE 158th Ave & NE Airport Way

FR-26

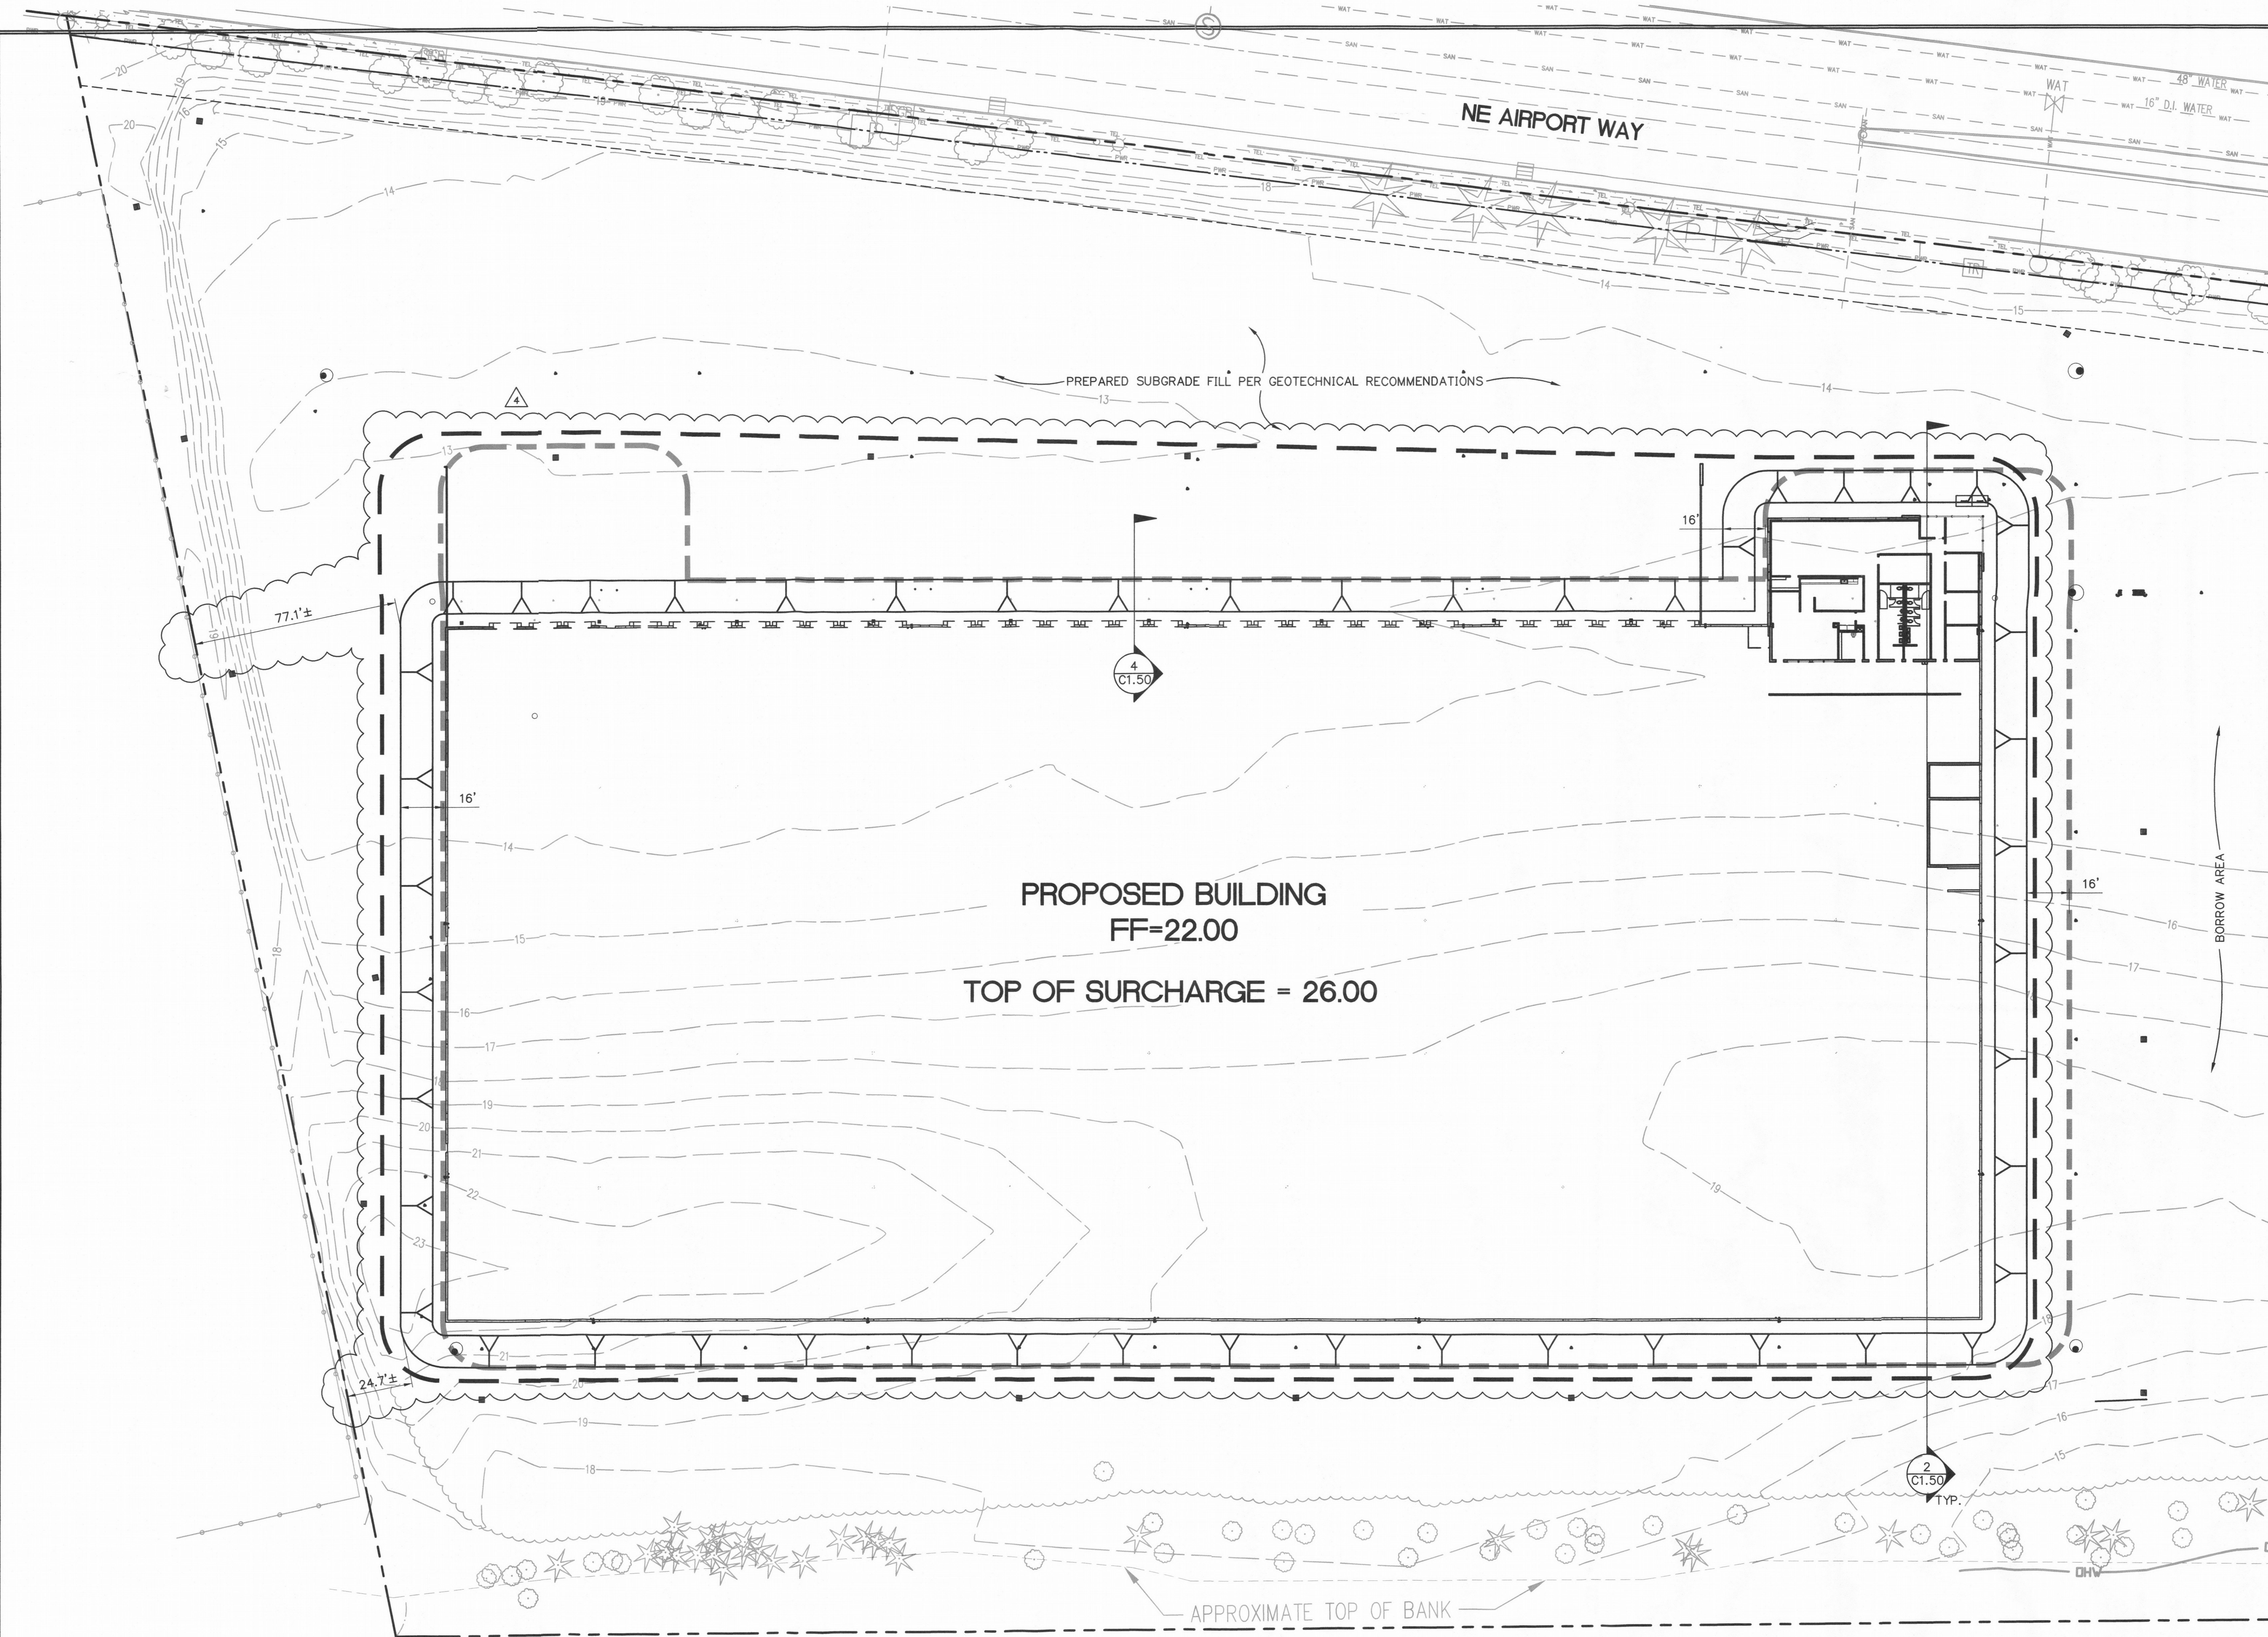
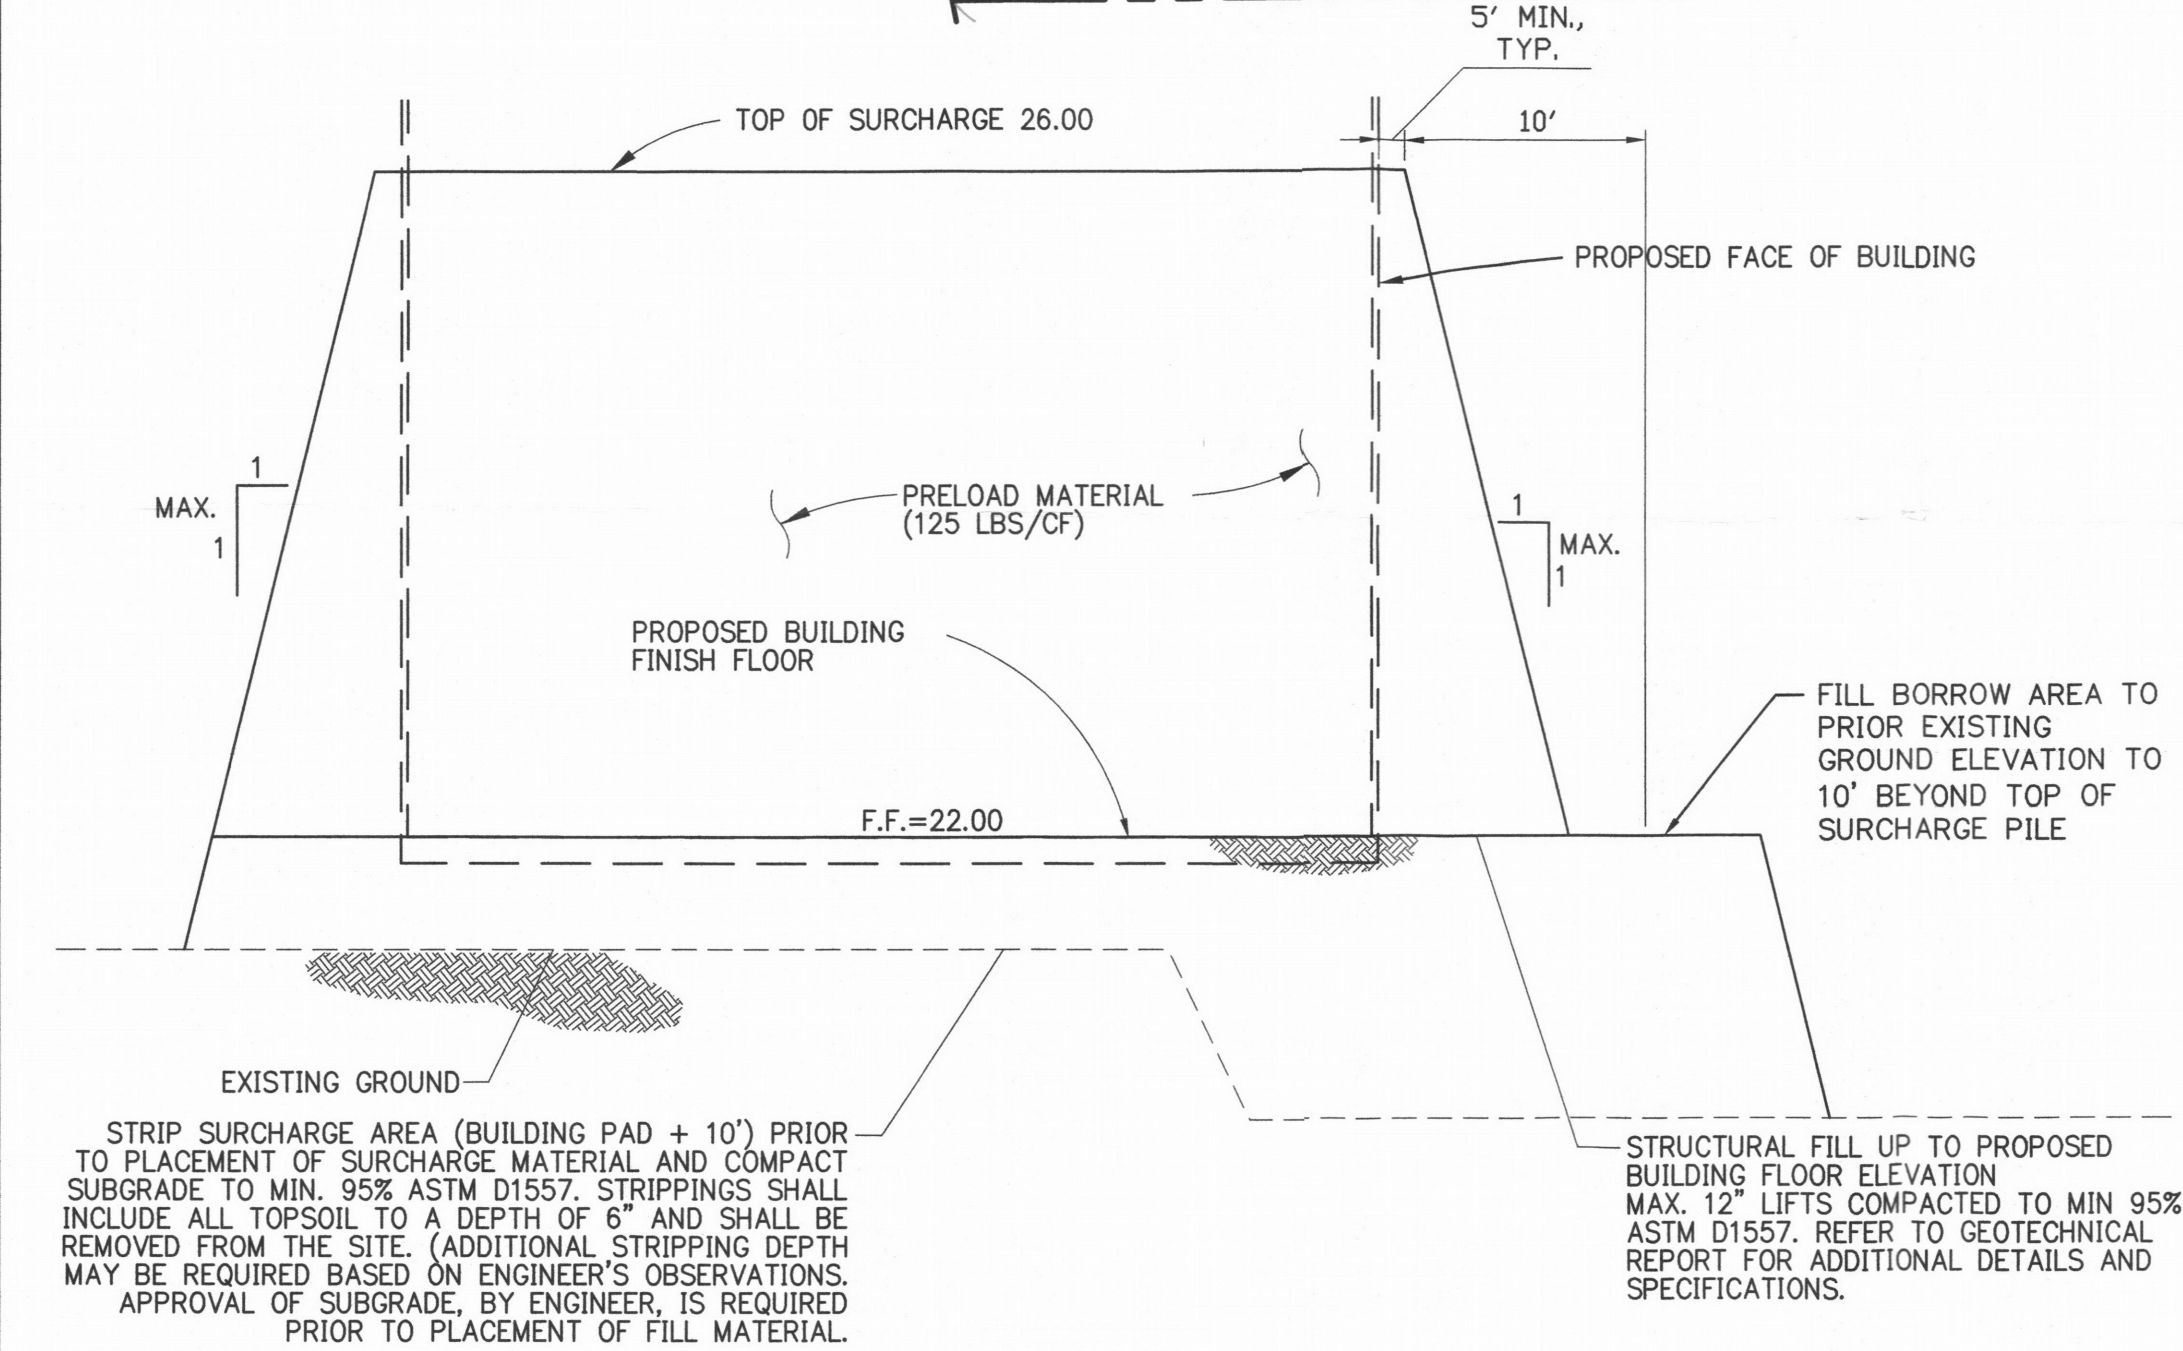
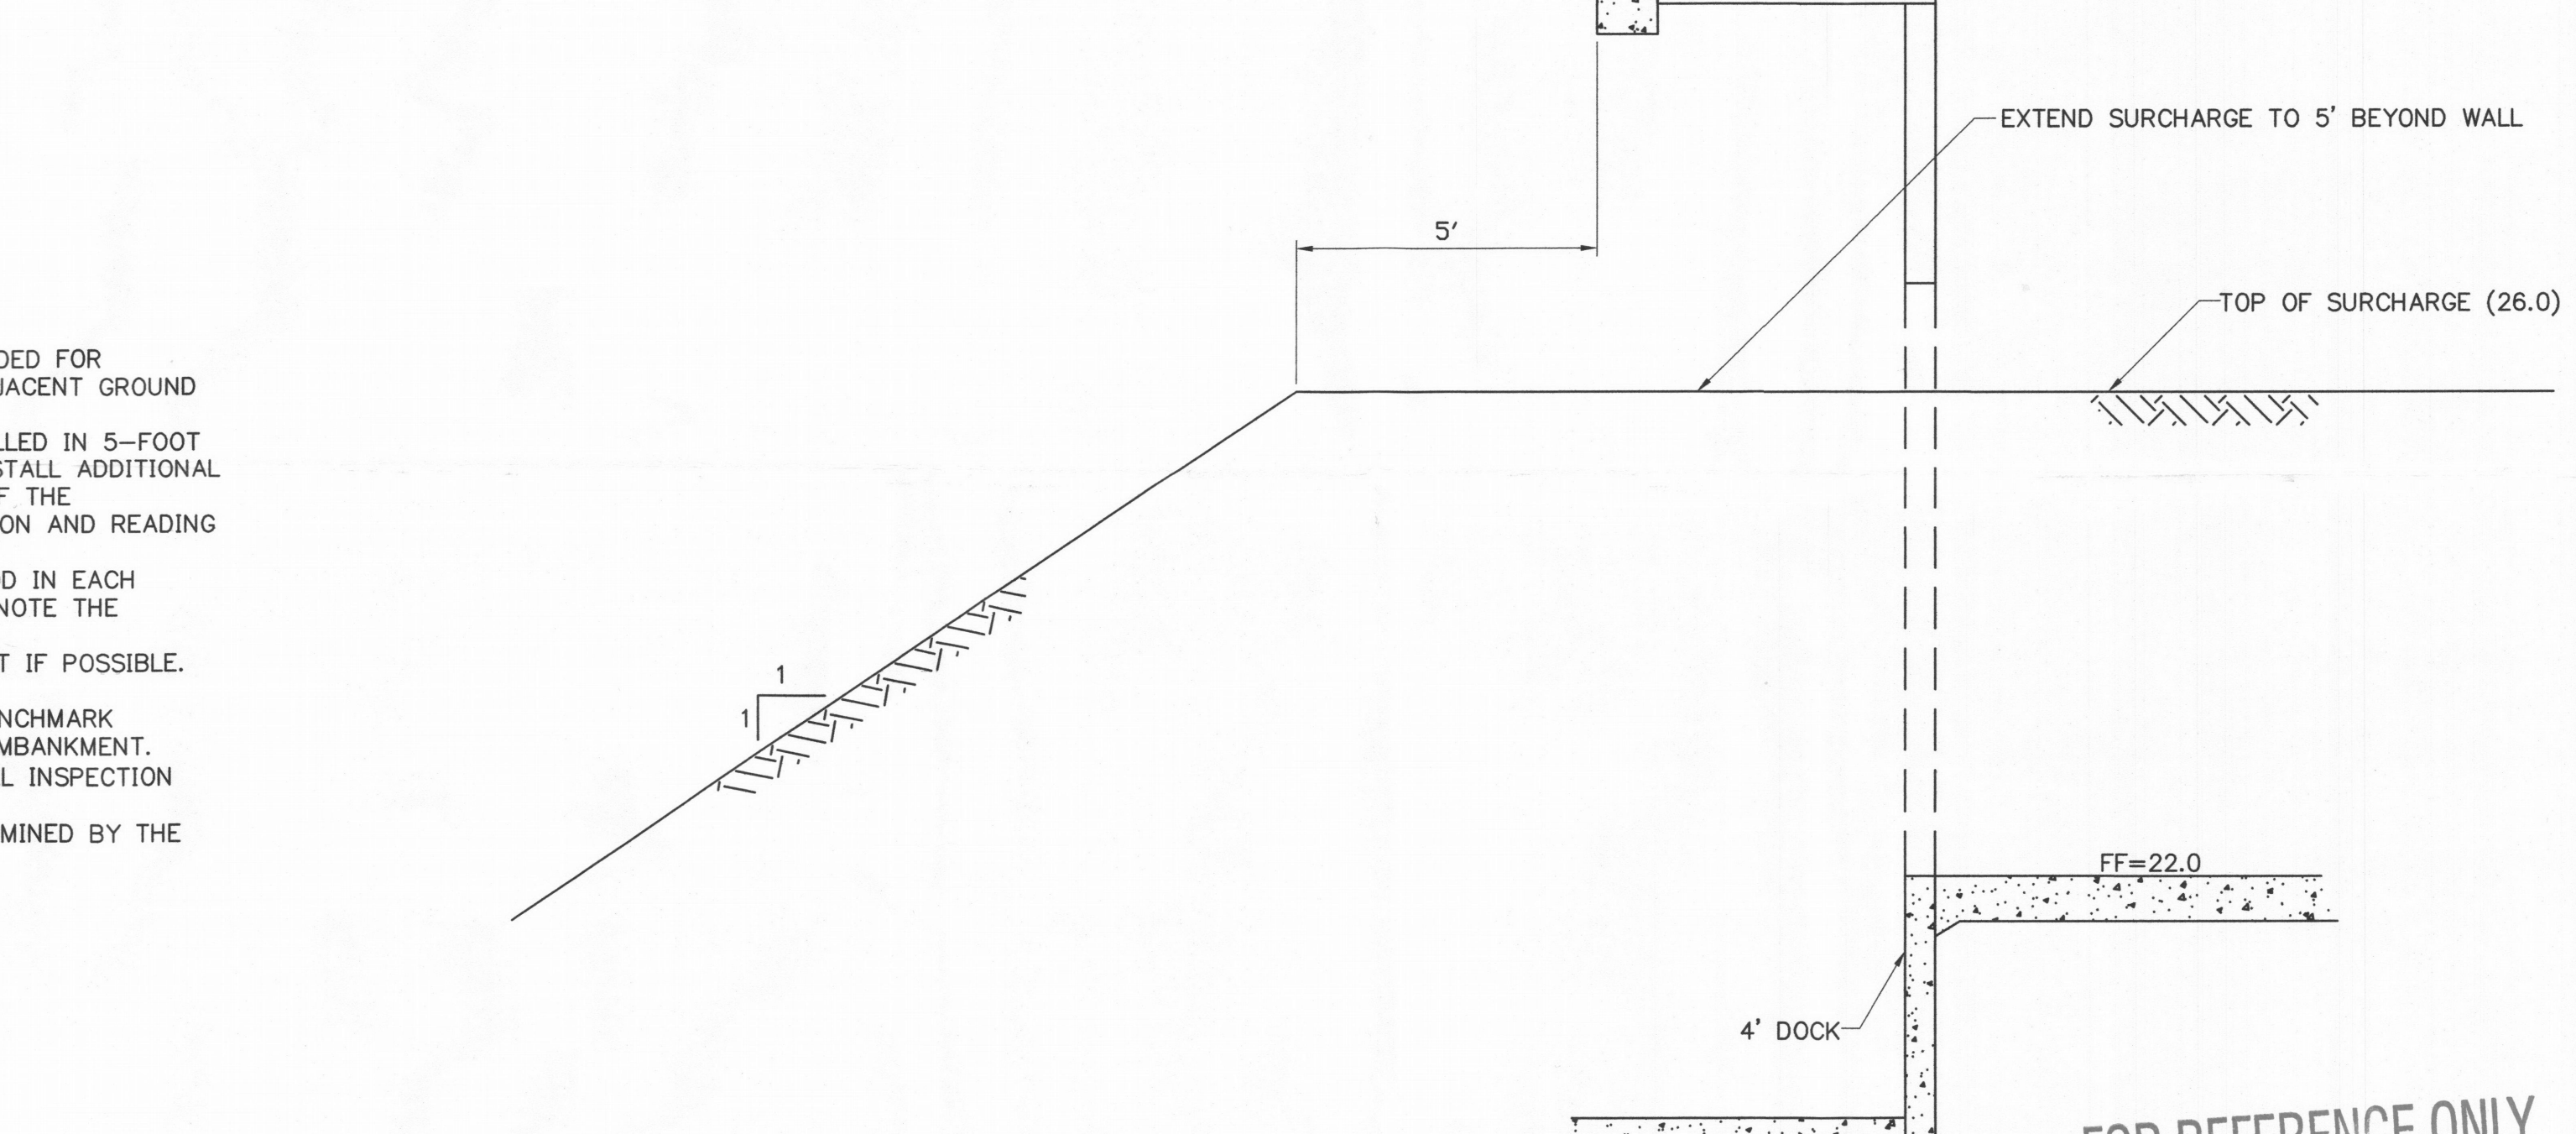
FOR REFERENCE ONLY
Figure 1
Plan check 11.8.19
PERMIT SET - 1.4.19

We understand that the proposed building at the site has been relocated approximately 16 feet west of its original location. Figure 1 presents the revised building footprint and the revised preload fill footprint constructed per our recommendations. We also completed two site visits to observe the preload fill placement within the revised building area west of the original building footprint. Our observations of the preload fill placement and evaluation are presented in the attached Field Reports 26 and 27, dated September 12 and 13, 2019, respectively. The settlement monitoring program developed and implemented for this project incorporated the revised footprint and therefore no updated preload summary letter is required.

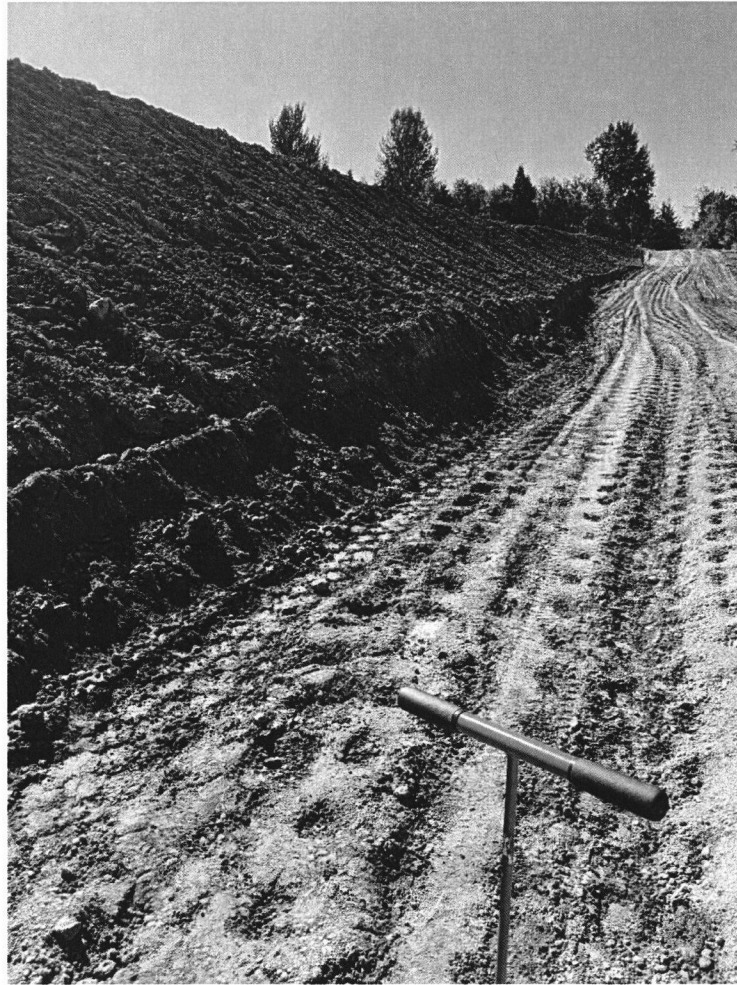
I observed the surface to be firm under foot traffic and that it appeared consistently blended. There were indentations in the surface consistent with the segmented roller previously observed compacting the material (photo 1). I probed this cement treated material with a ½-inch steel foundation probe, typical penetrations under my full body weight were 2-3 inches indicating a generally firm condition. The approximate extent of the cement treated area probed today is shown on the attached site plan.

Photo 1. Strip of treated native subgrade on the West edge of the building pad, taken looking south

Before leaving the site I discussed with John my concerns in adding to the existing building pad. The slope of the existing building pad was poorly compacted, as it had previously been located outside the building area. He stated that attention would be paid to keying into the existing slope and removing poorly compacted material when expanding the building pad.

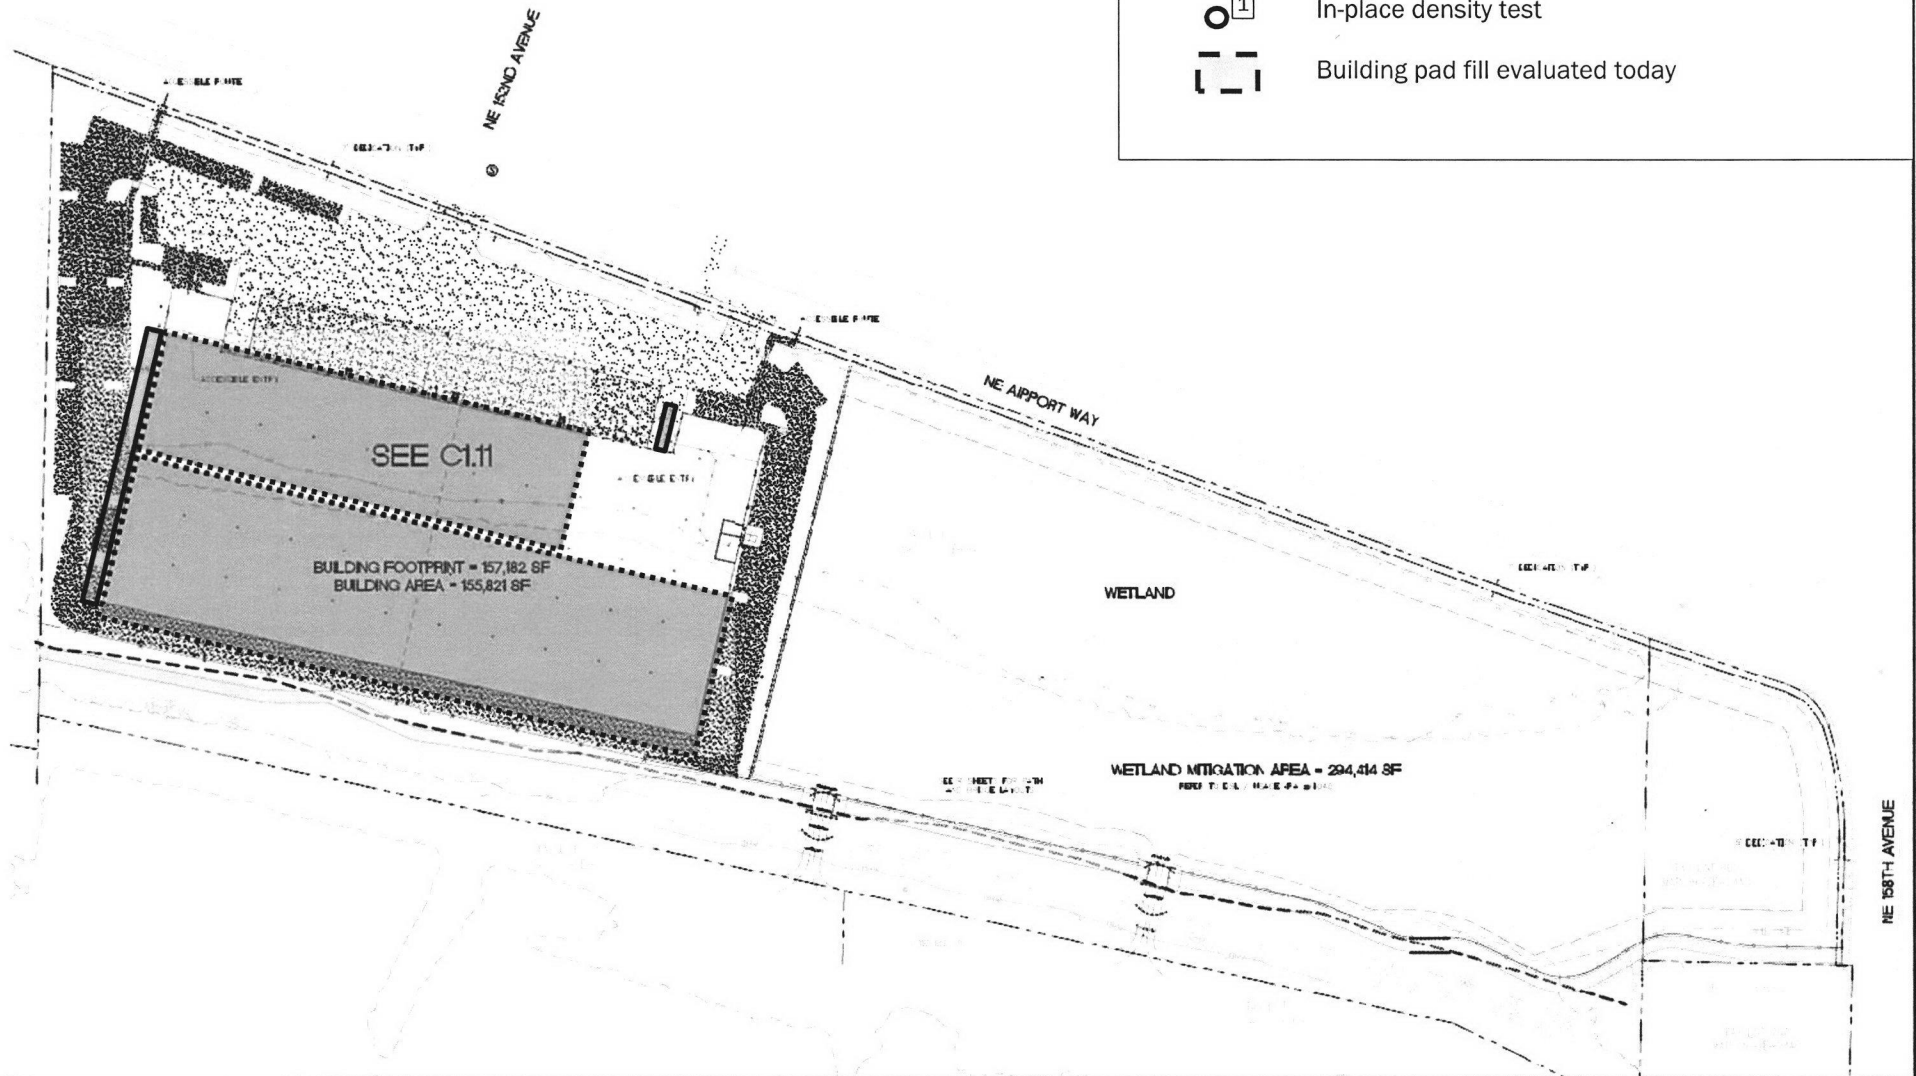
Site Plan to Accompany FR26, 9/12/19

Upon my arrival, I met with John (GBI) who informed me that recent changes to the building plan required that the building be moved 10-feet west of its current location. As such, an additional 10-feet of building pad would need to be constructed. He informed me that to facilitate construction of the new area of building pad, a 10-foot strip of native subgrade on the western edge of the existing building pad had been cement treated.

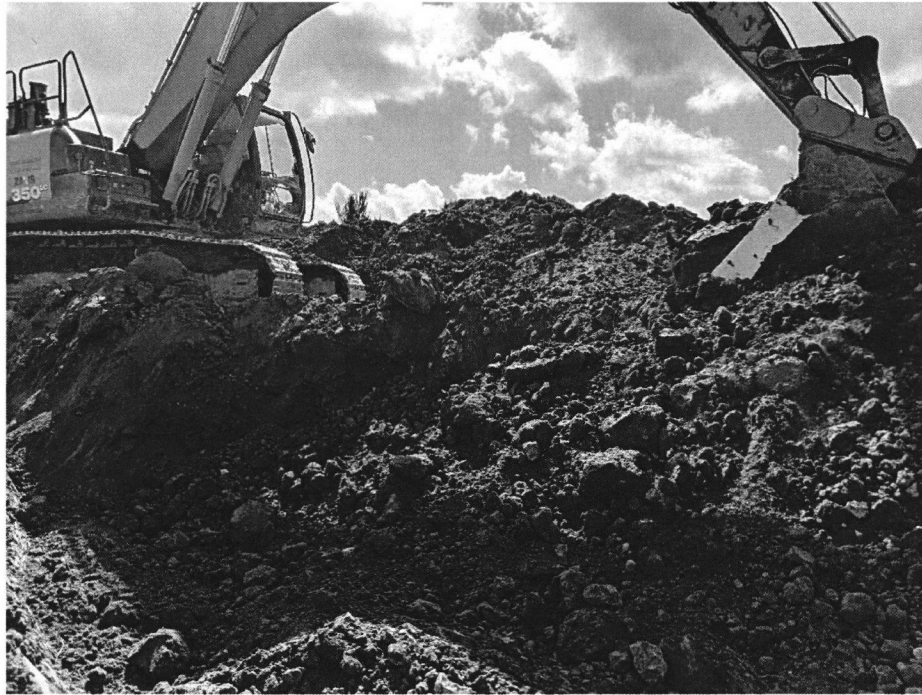
Upon my arrival, I observed that GBI had begun building the new pad area on the west side of site. I observed that they had stripped the placed surcharge back from near the working area, and removed much of the poorly compacted slope material, as discussed yesterday (FR 26, 09/12/19). I observed that they had placed a 12 to 18 inch lift of fill material over the cement treated subgrade observed yesterday. I observed them compacting the material with a CAT CS64 segmented roller. The fill material consisted of silt sourced from an area of the building pad that had been removed in the recent re-design (see attached site plan for location of borrow material). This source material was a mixture of cement treated and untreated material and can be seen in photo 1.

Photo 1. Borrow material used as fill today

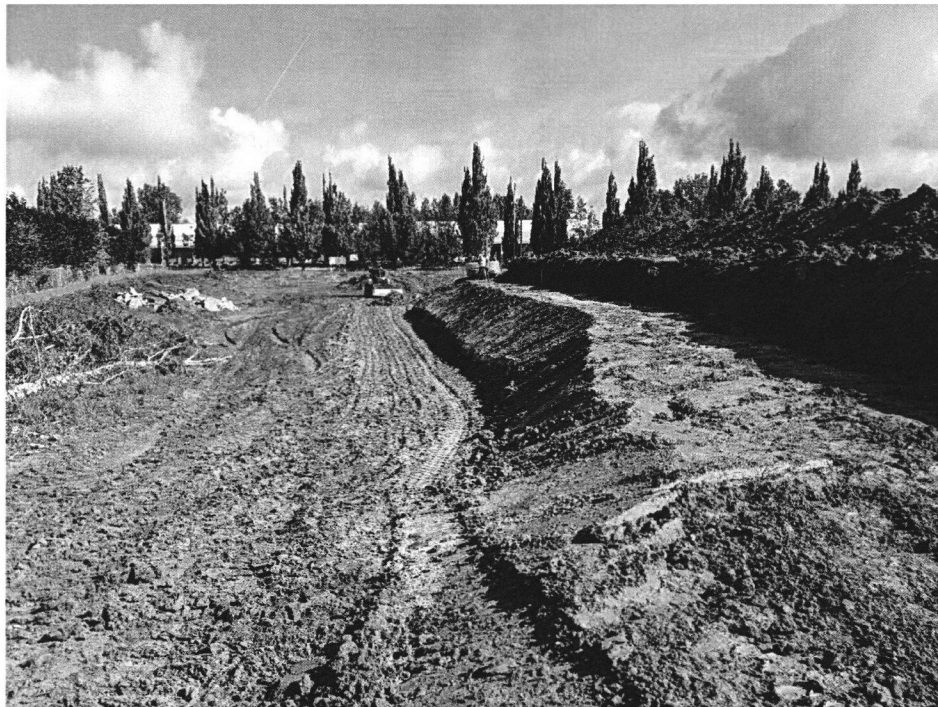
After the lift had been compacted with several passes of the segmented roller I probed the lift with a ½-inch steel foundation probe. Resulting penetrations under my full body weight were 3 to 6 inches indicating a medium stiff condition. When subjected to the roller loading, I observed the material deflecting up to 6 inches.

GBI proceeded to build this area with 18-inch lifts, further keying into the existing slope with each lift, mixing this material with the imported fill and compacting it. At each lift I conducted a series of in-place moisture tests on the prepared cement fill material. Tests were performed with a Troxler nuclear density gauge in general accordance with ASTM International (ASTM) Standard Practices Test Method D 6938-17a at a depth of 12-inches. Results were compared to a maximum dry density (MDD) of 96.8 pounds per cubic foot (pcf) with an optimum moisture content (OMC) of 21.9 percent. A summary of the results can be found in the attached Moisture Density Test Summary sheet.

Photo 2. Strip of pad being built on the West edge of site

Due to the presence of cement in the material density tests results were used to document the general consistency of the material. The compaction of the material was evaluated based on the results of probing each layer with a ½-inch steel foundation probe as described above, which provided consistent penetrations of 3- to 6-inches, and difficulty to drive the testing pin. I discussed with John (GBI) that this area will be further evaluated once the preload/surcharge fill is removed and that corrective measures of any soft spots may be required at that time.

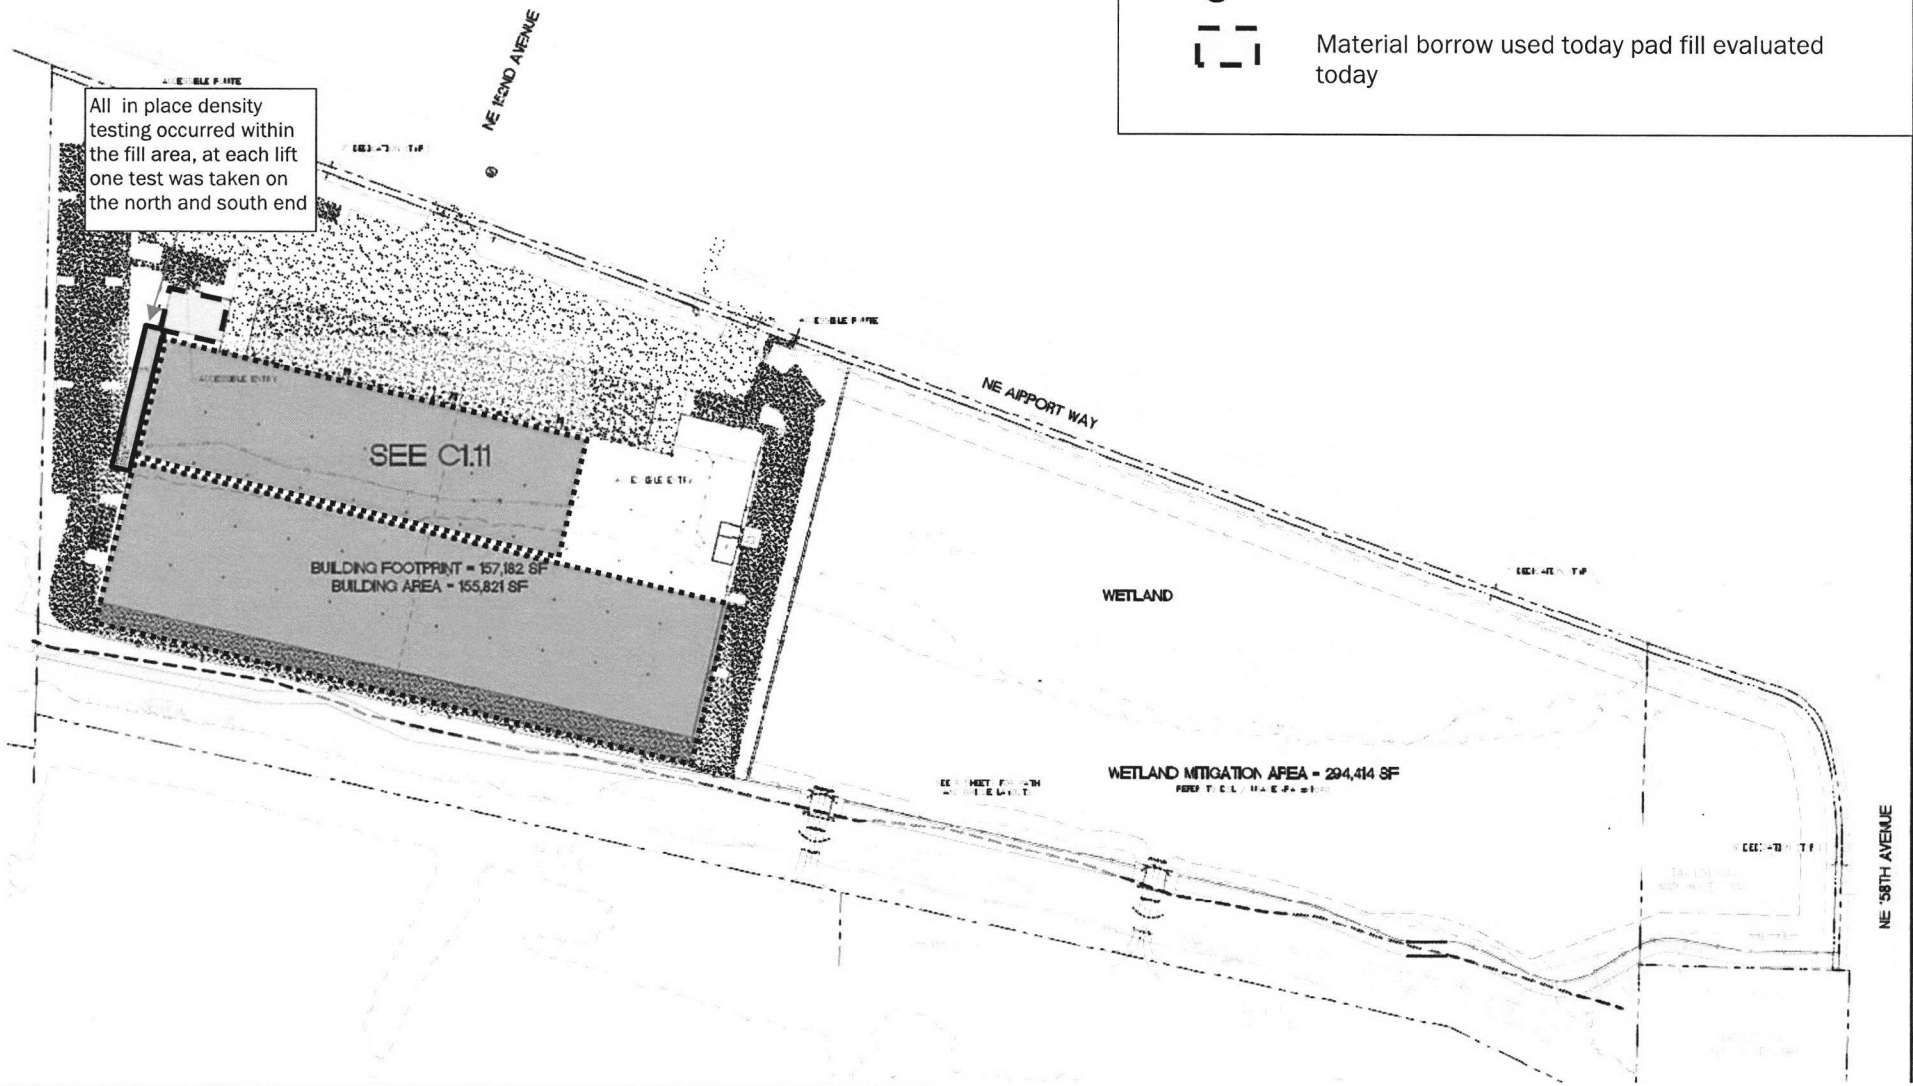
Site Plan to Accompany FR27, 9/13/19

All in place density testing occurred within the fill area, at each lift one test was taken on the north and south end
