APPEAL SUMMARY

Appeal ID: 14750	Project Address: 485 NW Glisan St
Hearing Date: 3/8/17	Appellant Name: Amy Perenchio
Case No.: B-016	Appellant Phone: 5038632463
Appeal Type: Building	Plans Examiner/Inspector: Amit Kumar, Larry Wright
Project Type: commercial	Stories: 11 Occupancy: A-2, A-3, B, R-1, S-1 Construction Type: I-B
Building/Business Name: Canopy Hotel	Fire Sprinklers: Yes - Throughout
Appeal Involves: Erection of a new structure	LUR or Permit Application No.: 15-265536-CO
Plan Submitted Option: pdf [File 1]	Proposed use: Hotel

Re: Pearl Canopy Hotel—Non-Conforming Reinforcing Appeal

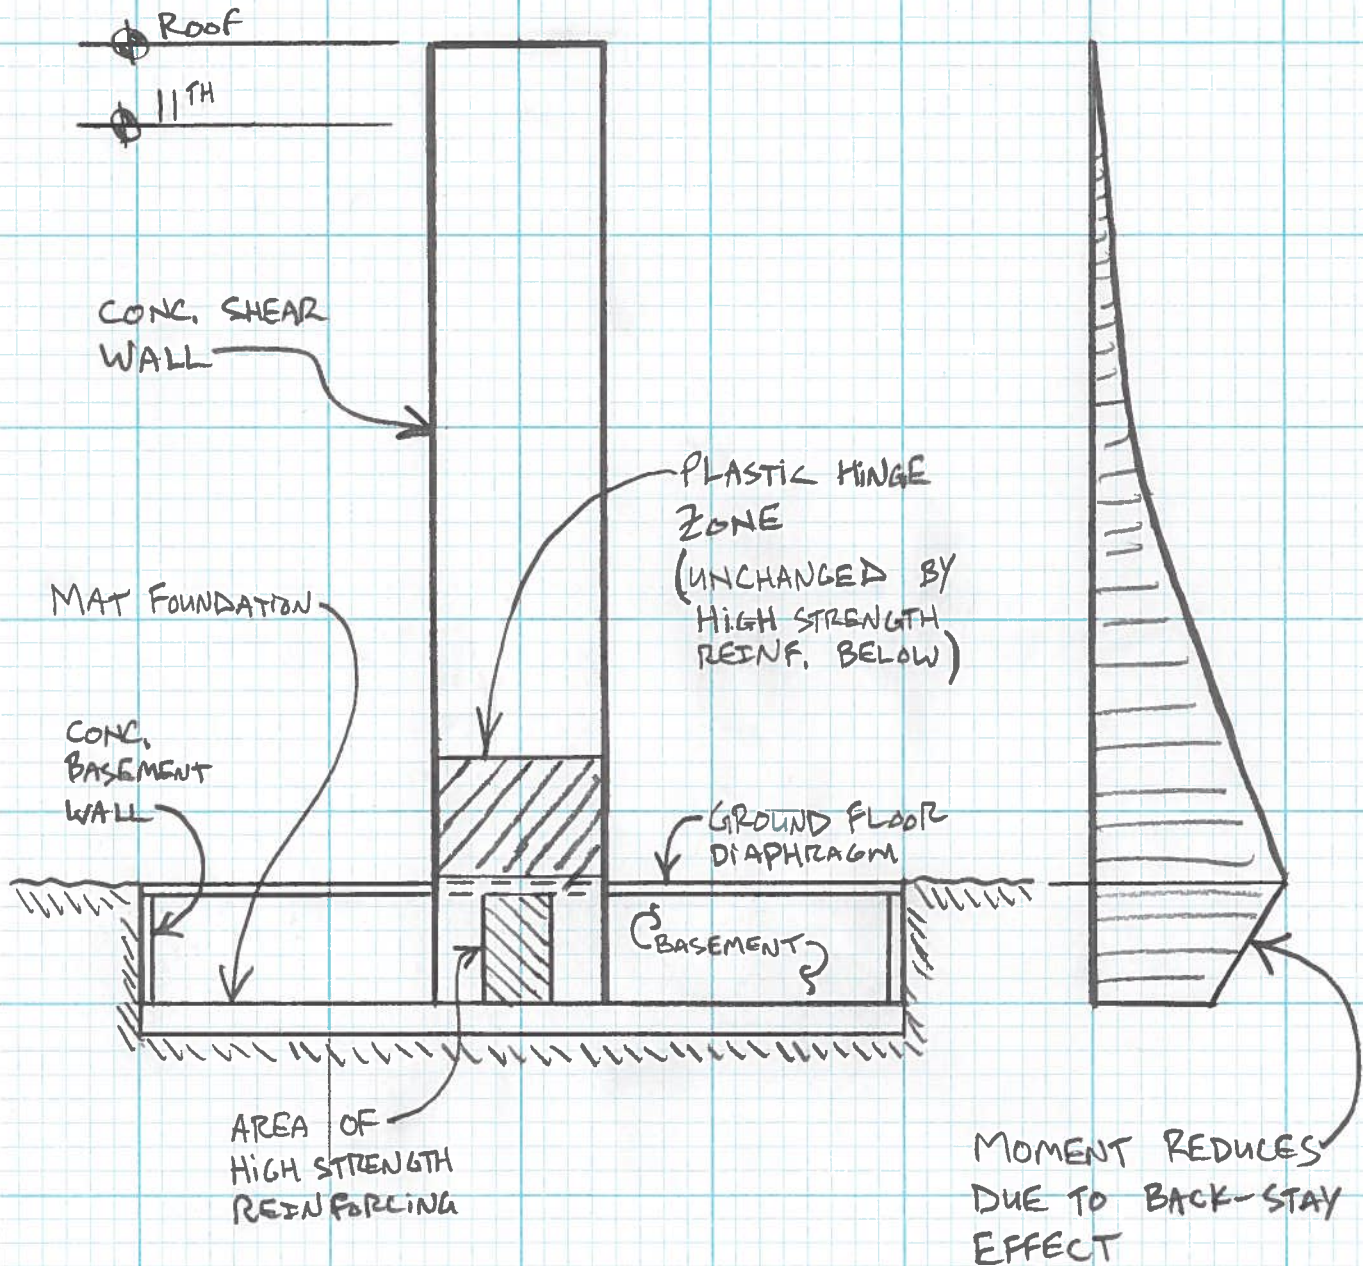
Attachment Sketch

We believe that the high yield strength reinforcing that was placed on this project does not alter the intended behavior required by the building code. Below the ground floor level, the flexural demand (bending moment) on the shear walls reduces due to the "back-stay" effect created by the ground floor diaphragm distributing load to the perimeter basement walls. Therefore, we would still expect the plastic hinge zone to form above the ground floor level where the reinforcing does conform to ACI requirements. Reference the attached sketch (dated 3-2-2017) for an illustration of this point. Therefore, the use of reinforcing that does not conform to Section 21.1.5.2.a below the ground floor does not alter the expected flexural hinge capacity or location and thus would not change the resulting shear demand as compare to the original design.

Based on the discussion above regarding the intent of the code, the placement of the reinforcing in question, and the expected behavior of the shear walls, we would recommend that no corrective actions are required for this specific instance of the reinforcing being outside of the limit of Section 21.1.5.2.a from ACI 318-11.
