**Re: Emergency Declaration for a BES Sewer Repair Project**

NE 33RD AVE & NE KNOTT ST  
SEWER EMERGENCY

## E11501 NE 33<sup>rd</sup> & NE Knott Sewer Emergency Commissioner Briefing for Ordinance

| Subject: | Alternatives Evaluation and Repair Recommendations – FINAL | | |

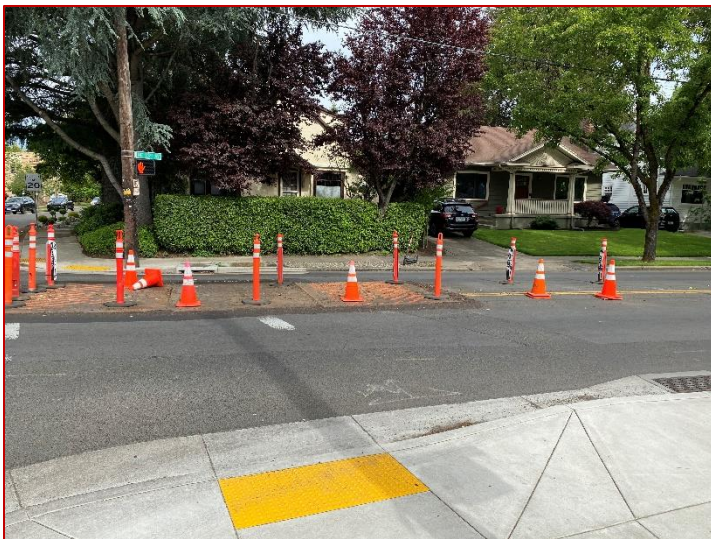
In late May 2022, BES was notified that a sinkhole had developed in the middle of NE 33<sup>rd</sup> Ave on the south side of the intersection with NE Knott St. A second sinkhole was later identified approximately 60 feet south of the first sinkhole. Both sinkholes were covered temporarily with steel street plates and traffic control devices as shown in Photos 1 and 2.

**Photo 1:** First sinkhole at NE 33<sup>rd</sup> Ave & NE Knott  
(crosswalk on south side)

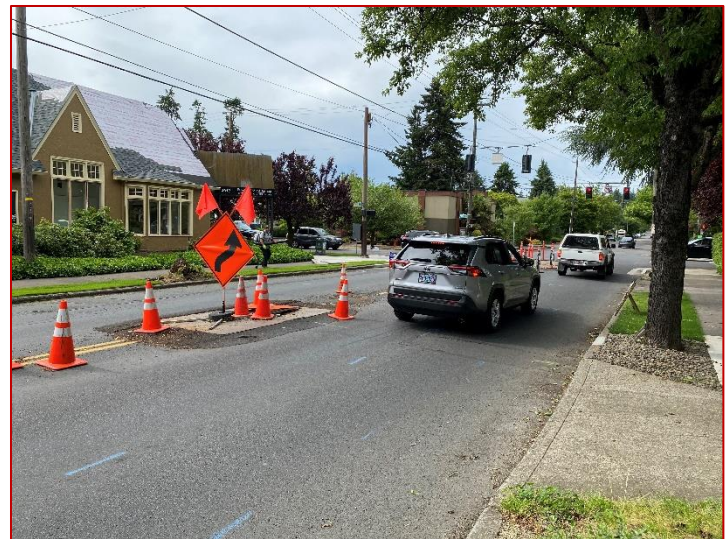
**Photo 2:** Second sinkhole on NE 33<sup>rd</sup> Ave  
(approx. 60 feet south of first sinkhole)

Regarding the second sinkhole approximately 60 feet south of the junction chamber, very little is known about this issue. McMillen Jacobs recommends further exploration to determine an appropriate sinkhole repair. During construction of the new junction chamber, shaft excavation will provide some indication of the problem. Potholing and trench excavation between the two sinkholes would provide additional input. Ground modification grouting may or may not be appropriate. It would be most economical and expeditious to have the Contractor perform the additional exploration and eventual repair. For bidding purposes, McMillen Jacobs recommends including a Bid Item called "Trench Rehabilitation" with a defined scope and typical detail – say 8-feet wide by 8-feet deep by 60-feet long – to get competitive pricing for this effort. After the Contractor is on board and the Team gains a better understanding, the scope of repair for the second sinkhole can be developed and implemented.

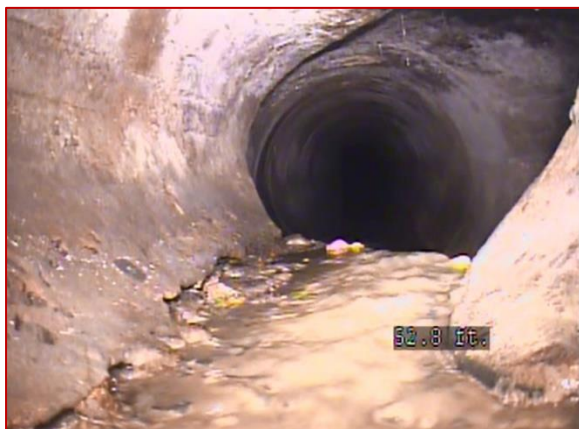
- **CCTV inspection video:** In late May 2022, BES inspected the 30" sewer from AAY400 to the junction chamber and the 66" sewer from ABD159 to the junction chamber. The CCTV videos showed severe deterioration in the invert of the 30" sewer and at the base of the junction chamber where flow cascaded. The bricks and concrete invert appeared to be missing at both locations (see Photos 3 and 4). The first sinkhole developed directly above.

Photo 3: Deteriorated invert at 30"/60" junction, looking downstream 53 feet from AAY400

Based on the above, it is McMillen Jacobs' opinion that the root cause of the sinkholes in the middle of NE 33<sup>rd</sup> Ave at NE Knott St was the severely deteriorated invert of the junction chamber directly below. Over many years, flow from the 30" sewer dropped into the junction chamber, scouring the invert. Eventually, the invert was fully eroded and the bare soil outside the junction chamber was exposed. This allowed the fine-grained soils around the junction chamber to slowly wash into the sewer each time it rained. Soil erosion and settlement increased over time as storm water infiltration found the path of least resistance. With the second sinkhole developing about 60 feet downstream of the junction chamber, soil erosion around the outside of the existing sewer appears to have propagated both upwards and down gradient at least 60 feet from the scoured invert. It is unknown what impact, if any, that recent construction activities may have had, but suffice to say that compaction of trench backfill above the sewer exacerbated the problem and accelerated ground settlement.

In light of the above, McMillen Jacobs recommends construction of a new junction chamber with a 144" maintenance hole, reducer slab, and 48" riser. This alternative prioritizes worker safety, public safety, cost, schedule, and long-term benefits. Upon conclusion of the repair, the new junction chamber will eliminate infiltration into the sewer (at this location), restore soil confinement around the existing sewer, reduce flow velocity/energy from the 30" sewer, and provide safe, convenient access for future maintenance and rehabilitation.

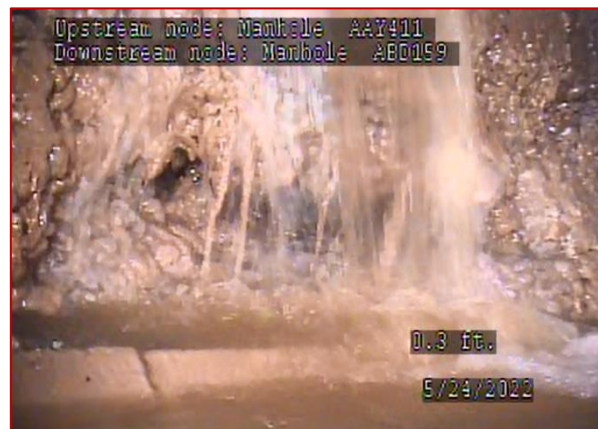
Photo 4: Scoured invert where 30" cascades to 66"

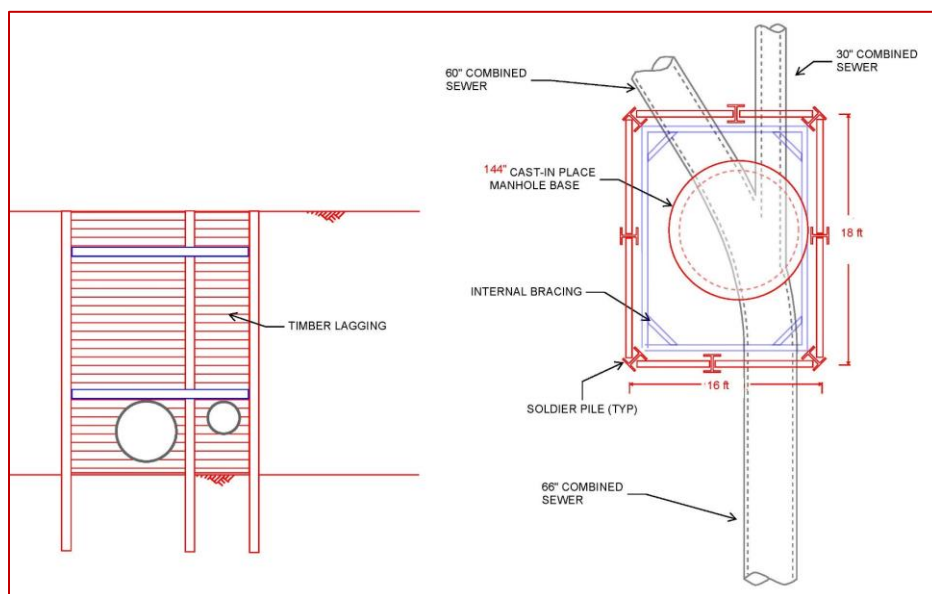
McMillen Jacobs performed preliminary shoring design calculations for this alternative. Figure 2 illustrates one feasible shoring method – soldier pile/lagging with two levels of internal bracing.

**Figure 2:** Feasible soldier pile/lagging shoring for new junction chamber

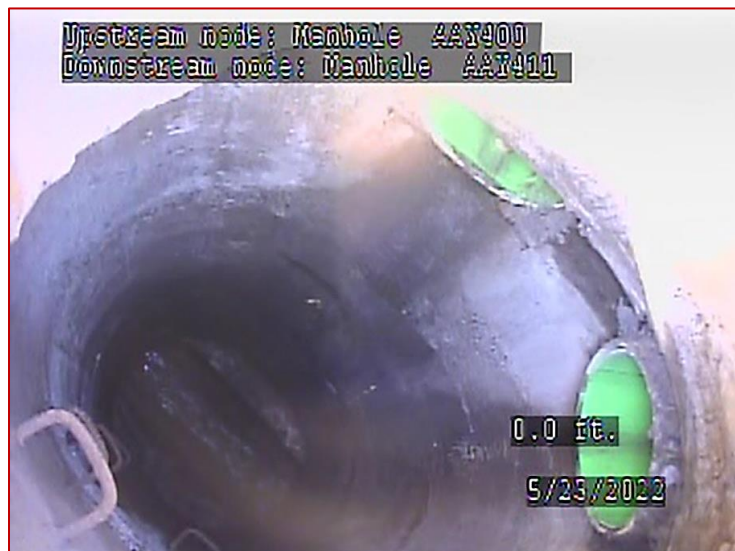
Given the advanced age of the existing concrete sewers (30", 60", 66") and challenging lack of safe access to these sewers, additional structural rehabilitation will be necessary at some point in the future. CCTV inspection video of the existing 30" sewer indicated severe deterioration in the invert upstream of the junction chamber. The existing maintenance hole AAY400 in NE 33<sup>rd</sup> Ave appeared to have minor defects and inflows around two storm drain penetrations (see Photo 5). In addition, this MH was oval approximately 30" diameter, which may not be large enough to facilitate CIPP rehabilitation in the future.

**Photo 5:** CCTV inspection photo of AAY400 on NE 33<sup>rd</sup> Ave

For future planning purposes, the total estimated construction cost to remove the existing AAY400 and replace with a new 48" maintenance hole (large enough to facilitate CIPP rehabilitation) would be \$384,000 to \$533,000 and take about 3 to 4 weeks. Alternatively, AAY400 could be patched from the inside for much less cost and time. This would repair the minor defects/infiltration and postpone construction of suitable access until the 30" sewer is scheduled for rehabilitation.
