**Liquid Storage Tanks at the Critical  
Energy Infrastructure (CEI) Hub  
Seismic Assessment of Tank Inventory**

May 2019

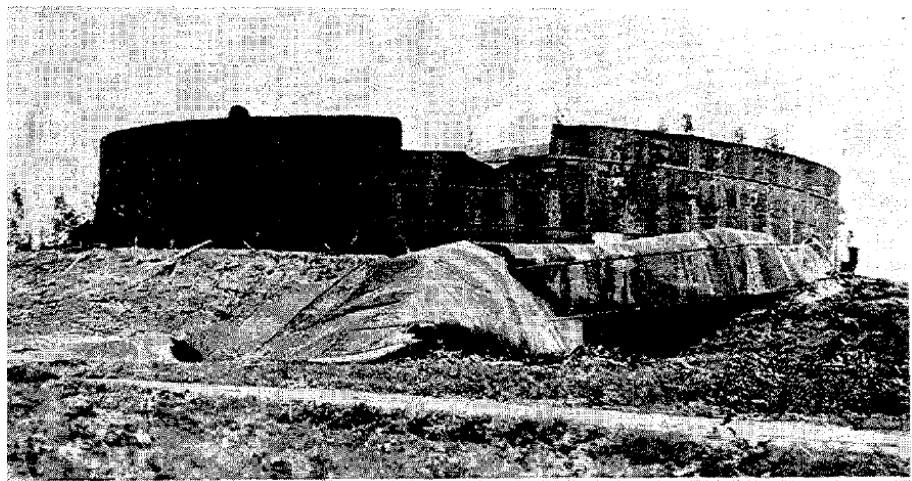
Although there are some references to an event in 1923 in Tokyo, the first reasonably well-documented case of damage to oil storage tanks followed the 1933 earthquake in Long Beach, California. The earthquake affected an industrial area that produced, refined, and stored petroleum. Complete tank failures were reported at three different locations, all less than 30 miles from the epicenter of the magnitude M6.4 earthquake. Peak ground acceleration (PGA) of 0.19g recorded at stations with similar distance from the epicenter were thought to be representative of those at the storage tanks (Housner 1952). Many tanks exhibited distortion, elongation, strain in riveted joints and buckling of the roof plates. Two of the tanks' riveted joints failed and while the tanks did not collapse as a result, the oil leaked. In one group of tanks, three partially full tanks sustained no damage while a full tank experienced total failure. The lost oil overcame the firewall and damaged neighboring buildings over 300 ft away (Nielsen & Kiremidjian 1986). There were other failures including overtopping where the roof was found 200 ft from the failed tank as shown in Figure 1. Other tanks did not necessarily fail in their structure, but were not anchored and separated from the inlet/outlet (I/O), resulting in loss of the oil. All failed tanks were of riveted construction and their structural failures were due to damage in the tank shell. The behavior of riveted shell wall tanks differs from the newer, welded shells construction. The long beach earthquake demonstrated that structural vulnerabilities of tanks relate to the riveted shell construction, to how full the tank is and to the connectivity of the I/O piping.

*Figure 1: Failed Tank following 1933 Long Beach Earthquake (Cooper 1997)*

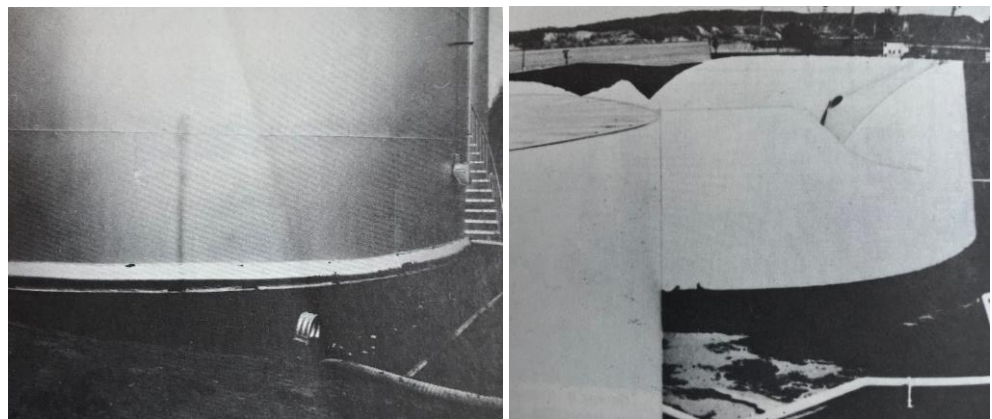
the petroleum industry was Alaska's largest mineral industry and damage to petroleum storage facilities was reported in the cities of Valdez, Whittier, Seward, Anchorage, and Nikiska. Direct structural damage to fuel storage tanks included: shell buckling near the bottom of the tank, buckling of cone roofs and top courses of shells, damage to floating roofs and accessories, and damage to I/O connecting piping (Rinne 1967). These were the result from liquid sloshing induced deformations, hydrodynamic pressure acting on the tank walls, shear force and overturning moment acting at the base of the tank, the buckling strength of tanks and, uplift on the axial stresses acting on the tank wall in contact with the ground. Sloshing can damage the top of the tank and can also result in roof damage. Buckling of the steel shell near the bottom of the tank is referred to as elephant-foot buckling. An example of roof damage and elephant-foot buckling is photographed in Figure 2. This type of damage usually occurs in tanks with a low height to radius ratio. Many tanks experienced elephant-foot buckling in this earthquake, all of them were near full capacity. Extreme elephant-foot buckling had resulted in leakage and also complete collapse. Sudden loss of oil from a leak can produce suction that implodes the roof of a tank. The structural damage to fuel storage tanks following the Great Alaskan earthquake exposed vulnerabilities even when the tank shells were welded.

*Figure 2: Elephant Foot Buckling (left) and Roof Collapse (right) following 1964 Great Alaskan Earthquake (Hanson 1973)*

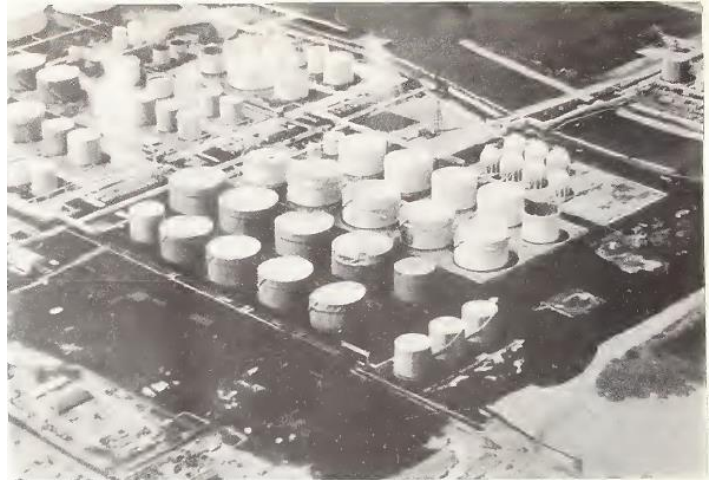
tanks were surrounded by a reinforced concrete dike, but the volume of spilled oil exceed the capacity of the dike and the oil escaped as shown by the dark areas in Figure 3. The top of the fixed roof tank buckled inward due to low pressure caused by rapid evacuation of the oil through the ruptured connection of the base and wall of the tank. While containment areas in the form of dikes or walls are common, the consequence of failure of fuel storage tanks can extend beyond these containment areas due to overtopping following multiple tank failures or due to potential earthquake damage to the walls themselves.

*Figure 3: Spilled Oil Past the Containment Dikes following 1978 Earthquake in Japan (NBS 1980)*

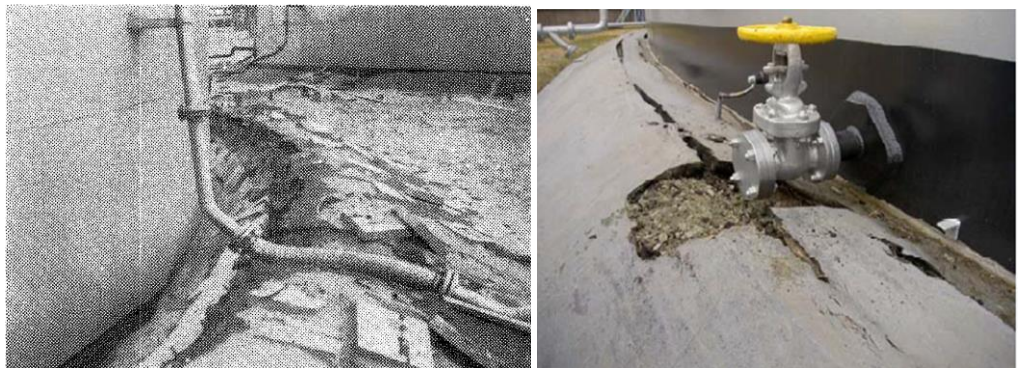
The Great Alaskan earthquake of 1964 resulted in numerous examples of damage caused by liquefaction. Another 1964 earthquake occurred in Japan and was a magnitude 7.6 near the city of Niigata. Two oil refineries were located near a river and had liquid fuel storage tanks built on loose sandy ground. Settlements due to liquefaction were observed to be 8 to 12 inches on compacted ground and up to 20 inches of unequal settlement in uncompacted sand. These resulted in many damaged tanks in both refineries. In contrast, newly built tanks constructed

on compacted soil at the refineries settled uniformly, and approximately 1 in. These tanks exhibited minimal to no damage and remained operational, while surrounding tanks were severely damaged from large ground settlement (Watanabe 1966).

Liquefaction induced lateral spreading can move entire tanks or cause relative ground deformations of the tank. During the 2011 Tohoku subduction zone earthquake, surrounding soil spread and caused uplift on the side of a tank of approximately 20 inches, resulting in the tank cracking and the contents leaking out (Zama et al 2012). An example of tank settlement and of lateral spreading induced uplift is photographed in Figure 4. In addition to damaging the tank itself, liquefaction can sever I/O connectivity. These examples underscore that minimizing the effects of liquefaction can minimize the risk of damage to liquid fuel storage facilities.

*Figure 4: Liquefaction Induced Settlement following 1964 Niigata and 2011 Tohoku Earthquakes in Japan (Watanabe 1966, Zama et al 2012)*

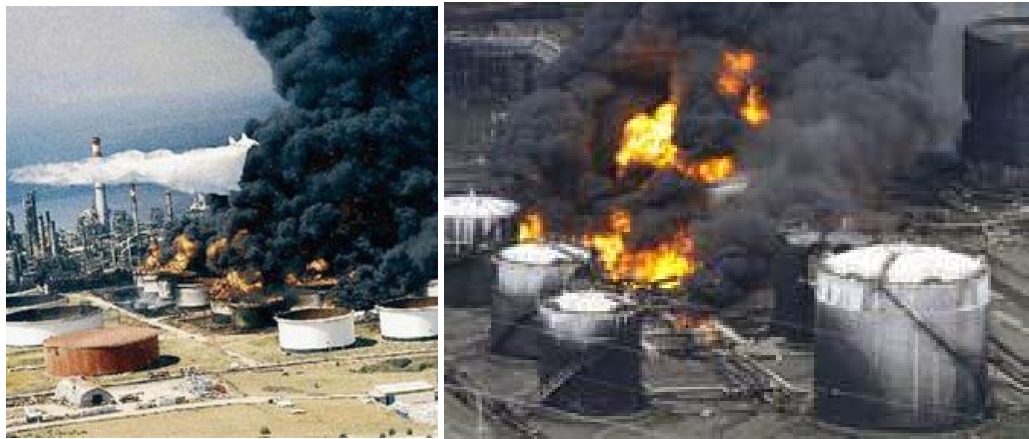
1983, the facility had a large tank farm with over 100 unanchored, aboveground liquid storage tanks. The tanks were designed by American contractors adhering to seismic design code of California in 1961 (Sezen & Whittaker 2004). The damage at the refinery is thought to have been largely overlooked due to the extensive damage in more populated areas. The majority of the damage was caused by a fire that was ignited by sparks created from the collision of a metallic floating roof seal against the tank wall. The tanks contained naphtha, a highly volatile and flammable petroleum product. A total of 6 tanks of diameter 33ft to 82 ft, completely burned down. The fire spread to other tanks and 30 of the 45 floating roof tanks were damaged (Yazici and Cili 2008). More recent examples of fire at fuel storage was also observed in 2011 Tohoku, Japan in different refineries built in 1963 and 1971. The fire was attributed in different instances to damage to the tanks themselves or to leaks in the surrounding pipes. In these examples, fire remains a threat to fuel storage facilities despite construction practices that had at least some awareness of the associated earthquake risk.

*Figure 5: Fire Caused by Tank Damage following 1999 Turkey (left) and 2011 Tohoku Earthquakes (right) (French Ministry of Ecology, Sustainable Development and Energy, 2013)*

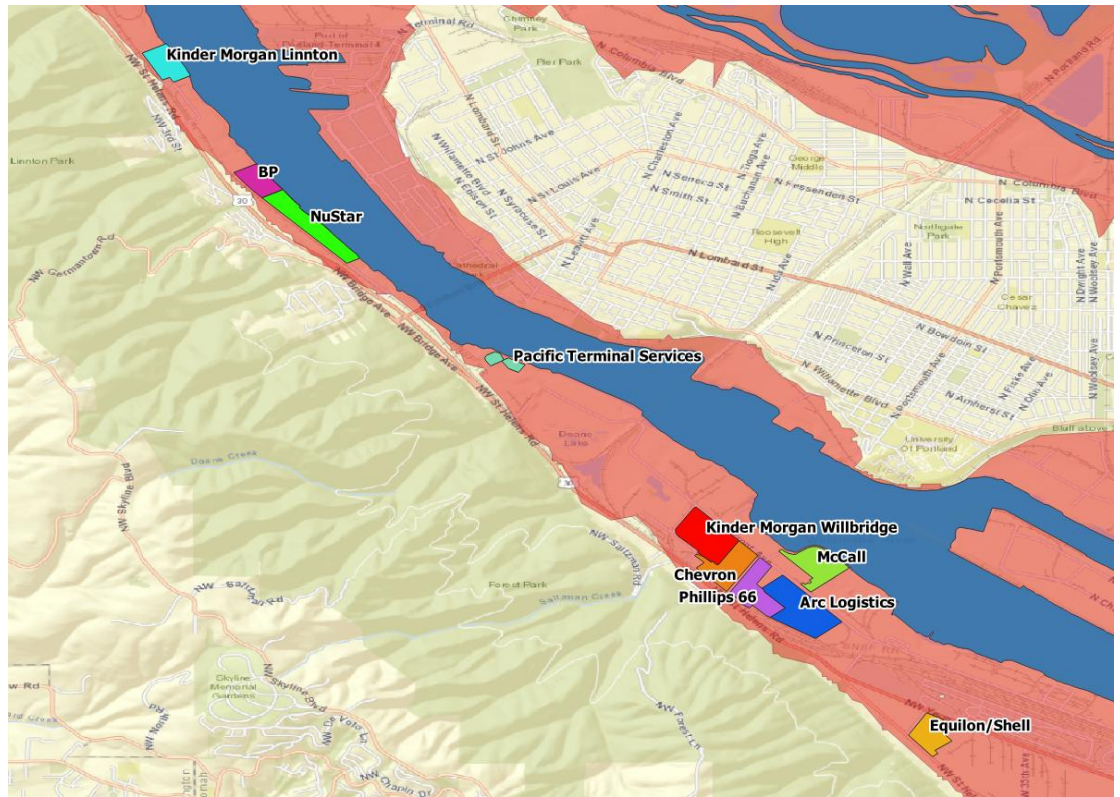
Detailed subsurface information at CEI hub in general is very limited. Based on the available information, loose to medium dense silty sand lie below the groundwater table and the soil is susceptible to liquefaction (Beatty et al 2014). There is also a possibility of landslides from the nearby slope entering the area. Raster data that included permanent ground deformations from liquefaction was made available by the Oregon Department of Geology and Mineral Industries (DOGAMI 2012) and was overlaid on the fuel storage facilities as shown in Figure 9. Because of the proximity to the river, the permanent ground deformations due to liquefaction and lateral spreading is expected to be very high at all fuel storage tank locations. The underlying raster data is a high level assessment and serves only as an indicator for liquefaction risk at any particular location within the hub. More detailed geotechnical assessment would be needed to quantify the severity, nonetheless, liquefaction clearly poses a significant risk for all of the liquid fuel tanks in the CEI Hub. If left unmitigated, the seismically induced damage observed in past earthquakes is likely to manifest.

Figure 9: Areas of High Permanent Ground Deformations (shaded red) following CSZ Earthquake (background Google Maps)

For storage tanks located further away from the edge of the river, lateral spreading may not necessarily be as great a concern. However, liquefaction settlement and bearing capacity failures could result in damage to the tanks. To mitigate liquefaction settlement, the ring foundations could be mitigated by installing sheet piles or compaction grout columns around the perimeter. Sheet piling consists of installing steel interlocking sheets around the perimeter. Compaction grouting displaces and densifies loose granular soils by staged injection of fluid grout. These sub surface columns would support the tank shell and potentially the I/O connections, but the centers of the tanks could still settle. Site specific studies would be necessary to assess the differential.

To mitigate lateral spreading in addition to settlement, jet grout columns could be installed under the tanks. Jet grouting is a hydrodynamic jet process that breaks up and loosens the ground, and mixes fluid grout with the soil. The jet grouting can be inserted at an angle, potentially reaching and mitigating soil under the tank as well as the perimeter. For large diameter tanks the jet grouting might require the tanks to be drained and cut open so that low-overhead equipment can work from within the tank.
