Stormwater Management Manual

Bureau of Environmental Services

Date: July 1, 2023

Drawdown Tests in Green Street Facilities with an Underdrain and a High-Fines Soil Blend

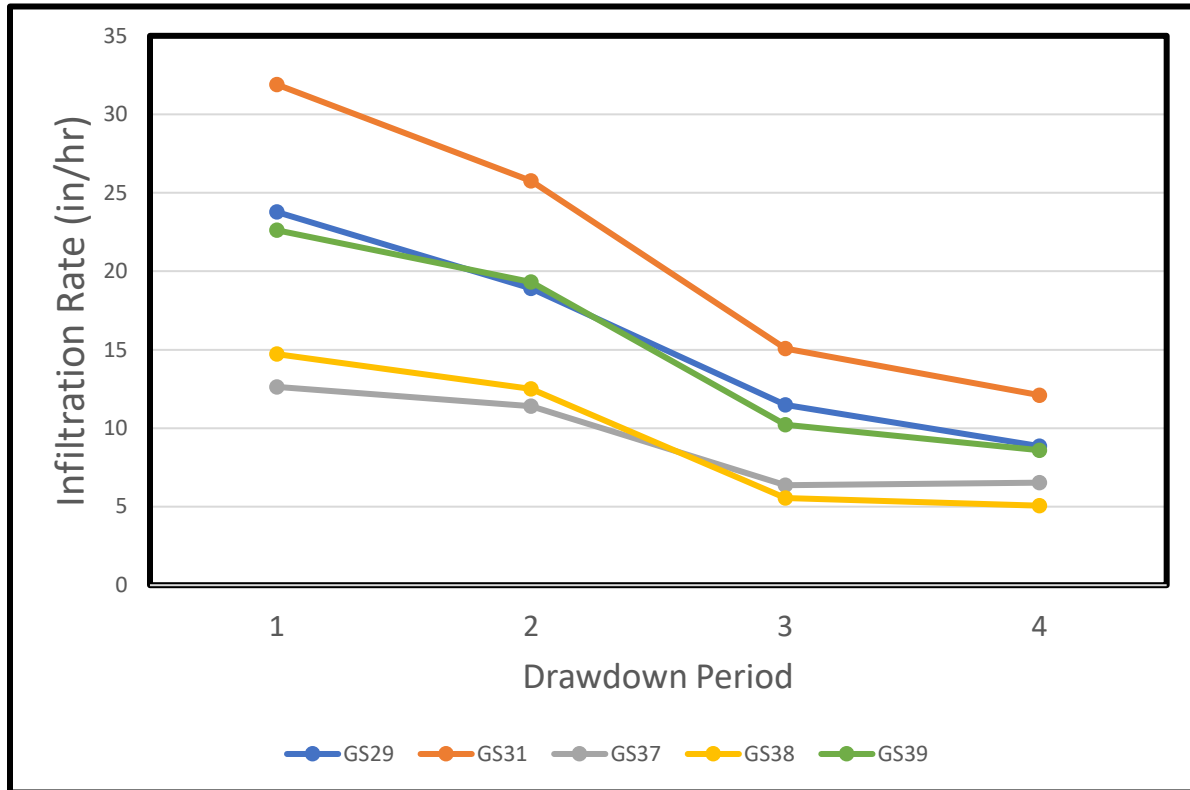
Figure 1. Plot displaying infiltration rate (in/hr) of facilities by drawdown period

Infiltration rates declined significantly during drawdown periods two and three, relative to the previous periods, with little or no change in rates during drawdown period four compared with the results for period three. These results suggest the systems may have been approaching steady-state conditions during which the imported soil blend was mostly saturated. (Figure 1). The rates ranged from 5.1-12.1 in/hr during the final drawdown period, with a much tighter grouping of results between the facilities during the final period compared with after the first filling.

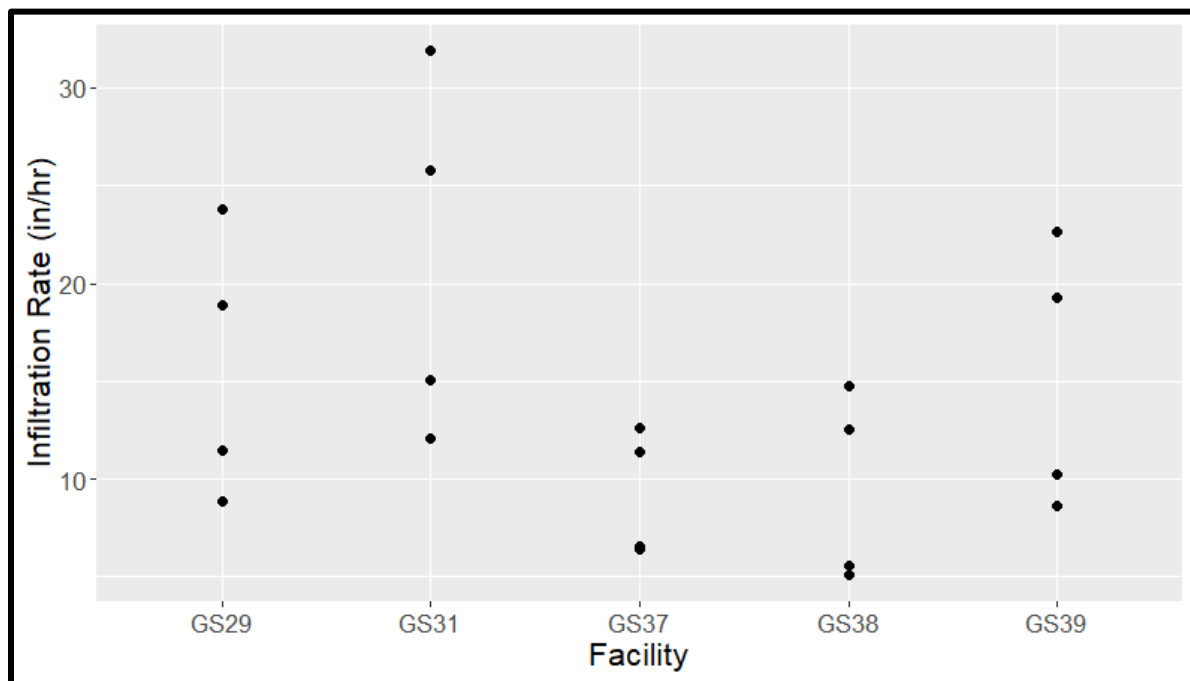
Figure 2. Plot displaying infiltration rate (in/hr) by facility

As expected, the final rates were substantially lower than the range of rates documented by BES in 2017 during similar trials for a group of older green streets containing BES’ standard soil blend. It’s interesting to note the range of infiltration rates after the first filling for the high-fines soil blend are similar to results for the final drawdown period in the 2017 tests (Table 3).

These results provide solid evidence the Slough 104B facilities containing the high-fines blend were draining within an acceptable range in their third winter of service, relative to BES’ design assumption of 6 in/hr for the blended soil. The data confirm the suitability of the high-fines blend in terms of its hydrologic performance in mature facilities and suggest facilities with the blend may provide substantially better flow-control performance than facilities containing BES’ standard blend for facilities.
