Stormwater Management Manual

Bureau of Environmental Services

Field Confirmation of Hydraulic Performance of Older Lined Green Street Facilities with the 2008 Stormwater Soil Blend

Infiltration Test Report May and June, 2017; January 2018

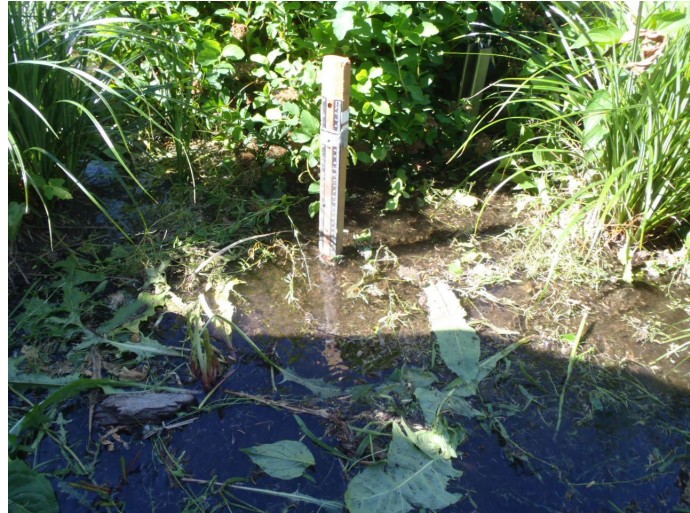
Figure 4 Depth gage in N Edison green street.

Depth gages, made of rulers taped to wooden stakes (Figure 4), were temporarily installed in each planter near the bypass drain if there was one, and at the far end of the facility from the inlet if there was not. Once overflow ceased, a stopwatch was started, and elapsed times were recorded at each inch reduction of ponded water.

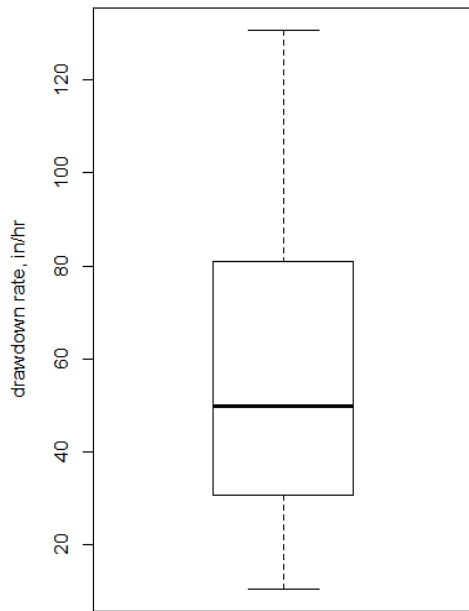
Figure 5 Boxplot of all trial mean drawdown rates. $n=46$.

Incremental drawdown rates spanned a large range (Table 3, Table 4). Averaged over each trial, no drawdown rate approached the SWMM's design rate of 2 in/hr. Mean drawdown rates were an order of magnitude larger than 2 in/hr for all tests, and several spring test mean rates were two orders of magnitude larger (Table 3, Table 4).

Trial mean drawdown rates ranged from a low of 10.64 in/hr to a high of 130.59 in/hr, with a median rate of 49.88 in/hr (Figure 5). The most extreme results were from the 8816 N Edison St facility. Water was pumped into the facility at a rate of approximately 400 gal/min. Given the facility's nominal catchment area of 3400 ft², the rainfall intensity required to produce a similar volumetric flow rate is 11.3 in/hr. For reference, the most rainfall ever recorded in one hour is 12 inches on June 22, 1947 in Holt, Missouri. Even with that high flow rate, very little water made it to the third bay of the facility. After 6 minutes, it was clear that there was not enough water in the flusher truck to overflow the facility through the third bay, and water drawdown was instead

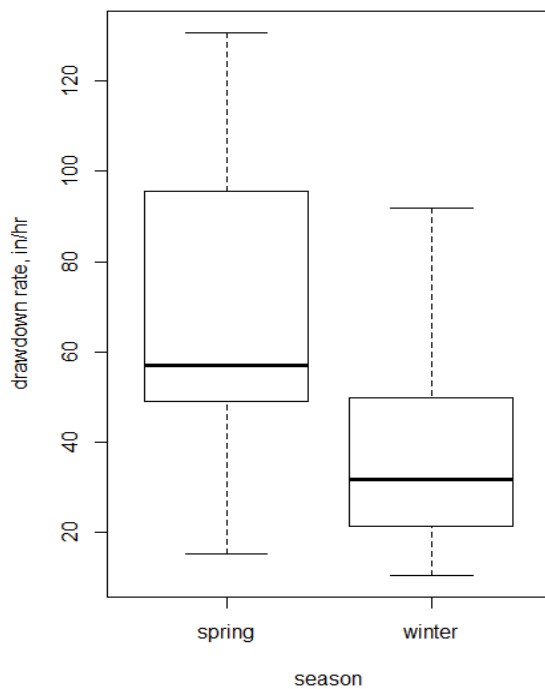
Figure 7 Boxplots of trial mean drawdown rates separated by season; spring(n=25) and winter (n=21).

Median rates were lower in winter than late spring (Figure 7). Performing a two-tailed t-test with season as the predictor gives a p-value of 6.122×10^{-4} , indicating that season had a statistically significant impact on drawdown rate.

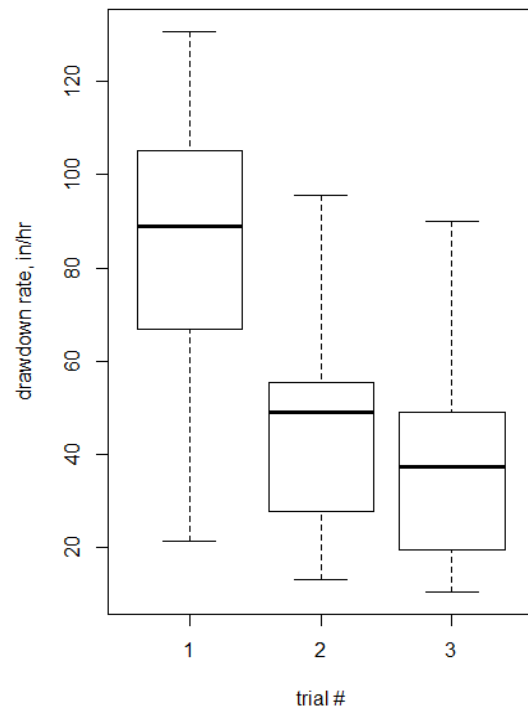
Figure 6 Boxplots of trial mean drawdown rates separated by trial; trial 1 (n=16), trial 2 (n=16), trial 3 (n=14).

Median drawdown rate decreased with each trial: rates were highest for the first trial of each facility and lowest for the last (Figure 7). This is consistent with increasing water content decreasing hydraulic conductivity, a well-documented phenomenon. Analysis of variance with trial number as the predictor gives a p-value of 1.97×10^{-5} , indicating that trial number had a significant impact on drawdown rate.

Figure 6 and Figure 8 show that rates for the first trial in each facility were larger than rates for the second and third trials.

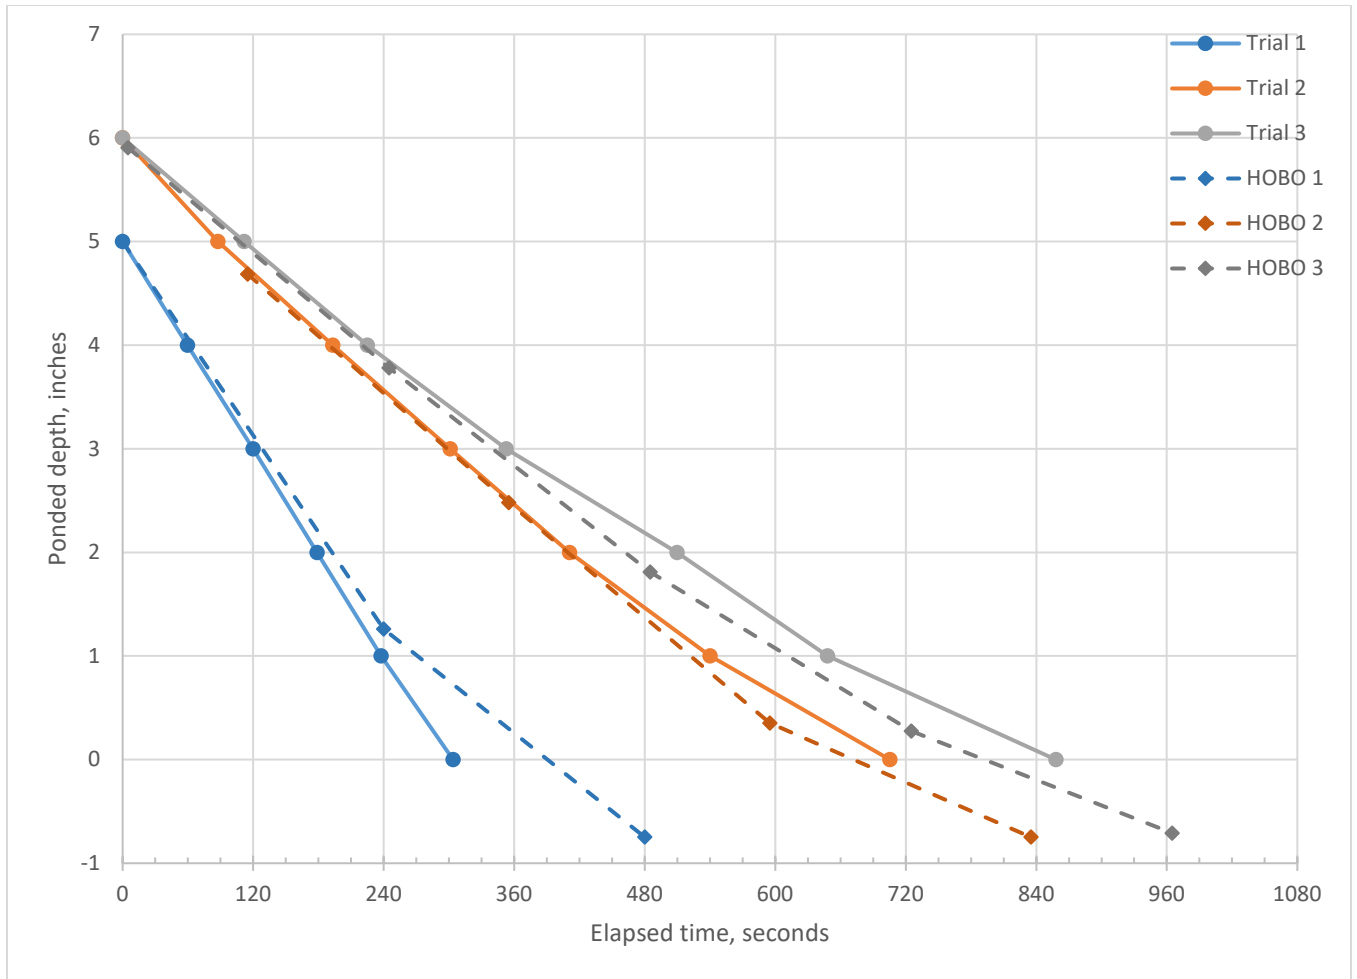
Figure 9. Results of simulated infiltration tests and HOBO data. 5403 NE 109th. 1-12-2018

HOBO and flood test data match well (Figure 9), providing evidence that HOBO data are reliable. Due to the infrequency of ponding in the monitored facilities, however, the HOBO record to date has added few meaningful measurements to the analysis. A forthcoming report will more thoroughly address the use of HOBO gages in monitoring of green stormwater infrastructure.
