WOODLAWN NEIGHBORHOOD DEVELOPMENT PROJECT

(PROGRAM A-5-1)

PARCEL NO. 6-13 ADDRESS 1115 N. E. Woodlawn Street

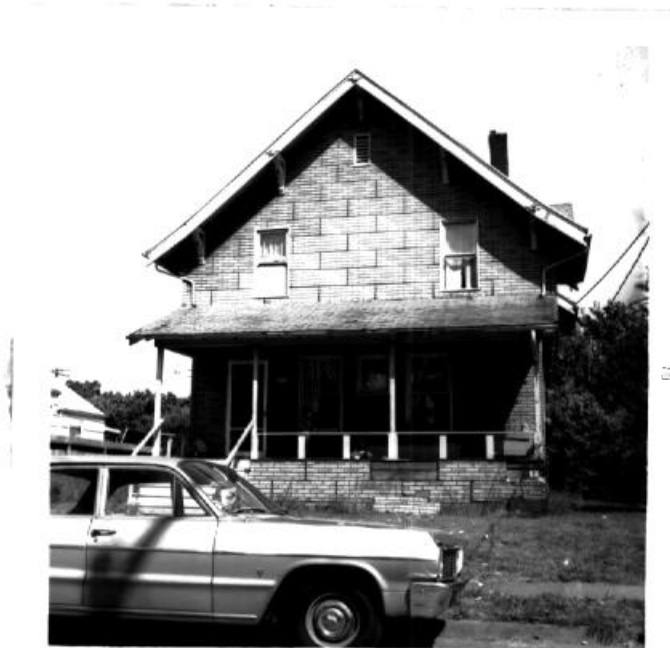
Subject is a 50'x100' lot, level 2' above the grade, improved with concrete paved streets, concrete sidewalks, concrete curbs, concrete walk, concrete driveway in very poor condition; lawn and some shrubs; very poor kept yard. All public utilities are connected.

Improvements include a 1½-story frame dwelling built during 1910 finished on the exterior with composition siding, much of which (especially on the front porch) is in very deteriorated condition. Eaves show need of scraping and painting; gutters and downspouts are in poor condition; roof appears to be in good condition although the chimney needs repointing and capping. Front porch steps appear to be in good condition as does the front porch floor. There are no accessways to show the condition of the footings on the porch area.
