## WOODLAWN NEIGHBORHOOD DEVELOPMENT PROJECT

## PROPERTY IDENTIFICATION

PARCEL NO. 12-1	ADDRESS 983 N. E. Dekum Ave	nue	
LEGAL DESCRIPTION_	Fraction of Block 12, WOODLAWN		
		LOT	
OWNER ASHLEY, Robe	william B. Forrest	_ AREA_	2,280 sq.ft.
PROPERTY DESCRIPTION

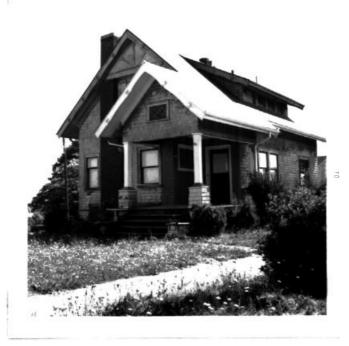
improvements include a  $1\frac{1}{2}$ -story frame dwelling built during 1910. It is finished on the exterior with cedar shingle siding. In places it is in very poor condition, some of it is in need of paint. There is a cedar shingle roof in good condition; galvanized iron gutters in some sections good and in other sections very poor and in need of replacement.

There is a wood front porch, wood steps in dilapidated condition; the flooring is alright. The steps to the rear porch are town away. There is a noticeable slant in the porch indicating a heavy settling. The south side of the roof has composition shingles in new condition.

There is a single car garage attached with a residential door access to it. The garage is finished with cedar shingle siding and a flat rolled composition roof. Some of the wood supporting the roof appears to be very rotted. The garage has little value because it is very narrow.

Both chimneys appear to need capping.
