WOODLAWN NEIGHBORHOOD DEVELOPMENT PROJECT

(PROGRAM A-5-1)

PROPERTY IDENTIFICATION

PARCEL NO. 13-2 & 3 ADDRESS 1024 N. E. Woodlawn Street

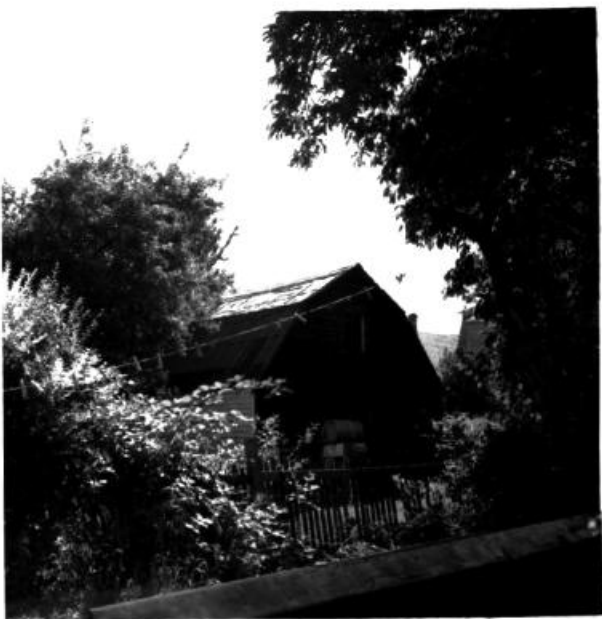
.3769

Improvements consist of a 1-story frame dwelling which was originally built in 1893 with cedar siding in fair condition; a composition roof in fair condition; gutters and downspouts in poor condition; front porch steps deteriorated; wood front porch.
