WOODLAWN NEIGHBORHOOD DEVELOPMENT PROJECT

(PROGRAM A-5-1)

PROPERTY IDENTIFICATION

PARCEL NO. 13-4 & 5 Lot 4: Vacant
ADDRESS 1044 N. E. Woodlawn Street

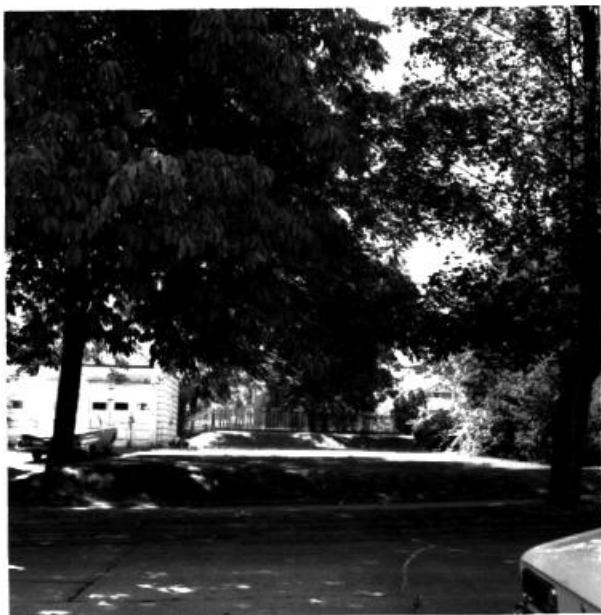
.3771

Subject is composed of two sites; each 50'x100' in size. Lot 4 is unimproved and is approximately 2' above the street grade. It has a wooden fence on the southerly side and the easterly side, shrubs and completely landscaped.

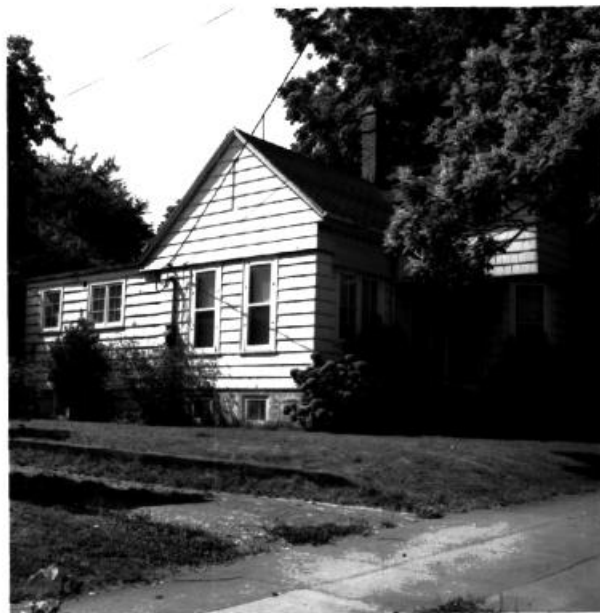
.3772

The site upon which the improvements are located has concrete driveway connecting the street to a 2-car garage. It has concrete paved street, concrete curbs, concrete sidewalk, concrete walks, concrete steps, lawn, shrubs, shade trees on the parking area and a shade tree on the side. It is a level lot which has fencing at the rear. There are three apple trees on both of the sites. All public utilities are connected to the site. There is approximately 80' of concrete retaining wall; a 1' - 2½' in height. There is no settling or any drainage problems.

There is a 1-story and a 1½-story frame building with cedar shingle siding, composition roof, galvanized iron gutters and downspouts; all storm windows on the exterior, concrete foundation, built in 1903 with approximately 882 sq.ft. on the main floor. It has a full basement. It has a colonial wood door, weatherstripped.
