WOODLAWN NEIGHBORHOOD DEVELOPMENT PROJECT

(PROGRAM A-5-1)

PROPERTY IDENTIFICATION

PARCEL NO. 13-7 ADDRESS 1064 N. E. Woodlawn Street

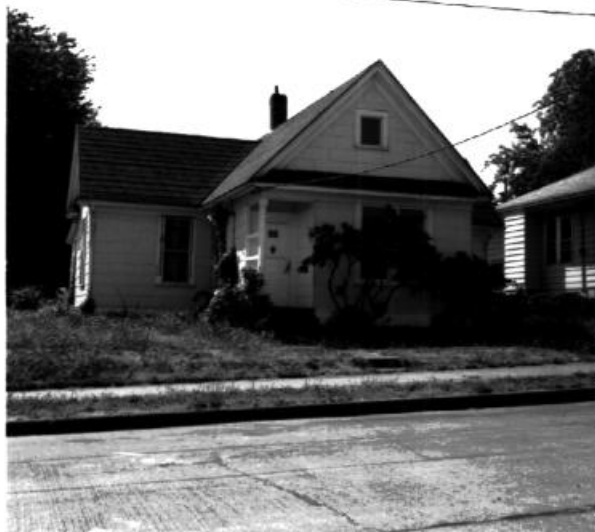
.3774

Improvements are a one-story frame bungalow, built during 1903 with approximately 892 sq.ft. on the main floor. It has asbestos shake siding, composition roof, galvanized iron gutters and downspouts in fair condition. Part of the property appears to be on concrete foundation and another section appears to be on wood. It has frame skirting covered with composition siding. There is a covered porch area.

The property shows some deterioration in the skirting area foundation walls. No evidence of ventilation or access to the crawl area. Access to the basement area is from the outside. It is not a full basement; it has concrete walls, concrete floors, approximately a 50% basement. There is an automatic electric hot water heater. The stairway to the basement shows settling and cracking. The property does not have a garage.
