WOODLAWN NEIGHBORHOOD DEVELOPMENT PROJECT

(PROGRAM A-5-1)

PROPERTY IDENTIFICATION

PARCEL NO. 13-11 ADDRESS 1053 N. E. Winona Street

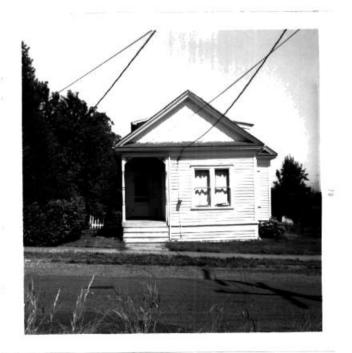
Improved with a 1-story and attic frame dwelling originally built in 1903. It has cedar siding in fair condition, composition roof in poor condition, gutters and downspouts in poor condition. It has a 75% basement with concrete floors and walls. There is some evidence of dry rot and considerable settling in the dwelling. There are concrete steps leading to a wood porch that is covered.
