WOODLAWN NEIGHBORHOOD DEVELOPMENT PROJECT

(PROGRAM A-5-1)

PROPERTY IDENTIFICATION

PARCEL NO. 13-12 ADDRESS 1043 N. E. Winona Street

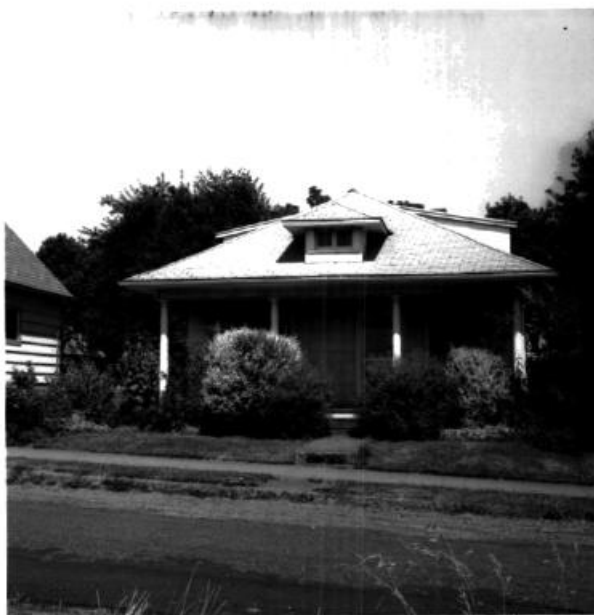
Improvements consist of a 1-story frame bungalow originally built during 1909. It has a full basement, asbestos shake siding, wood porch on a concrete foundation wall, composition roof in good condition, galvanized iron gutters and downspouts in good condition, plywood eaves show deterioration and are in need of paint, one section needs replacement.

There is a single car garage, 10'x16' in size, attached, with swinging doors, asbestos siding, flat composition roof. Subject has a storm door, good screened windows.
