WOODLAWN NEIGHBORHOOD DEVELOPMENT PROJECT

(PROGRAM A-5-1)

PROPERTY IDENTIFICATION

_		-	-		Street		
LEGAL DESCR	IPTION	Lot 14,	Block 13,	WOODL	AWA_	1			
OWNER CHA	NDLER, Harvey	y W. and	Rausalynd	J.			LOT AREA	5,000 s	sq.ft.

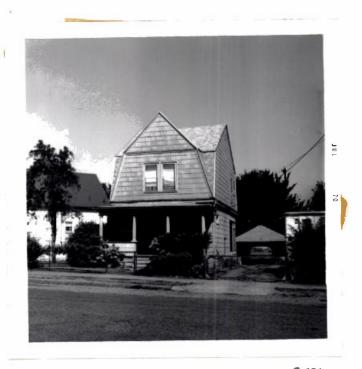
This is a 50'x100' lot which fronts on Winona Street. It has oiled gravel street, concrete curbs, concrete sidewalks, concrete walks to the dwelling, oiled gravel drive, fencing around the front, two sides which is wire plus steel posts. The yard is well maintained and has good lawn, good shrubbery, plantings, some shrubs and hedges in the rear yard.

Improved with a 2-story dwelling built during 1907 and has a 50% basement. The residence has modernized asbestos shake siding, composition roof, galvanized iron gutters and downspouts. There is a covered front porch area. The exterior is in excellent condition.
