WOODLAWN NEIGHBORHOOD DEVELOPMENT PROJECT

(PROGRAM A-5-1)

PROPERTY IDENTIFICATION

PARCEL	NO1	3-15	_ ADDR	ESS	10	11 N.	E.	Dekum	Street		
LEGAL	DESCRIPTI	ON	Lot 15,	Block	13,	WOOD	LAWN	ı			
0.0.50	VDANT 7	Eduaba	ν						LOT	6 207	54
OWNER_	KKANIZ,	Edythe	κ.						A REA	0,30/	sq.ft.

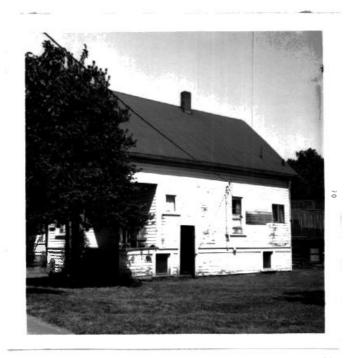
Subject is a 1½-story frame dwelling which appears to be single construction with cedar siding in need of paint, composition roof which appears in good condition, no gutters or downspouts. It is concrete foundation; some of the skirting near the porch area appears to be dry rotted. There is some evidence of dry rot in the south and west side of the foundation.
