## WOODLAWN NEIGHBORHOOD DEVELOPMENT PROJECT

(PROGRAM A-5-1)

## PROPERTY IDENTIFICATION

TAROLL IN	0. 14-4	ADDRESS	1136 N. E.	Wood lawn	Stree	t
LEGAL DES	SCRIPTION	Lot 4, Block 14	, WOODLAWN			
					LOT	
OWNER	LINCOLN LOAN	COMPANY			AREA_	5,000 sq.ft.

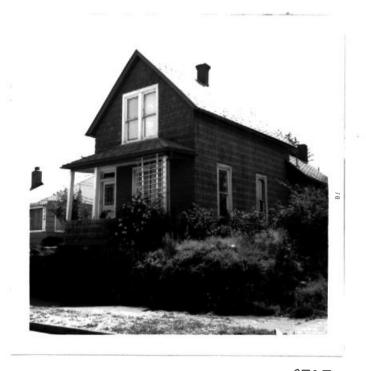
This is a 50'x100' lot about five feet above the street grade with concrete curbs, concrete sidewalks, concrete steps, concrete walks. The yard is in very poor condition. All public utilities are connected.

Subject is a  $1\frac{1}{2}$ -story frame dwelling built during 1892. It has approx. 672 sq. ft. of living area on the main floor plus the second floor. It is finished with cedar shake siding, composition roof in fair condition. The wood front porch shows extreme settlement and there is sindication of heavy dryrot and it lacks good foundation walls.

The property was vacant at the time of inspection.
