WOODLAWN NEIGHBORHOOD DEVELOPMENT PROJECT

(PROGRAM A-5-1)

PARCEL NO. 14-6 ADDRESS 1158 N. E. Woodlawn Street

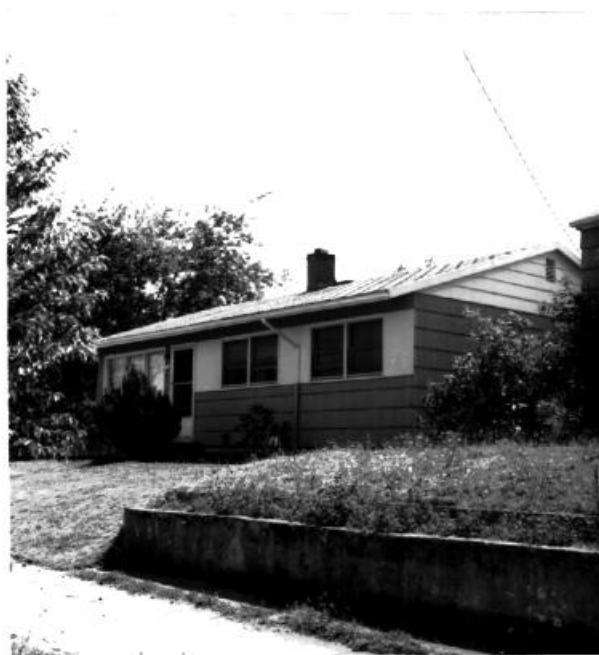
Improved with a 1-story, no basement, frame dwelling finished with cedar shake siding, comp. roof, good galv. iron gutters and downspouts. Entry to house has a good concrete stoop and a storm door and good mahogany door. Interior consists of entrance into living room with good sheetrock walls, guest closet, good oak floors; living room; dining room open to kitchen which has birch cabinets, new formica counter tops, ceiling fan, double sink with new plumbing fixtures; wired for range and refrigerator, good linoleum floors. Kitchen opens into a utility room on a concrete slab, wired for washer & dryer, has an automatic gas hot water heater. Also an additional storage shed attached.

The property is in good condition.
