LaVIELLE GEOTECHNICAL P.C.

October 19, 2000

RE: REVISED GEOTECHNICAL ENGINEERING INVESTIGATION  
3227 NW LURAY TERRACE  
PORTLAND, OREGON

RE: GEOTECHNICAL ENGINEERING INVESTIGATION  
3227 NW LURAY TERRACE  
PORTLAND, OREGON

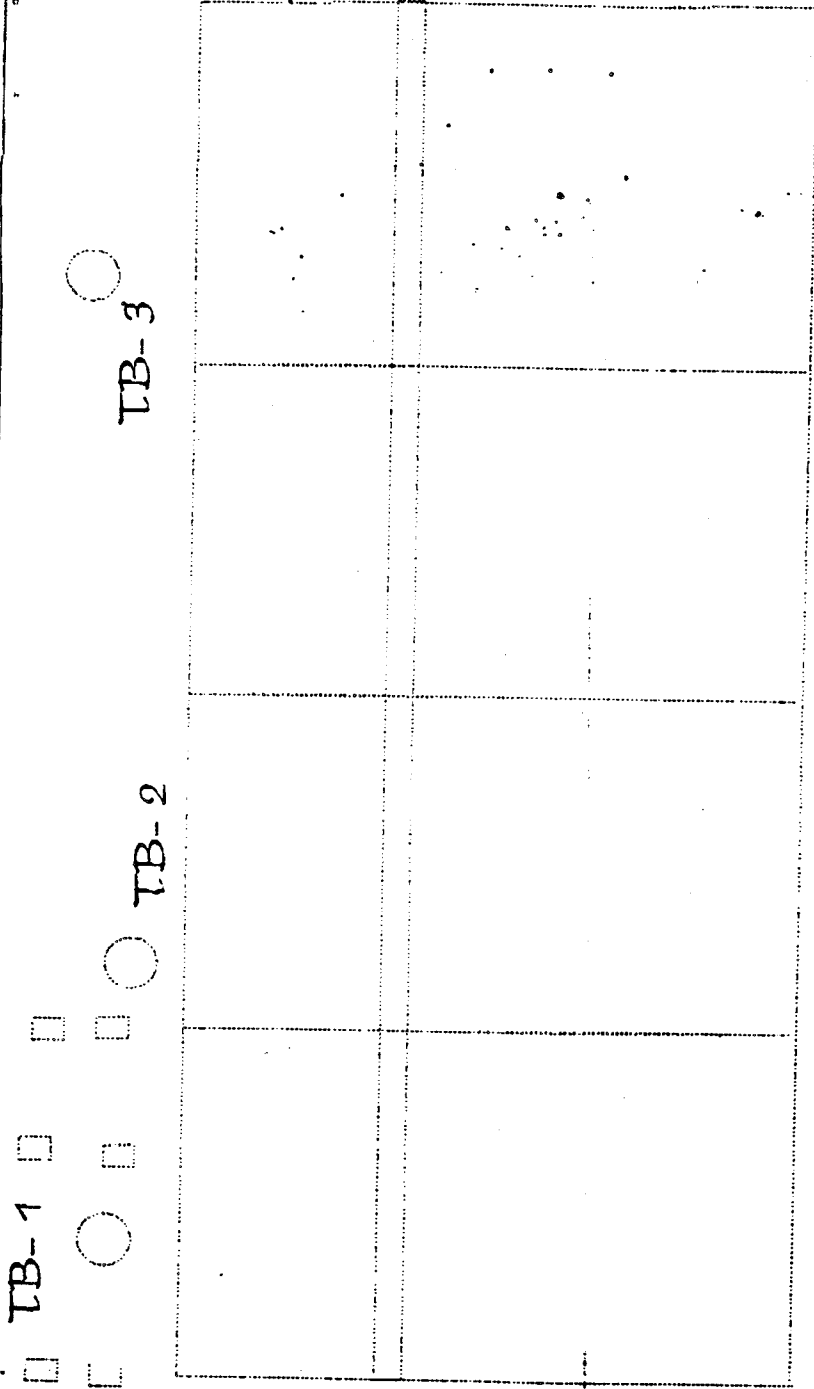
Site Plan, Figure 2  
3247 NW Luray Terrace  
Portland, Oregon

Indicates Approximate  
Location of Test Boring  
○ TB-3
