**MICHAEL E. ELIA, P.E.**

July 31, 2001

Re: Limited Geotechnical Study  
2133 N.W. 33<sup>rd</sup> Ave.  
Portland, OR 97210

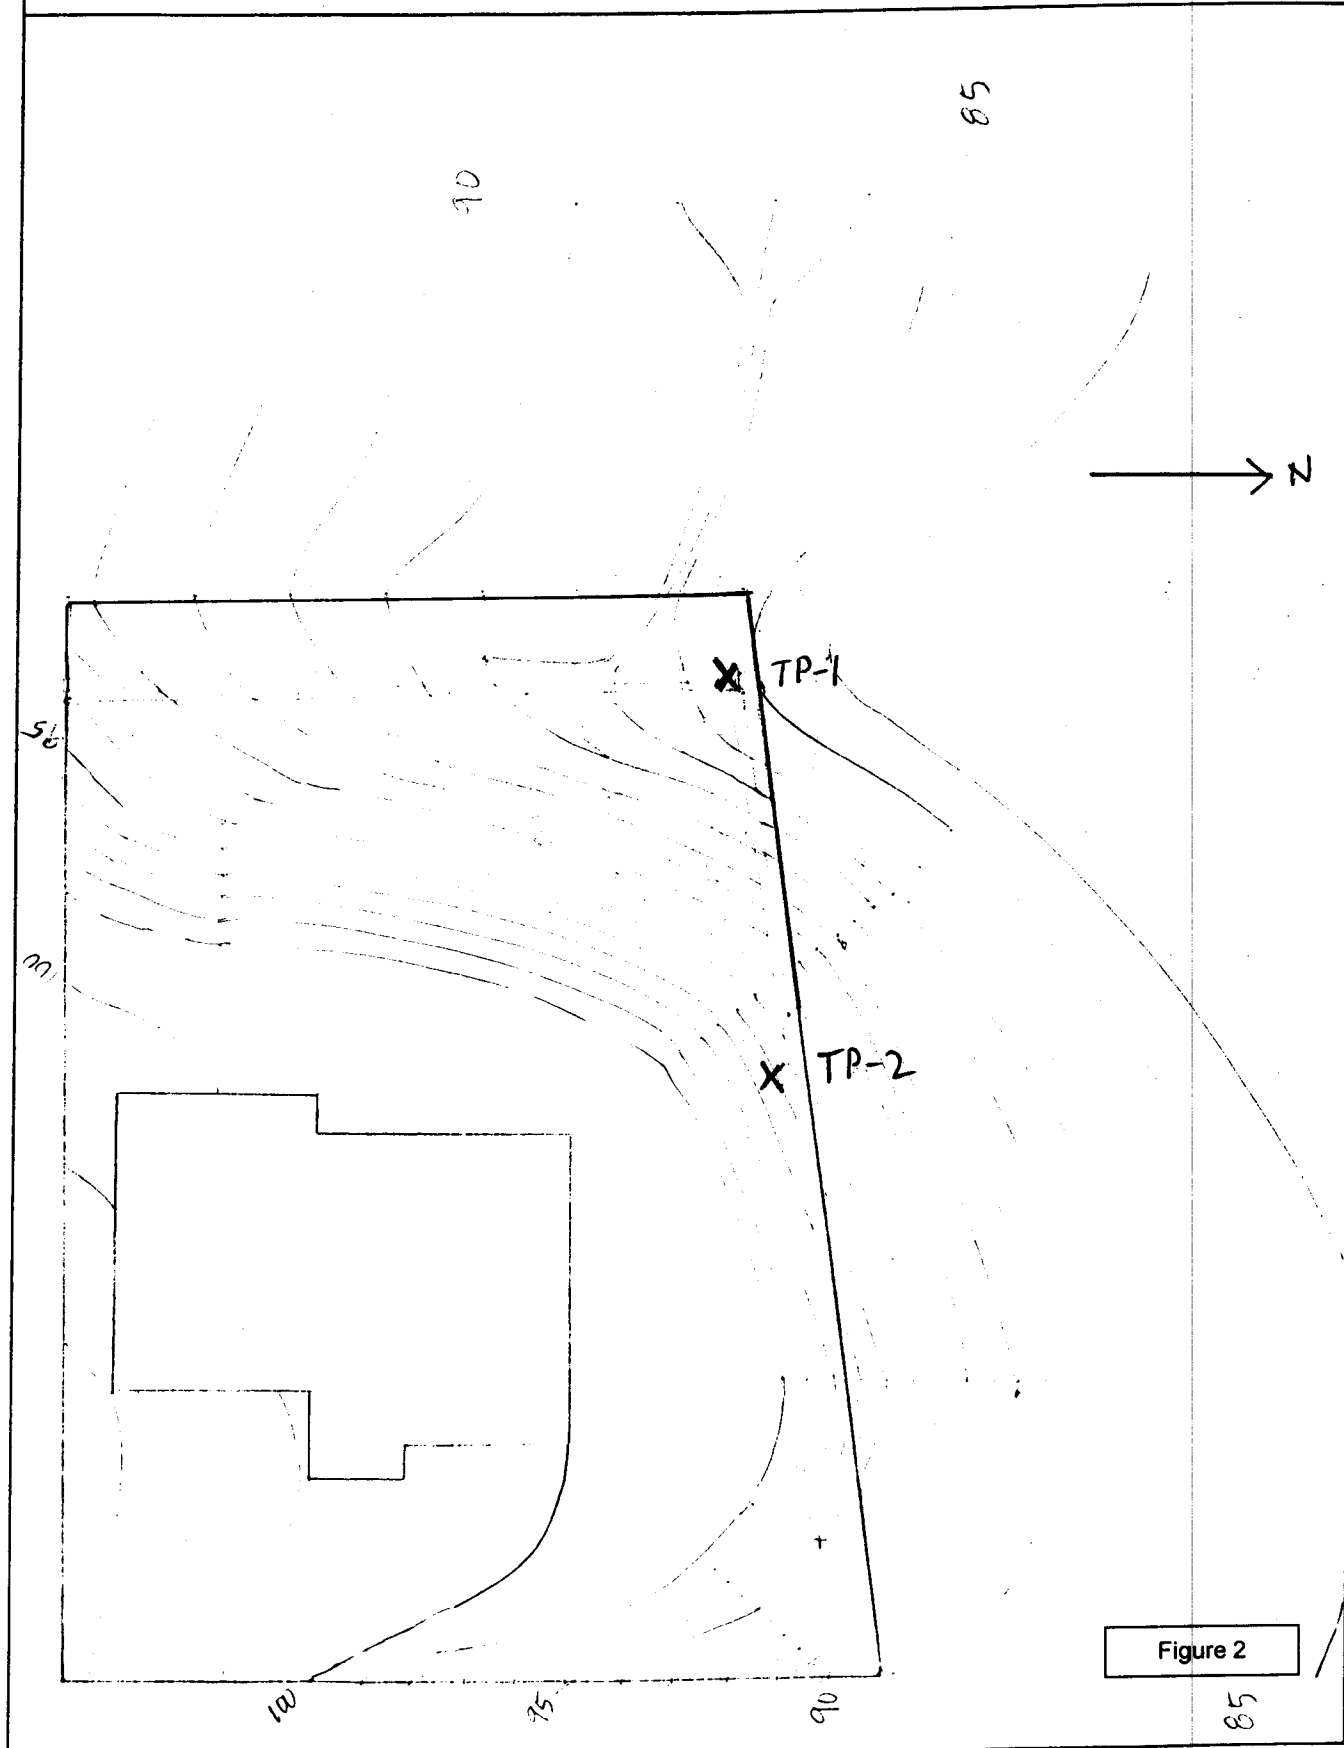
# TEST PIT LOCATIONS

**Subsurface Conditions.** Two test pits were excavated using a Takeuchi TB035 trackhoe and a 22-inch wide bucket. The locations of the test pits are shown on Figure 2

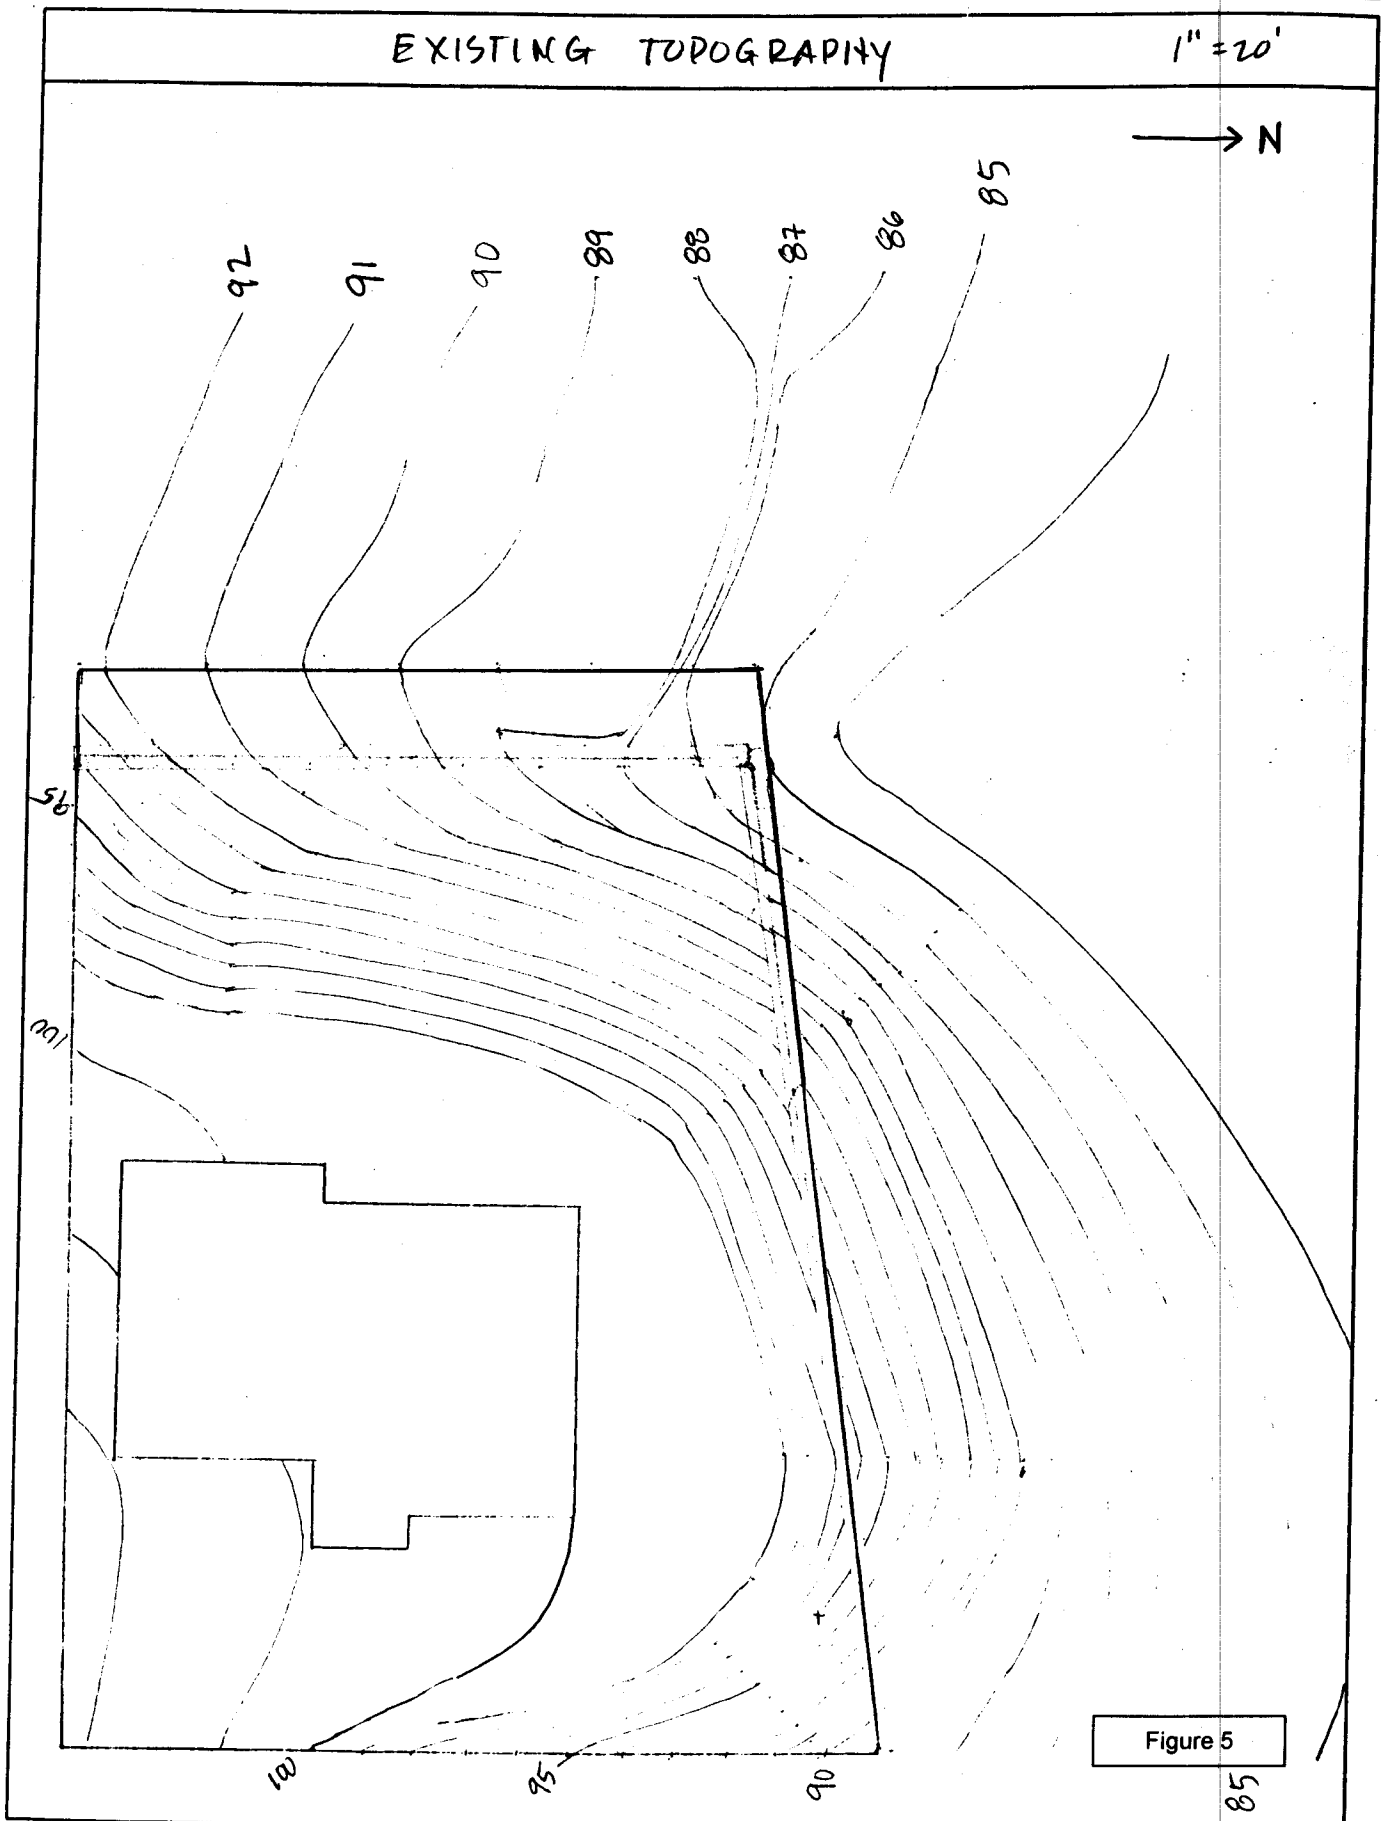
EXISTING TOPOGRAPHY

- The approximate existing slope topography is shown in Figure 5 in the Appendix. A proposed topography shown in Figure 6. The regrading of the existing slope to approximately conform to the proposed topography will likely not cause issues of slope instability. The slopes may be regraded as shown in Figure 6.

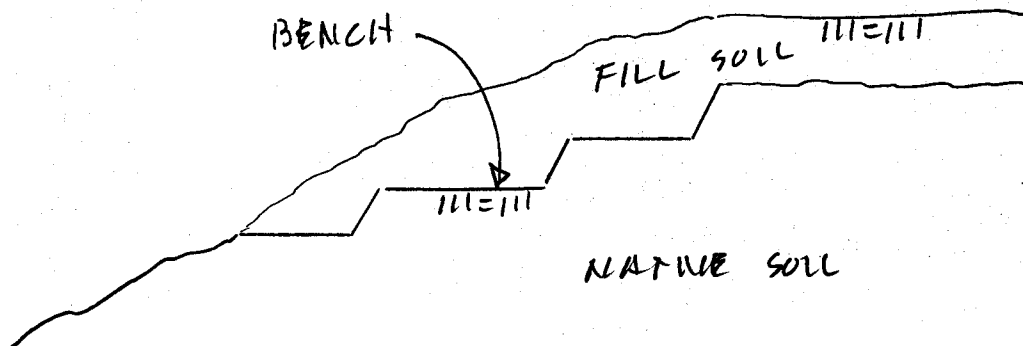
BENCHES CUT INTO NATIVE SOIL TO RECEIVE FILL.

- Recently placed fill free of organics should be excavated and stockpiled on site for later use.
- The exposed ground surface free of organics should be stepped to receive fill. Please see Figure 7 in the Appendix for a conceptual representation of a stepped slope prepared to receive fill.

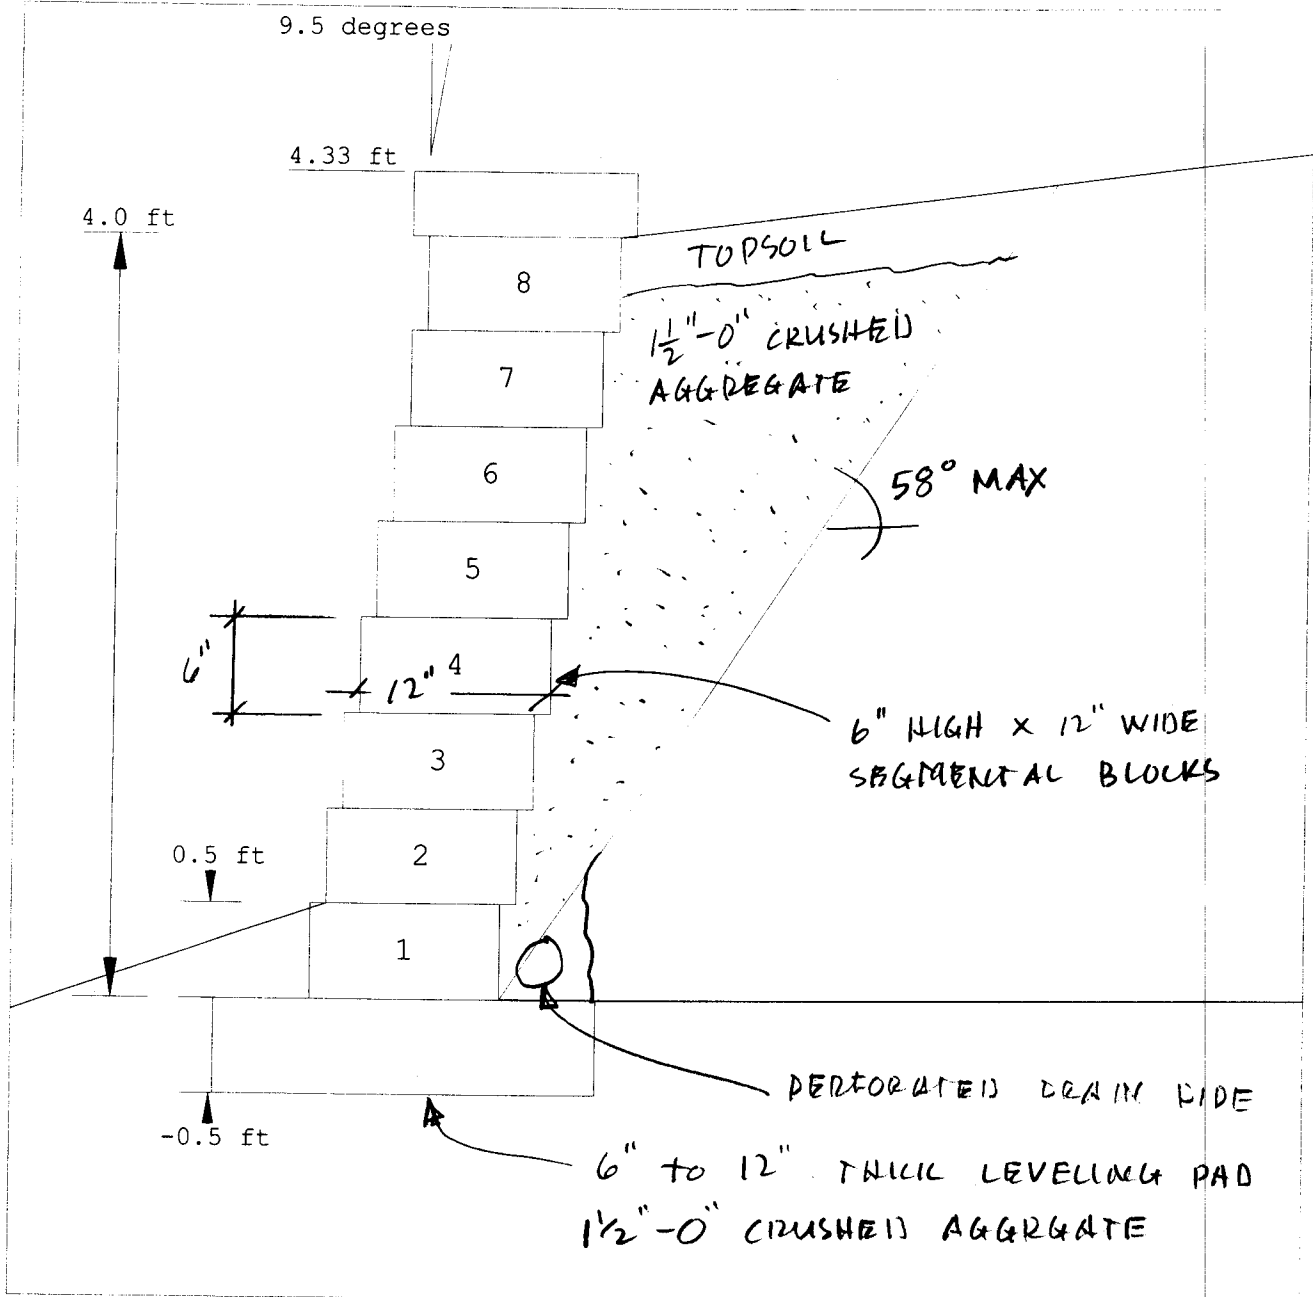
Calculated	Design Criteria
FOS Sliding	1.55	1.5 OK
FOS Overturning	1.57	1.5 OK
FOS Bearing Capacity	6.84	2.0 OK
Base Footing Width (Bf) (ft)	1.5	N/A
Base Eccentricity (e) (ft)	0.21	N/A
Base Eccentricity Ratio (e/Bf')	0.2	N/A

SRW Unit #	Heel Elev (ft)	Geosynthetic Type	FOS Over- turning > 1.5	FOS Shear (peak) > 1.5
8	3.5	none	63.27	>99
7	3.0	none	17.13	62.23
6	2.5	none	8.2	30.0
5	2.0	none	4.94	18.19
4	1.5	none	3.37	12.49
3	1.0	none	2.49	9.26
2	0.5	none	1.94	7.23
1	0.0	none	1.57	1.55

- Please see Figure 11 in the Appendix for a sketch of the proposed 4 feet high landscaping wall. The proposed wall is a segmental block wall. The leveling pad and backfill should be constructed with 1½"-0" crushed aggregate to the dimensions shown. The leveling pad should be constructed on firm, undisturbed native soil to a minimum thickness of six inches. If the native soil is soft or if the wall is constructed over old fill, the thickness of the leveling pad should be increased to 12 inches. The leveling pad should be placed and compacted in six-inch lifts. Compaction may be accomplished with repeated passes of a small walk-behind vibrating plate compactor.

- A perforated wall drain should be installed at the base of the wall in the backfill. The wall drain should transition to solid pipe as it departs from the wall. The pipe should daylight away from the wall and away from all new and old fill.
