## WASHINGTON PARK HISTORY AND SIGNIFICANCE

The work is divided into two phases: Phase A – Mount Tabor Park, and Phase B – Washington Park. This RHSR pertains only to Phase B– Washington Park Reservoirs Historic Structures, and analyzes the condition of historic features as identified in the Washington Park Reservoirs Historic District (January 15, 2004). Buildings, structures, and objects included in this analysis are:

CITY OF PORTLAND  
WATER BUREAU  
Washington Park

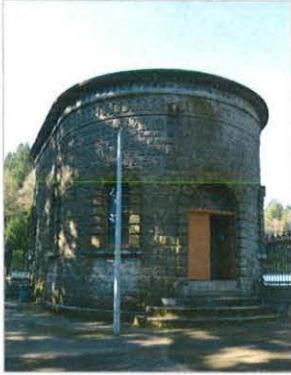
### Reservoir 3 - Gatehouse 3

**Condition/Observations:** The exterior wall is in fair to good condition. There are some new cracks and spalled areas, some where reinforcement is exposed. There are some horizontal hairline cracks at the concrete cold joints, although none run through the wall to the interior. There is some soiling and moss accumulation on the exterior water table projection, sills and other horizontal projections. The roof coating is over 20 years old and well worn. Moisture was noticed at the top of the interior wall on the southwest, south and east sides; this appears to be due to roof and rain drain leaks at these locations. There is also some leakage in the center of the roof. The interior is reported to typically have significant condensation. Below the deck level at the waterline the wall is eroded. The roof drain design is prone to clogging.

**Treatment Recommendations:** The patterned concrete above the waterline requires protection to minimize future deterioration. Damaged and spalled areas should be patched. The original concrete finish should be expected to be difficult to match.

**Option A.1: Preserve and Repair** – Gently clean the concrete exterior; test for water absorption, perform patch tests; install cementitious patching to rebuild severely deteriorated horizontal projections and apply a breathable sealer to the above waterline, articulated concrete finish; retain lower below waterline wall as is.

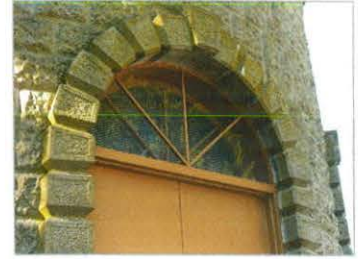
**Condition/Observations:** The non-original paired hollow metal entry doors and frame are in fair condition.

**Option A.1: Preserve and Repair** – Maintain the existing metal door assembly as is. Preserve the existing cast iron sill.

**Option A.2: Repair and Replace** – Replace the doors and frame with historically appropriate wood doors. Preserve the existing cast iron sill.

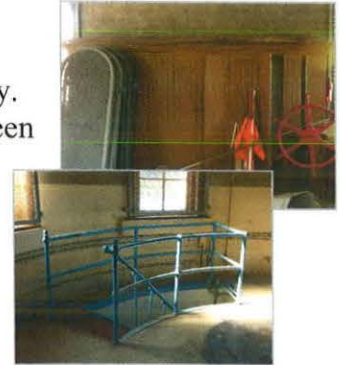
**Condition/Observations:** The metal stair has some surface rusting, but appears structurally well maintained.

**Option A.1: Preserve** – Maintain metal stairway and railing to the extent possible, wood cabinet, and existing historic mechanical equipment intact; New equipment modifications added as needed with minimal removal or replacement of historic materials.

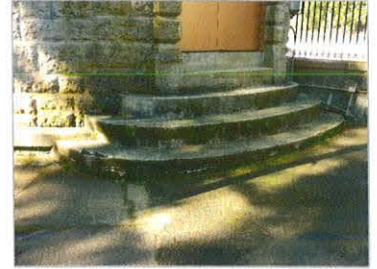
**Condition/Observations:** There is some spalling on the lower steps on the south end.

**Option A.1: Preserve and Repair** – Preserve, patch and repair the entry steps with matching material; Clean concrete surfaces, remove loose and deteriorated material; patch tests; patch spalled areas.

**Option A.2: Preserve and Repair** – Preserve the remains of the original plaza and sidewalk and restore missing portions or those overlaid with new construction. Coordinate work with adjacent site paving.

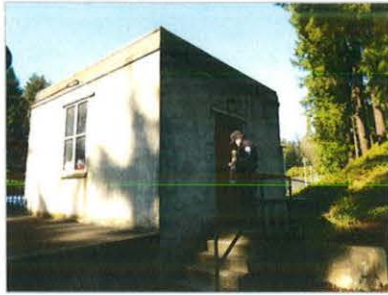
## Reservoir 3 – 36 Weir Building

**Condition/Observations:** The exterior walls are in good condition. The roofing appears to be in good condition. The small roof drain is prone to clogging.

**Option A.2: Preserve and Repair** – Consider a cementitious or concrete finish coating to allow a uniform and protective finish.

**Option A.3 Preserve and Repair** – Revise the existing roof drain; Provide a free standing roof drain connected to the existing pipe and an open overflow, or revise the drain to be an open scupper style.

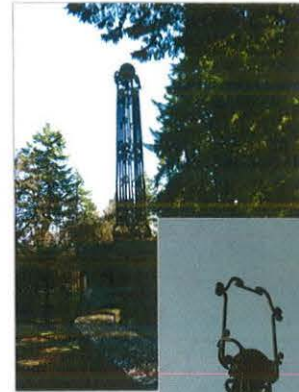
**Condition/Observations:** The low concrete wall has many areas that are deteriorated, including the cap, projecting diamond patterns, and joint edges. There have been some prior patching repairs, but many other defects now are evident. The iron fencing is in fair condition needing minor repairs and repainting. Security monitoring cables have recently been attached to the metal work. Lighting on the fencing was discontinued long ago and the actual fixtures are missing, however most of the posts are in place. Electrical conduit feeds for the current light poles are surface mounted on the walkway side of the low wall and junction down to the base of each metal lamp post (50-foot spacing). The installation nearly covers the wall making it difficult to perform repairs. Additional security measures include cameras are mounted on these and newer posts.

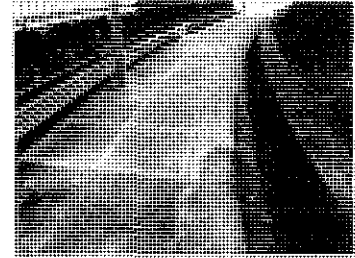
**Condition/Observations:** The walkway has some damaged areas, including broken slabs, corners, spalls, and roughened surfaces, but is generally in good condition. Portions of the paving have been replaced as part of electrical and security improvements. At the northwest side approximately 200 linear feet of walkway and accompanying gutter have been replaced [this coincides with the earth movement zone]. The pavement tooling pattern at this section does not match the original and the gutter has a "V" shaped profile instead of the broad "U" shape. The gutter is in worse condition than the walkway having many deteriorated sections. The outer retaining walls are heavily soiled and mossy, and there are some areas of surface damage to the original block pattern. The free standing urn at the southwest corner of the basin has developed a lean, and is slightly deteriorated and soiled.

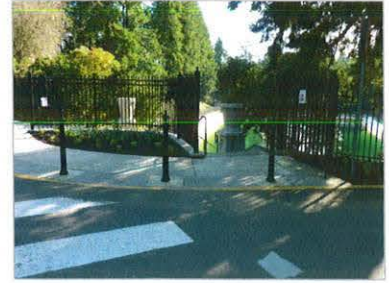
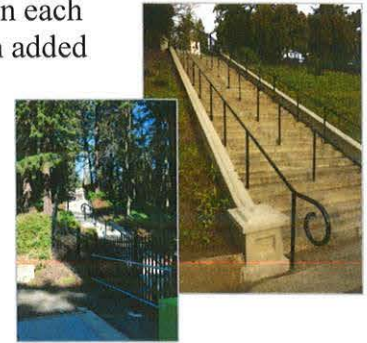
**Condition/Observations:** The main and secondary stairs are in good condition following the recent rehabilitation work. The patches on the main stairway are very noticeable due to their color difference. The urns and associated walls at the top entry of this stairway are in good condition.

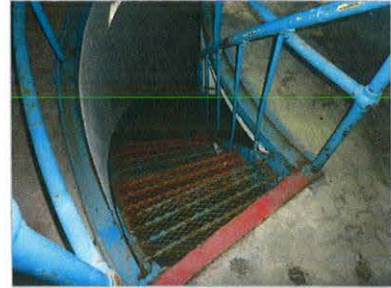
**Condition/Observations:** The metal stair has minor rusting, but appears to be structurally sound. Existing valve operators appear to be in good condition and are well-maintained.

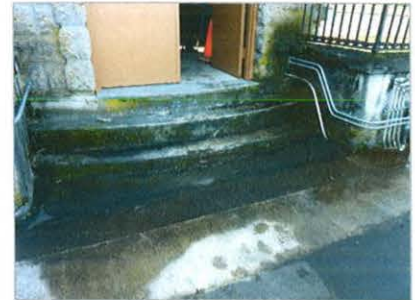
**Condition/Observations:** There is some staining and spalling at the steps. The entry receives moisture dripping off of the coping, and there is some ponding at the downspout terminus.

**Treatment Recommendations:** Repair of the steps should be coordinated with rain drain and adjacent sidewalk paving repairs.
