# **PUMP HOUSE 1**

## Reservoir 4 – Pump House 1

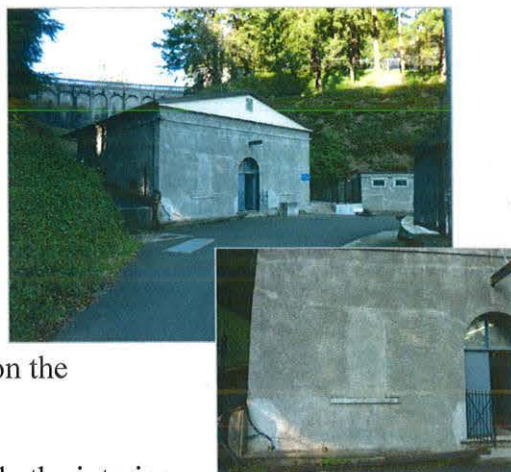
The exterior walls have been extensively repaired, most recently in 1988-89 under Water Bureau Project Number 3750, Washington Park Concrete Demolition and Restoration at the same time as work was performed on Gatehouse 3 and the rebuilding of 'Thumper'. Work included high flow crack injection [cementitious and epoxy], and patching. The walls remain in good condition, although since there was no exterior plastering, those repairs are visible. The damage was related to earth pressures against the partially underground building.

**Condition/Observations:** The scuppers are worn from use and weather exposure, but are no longer employed since the replacement roof has gutters and downspouts. The prior crack patching and window infills are visible. Door and window sills extend past the existing openings suggesting that former raised opening surrounds once existed.

**Option A.1: Preserve and Repair** – Maintain the walls in good structural condition. Clean and seal cornice band with breathable coating to reduce staining and deterioration.

**Option A.2: Preserve and Repair** – Preserve and rehabilitate original rain scuppers.

**Option A.4: Preserve and Repair** – Coat exterior with cementitious finish more consistent with original finish texture and concealing prior crack repairs; correct uneven window infill; restore door and window surrounds.

**Option A.5: Preserve**–. Remove gabled roof construction and install membrane roofing over original concrete deck; provide new skylights to overlay and protect existing leaking Ransome lights; provide revised rain drains to prevent damage from the historic scuppers.

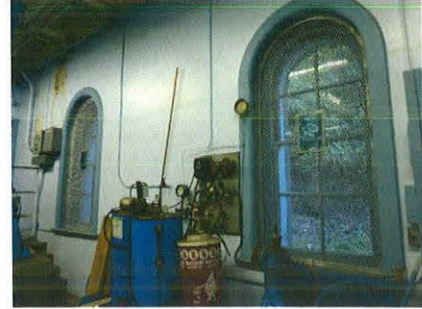
**Condition/Observations:** The remaining exterior windows are in good condition.

**Treatment Recommendations:** Restoration of removed window may not be feasible due to alterations in interior function and site limitations. Existing historic windows should be preserved.

**Option A.1: Preserve and Repair** – Preserve the wood windows. Provide needed minor repairs including caulking, patching and painting. Renew rope suspension on windows designated to be operable; Suspension improvements are not needed on inoperable units.

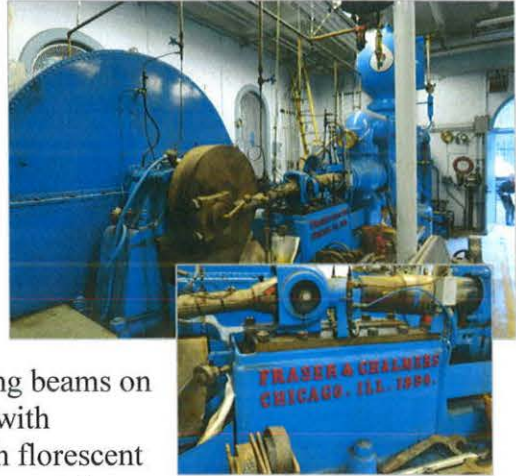
**Condition/Observations:** The equipment is all kept operational. Although "Thumper" is not used, it is operational. The Pump House retains more historic equipment than the other buildings in the district. That equipment operates in conjunction with new machinery.

**Option A.1: Preserve and Repair** – Preserve historic equipment; if no longer used, and space is required, develop alternatives for its preservation.

**Option A.2: Preserve and Repair** – Provide regular interior maintenance of interior finishes and equipment as necessary including floor painting.

**Option A.3: Preserve and Repair** – Develop historic interpretive materials describing the operation and design of the equipment and water system.

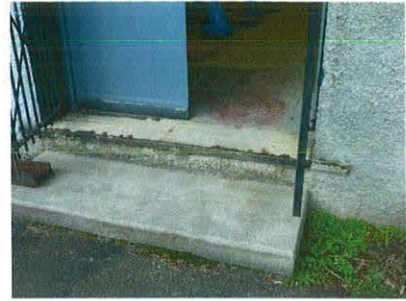
**Condition/Observations:** The entry is in good condition, although the step appears to have been narrowed. The perimeter walkways and platforms are in good condition. It was noted that the hillside to the west has displaced the short retaining wall and that geologic force is the likely cause for prior damage to the building structure.

**Option A.1: Repair and Replace** – Replace existing step when deteriorated, with one matching the original design; coordinate with installation of raised door opening surrounds. There is sufficient room to provide a level landing with the revision.

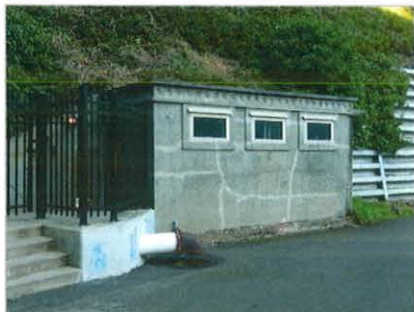
**Condition/Observations:** The building was rehabilitated in 1988 during Water Bureau Project Number 3750, Washington Park Concrete Demolition and Restoration, at the same time work at the Pump House was performed. Work included patching and crack filling. The walls are in good condition, although repairs are visible. There is staining below the scupper. The scupper was plugged and the roof was ponded to a depth of 6 inches at the time of inspection. Vegetation and soil from the hillside on the east has overgrown the roof.

**Option A.1: Preserve and Repair** – Remove vegetation and lower soil level at the hillside above the structure to at least 12” below its roof line. Maintain roof drainage operational; install overflow drain.

**Option A.2: Preserve and Repair** – Periodically clean and maintain the walls in good structural condition. Seal the cornice band with breathable coating to reduce staining and deterioration.

**Option A.3: Preserve and Repair** – Preserve and rehabilitate original rain scupper.

**Option A.4: Preserve and Repair** – Coat exterior with cementitious finish to conceal prior crack repairs.

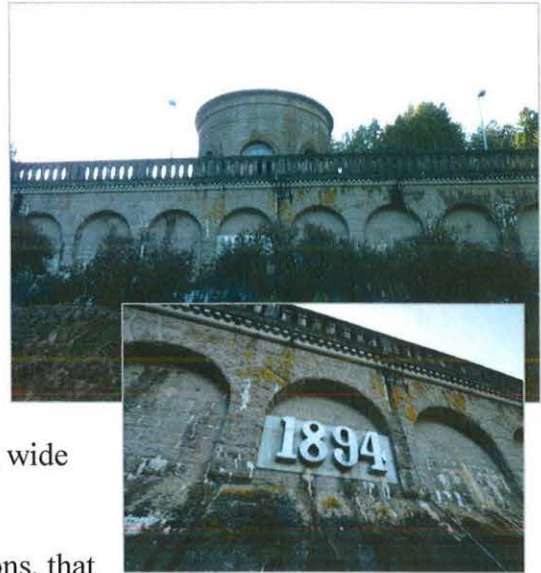
**Condition/Observations:** The basin lining has numerous patches that give it a spider web appearance. The dam has heavy staining and biological growth on its lower sloped walls and below top drainage outlets. Water leakage appears to have been an ongoing issue, as evidenced by the extent of efflorescence and calcium/lime buildup at numerous locations on the lower portions of the downstream dam face. Some areas were wet during the site observations, indicating leakage is continuing.

The wall of the dam is heavily stained from the long term effects of moisture and biological matter. The lower section with block pattern design is nearly black, as is the exterior side of the guard rail. PVC pipe drains have been installed along the roadway on the open side.

**Option A.1: Preserve and Repair** – Gently clean the concrete dam face, walls and urns; test for water absorption, perform patch tests; install cementitious patching to rebuild severely deteriorated areas; apply a breathable sealer to the wall caps and urns.

**Option A.2: Preserve**– Provide regularly scheduled cleaning of the dam face to reduce biological and environmental damage and the subsequent need for stronger cleaners; consider application of a breathable sealer to deter soil build up for this very prominently visible structure.

**Option A.3: Preserve and Repair** – Maintain the reservoir basin structure, and monitor leaking. Provide waterproofing or basin liner as necessary similar to the other basins to preserve structural integrity.

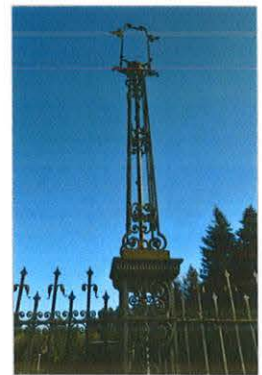
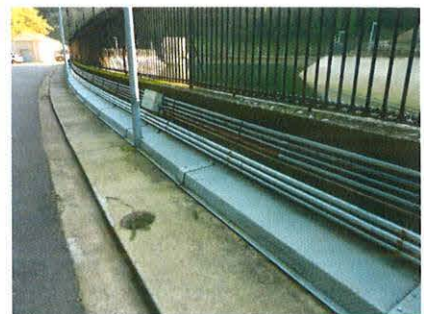
**Condition/Observations:** The low wall has normal wear and tear associated with its age. There have been some prior patching repairs (most with noticeable color difference), but many defects remain, including some exposed reinforcement. Walls are heavily soiled and stained. Lighting on the fence was discontinued long ago, and none of the actual fixtures are in place, although the framework is still extant. Multiple electrical conduit feeds for the newer separate pole lighting and security measures are surface mounted to the walkway side of the low wall and provide a junction point to feed each of the new metal lamp posts. The installation nearly covers the wall making it difficult to perform repairs. Additional security measures include cameras mounted on these and newer posts. The wrought iron fence is intact, but rusted. It needs repairs and needs to be repainted.

**Option A.1: Preserve and Repair** – Gently clean the concrete basin walls; test for water absorption, install patch tests to develop best match; install cementitious patching to rebuild severely deteriorated areas; apply a breathable sealer to the wall caps.

**Option A.2: Preserve and Repair** – Preserve metal fencing and light fixture posts; make repairs and repaint.

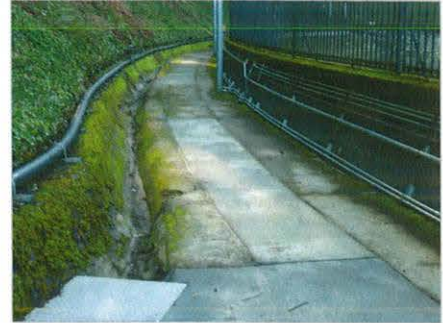
**Condition/Observations:** The walkway has some damaged areas, including broken slabs, corners, spalls, and roughened surfaces, but is generally in good condition. Portions of the paving have been replaced as part of electrical and security improvements. On the west side, some walkway and accompanying gutter have been replaced (earth movement zone). The pavement tooling pattern at this section does not match the original and the gutter has a "V" shaped profile instead of the broad "U" shape. The gutter is in worse condition than the walkway having many deteriorated sections and largely soiled. The outer retaining walls are heavily soiled and mossy, there are some areas of surface damage to the original block pattern.

**Option A.3: Repair - Replace** – Replace, patch damaged walkway slab; match original paving pattern and texture.

**Option A.4: Repair - Replace**— Replace, patch damaged gutter sections with new to match original pattern.

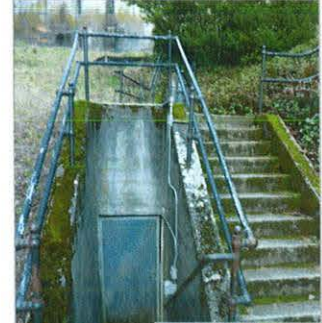
**Condition/Observations:** The exposed portions of the gate tunnel accesses are in fair condition; the concrete is covered with moss, and railings are in need of painting.

**Option A.1: Preserve - Repair**– Maintain gate tunnels and access stairs and railings; if required to alter, provide documentation.

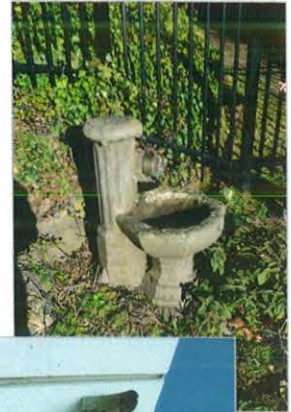
**Condition/Observations:** The public fountain, located just outside of the security fencing, is largely intact. The outside of the receiving bowl has spalled-broken corners. There is also some minor wear and surface damage on the bowl and pedestal. The interior of the basin and splash area is heavily stained. Plumbing fittings are missing and the site is overgrown. The fountain probably operated continuously.

**Option A.1: Preserve– Repair - Public Fountain:** Patch and repair concrete; clean concrete. Clean up adjacent landscaping.

**Option A.2: Preserve– Repair - Public Fountain:** Restore for operation: refit plumbing, fit with bubbler and operator for on demand use.
