National Register Reclassification Request Form

2107 NE 14th Ave | Portland, OR 97212

**JOHN C. KENNEDY HOUSE
EXISTING PHOTOS**

**2107 NE 14TH AVE
RECLASSIFICATION
TO CONTRIBUTING**

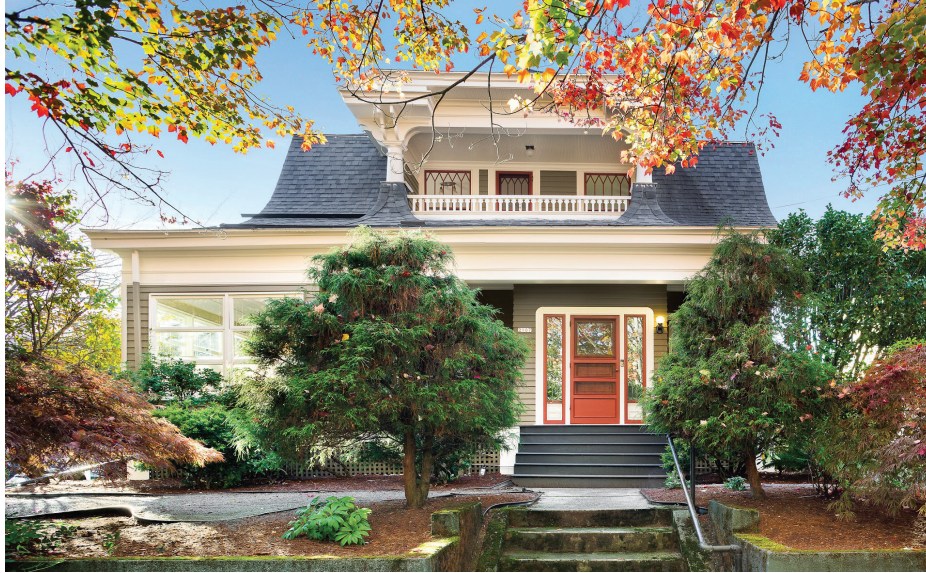
**FRONT (WEST)
FACADE**

We purchased the house in November 1997. The house had vinyl siding which we estimate was only few years old. The house was in very poor condition from years of neglect and barely livable.

We removed the vinyl siding in 1999, exposing the original fir (old growth) siding. Except for some repair work (detailed) below, it was in relatively good condition; except for years and year of paint that we had removed down to the bare wood. This includes all the trim and porch floor. The paint colors selected reflect the period of the house, circa 1900.

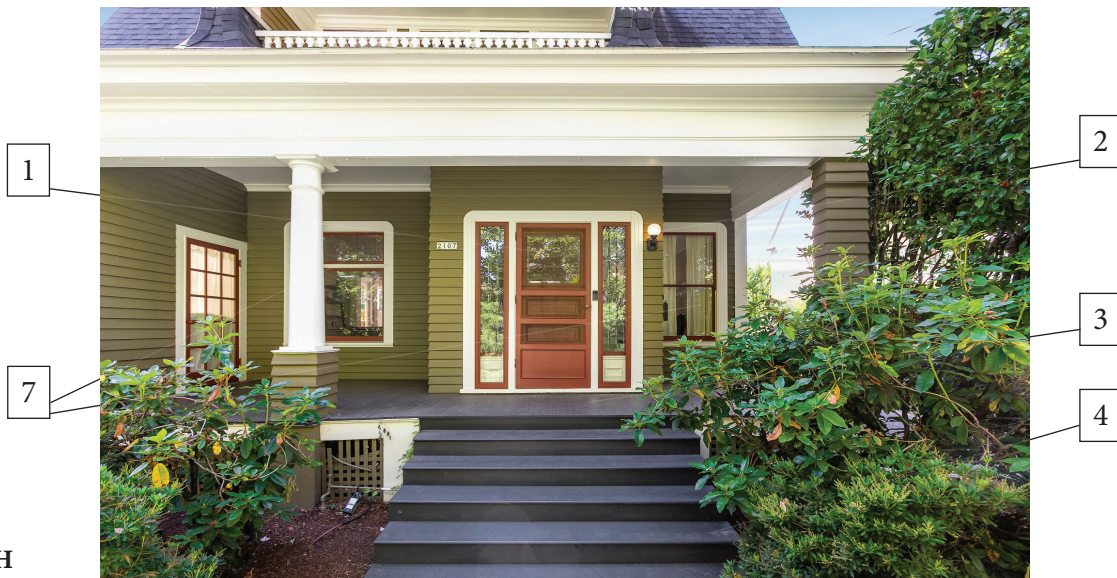
FRONT PORCH

I used custom
INDOW storm
windows which
were inserted
from the inside
so as not to
distract from
the street.

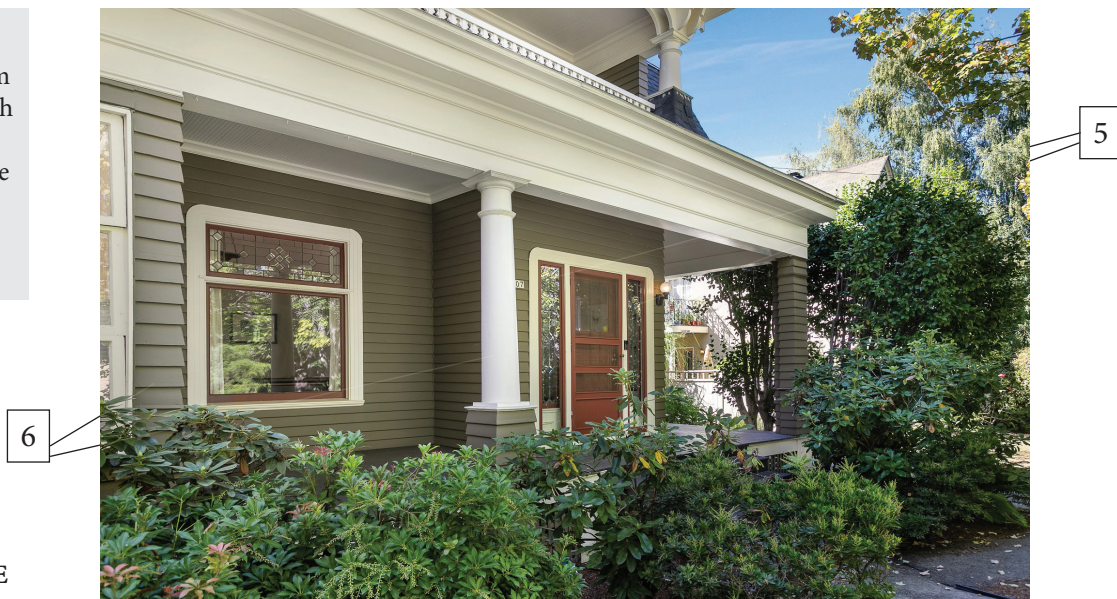
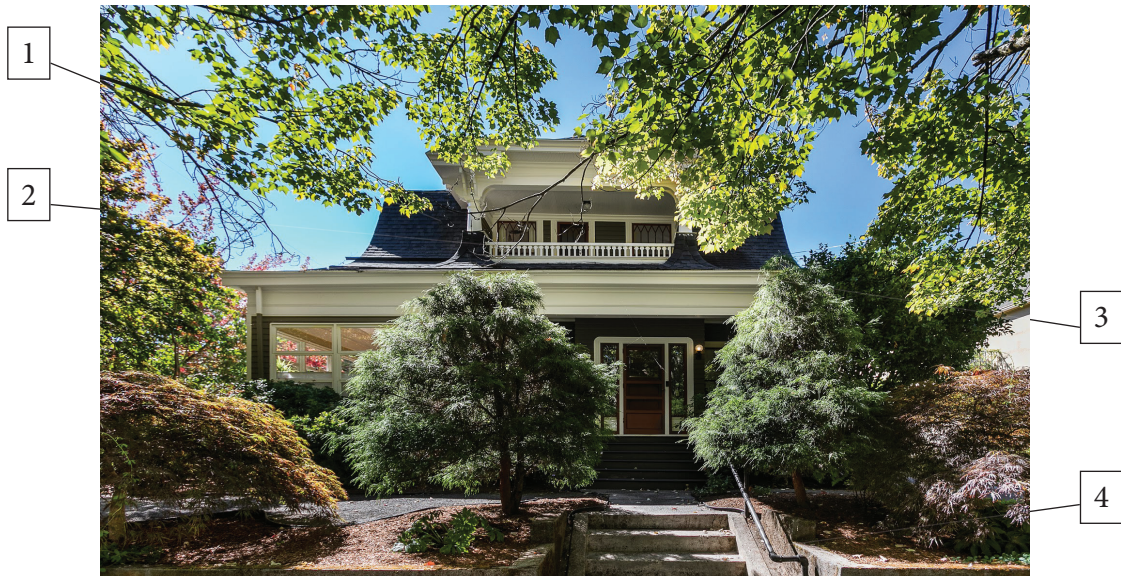
WEST FACADE

- 1 The front and screen door are original. There was a large amount of restoration associated with both these doors.
- 2 The porch light was sourced at Rejuvenation Hardware and is period appropriate.
- 3 The porch floor, tongue-and-groove fir, is all original except for a couple of boards. These were sourced in Seattle and replaced. All the paint was removed from the porch boards before they were repaired and repainted.
- 4 The front porch stairs were unsafe and had to be replaced. They were rebuilt with no change in design.
- 5 The leaded glass side windows are original and very delicate. I installed side window covers to protect the leaded glass.
- 6 The siding and pillars are all original. All the paint was removed from the boards before they were repaired (surprisingly in good condition) and repainted.
- 7 The leaded windows on left and right are original wavy glass.

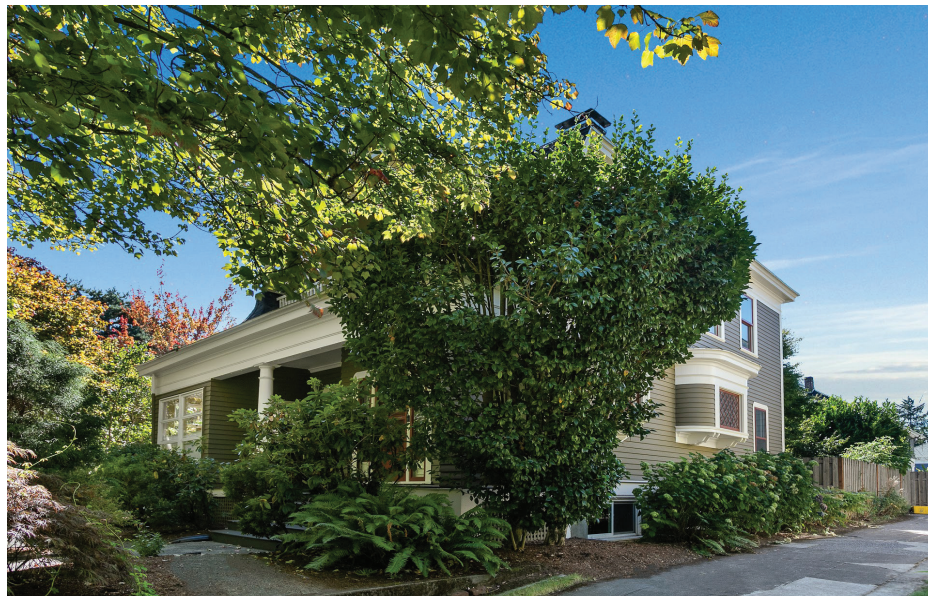
NORTHWEST
CORNER

- 1 Roof was a tear off in 2009; it had six layers of shingles, including the original roof shingles!
- 2 The upper porch is all original. The porch railing was in very poor condition and required extensive repair. The upper porch light is period appropriate, purchased at Rejuvenation Hardware.
- 3 The built-in gutters in the front and south side of the house were restored; again this was extensive restoration.
- 4 Concrete stairs are original. There was a stamp 'Kennedy' (original owner) in the concrete in the base stair footing. This was unfortunately destroyed when the street sidewalks were replaced approximately 10 years ago. However, this allowed me to date the staircase to 1901.

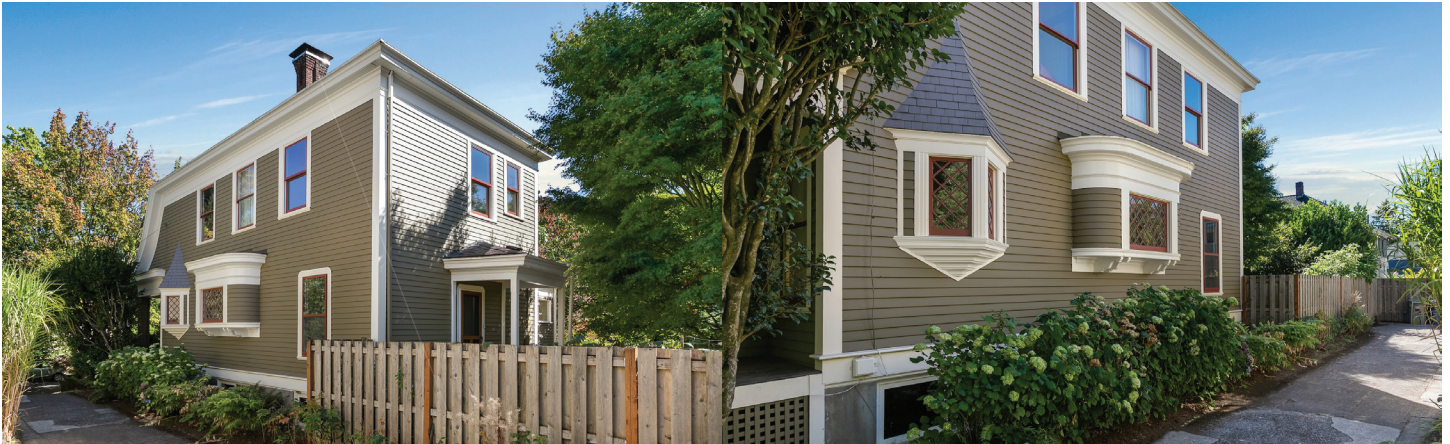
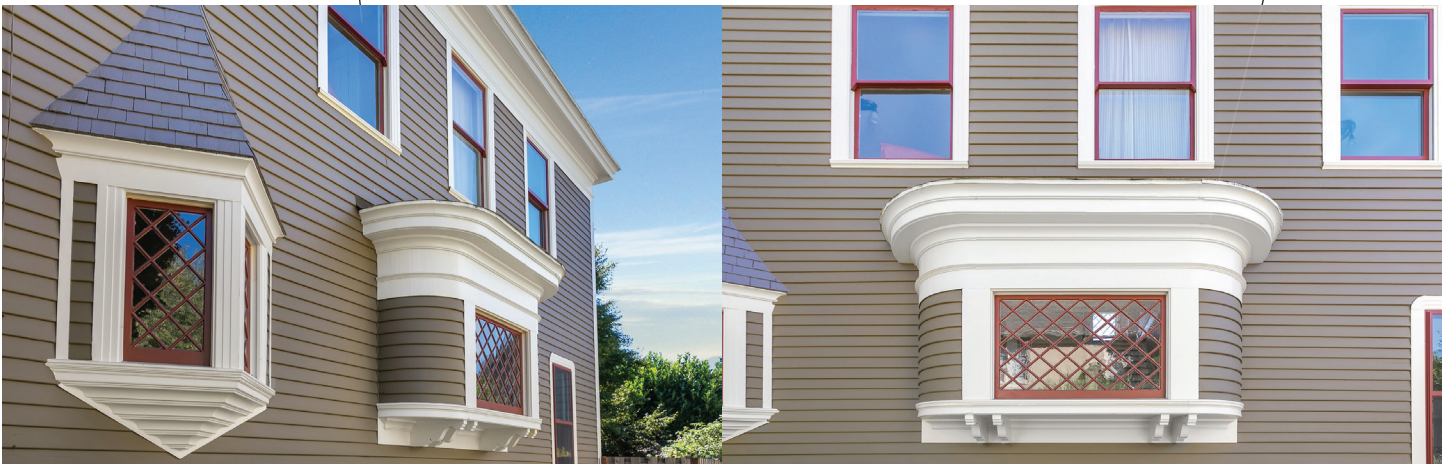
NORTH FACADE
DETAILS

All the elements are original to the house with no modifications. The north side was weather protected (for the most part) and required minimal repair work. All the paint was removed to the bare wood, then the boards were repaired and repainted.

- 1 The chimney was repaired and repainted. The cover is not original but was designed to fit the period of the house.
- 2 The windows and trim are original except the upper northwest window that had to be replaced.
- 3 The shingles on the east main floor window are original.

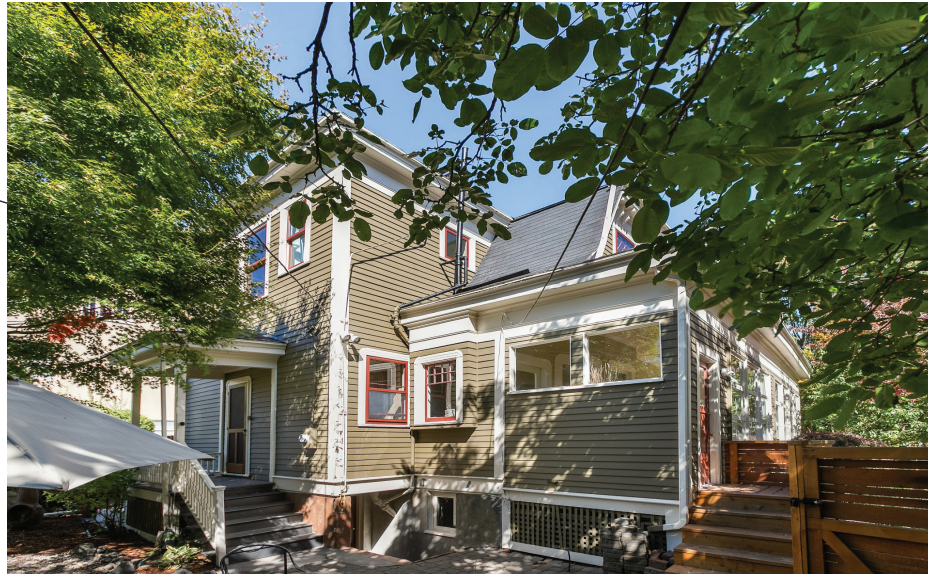
EAST FACADE

All doors and main floor and basement windows had “security” bars not original to the house which we removed.

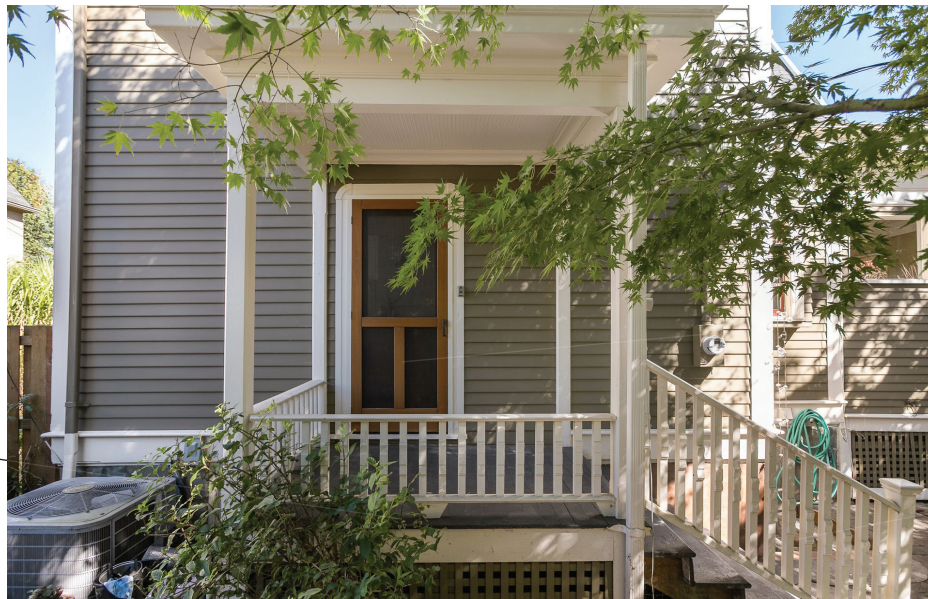
EAST PORCH

- 1 The east side of the house required significant restoration work. Some of the siding was replaced but re-milled to fit the profile of the original boards. The fascia boards required significant repair work, but are original.
- 2 The back porch pillars are all original and required very little restoration after the paint was removed.
- 3 The back porch was in very bad condition and not usable. We salvaged the tongue-and-groove floorboards, but the porch frame had to be rebuilt. The stairs, similar to the front porch, had to be replaced.
- 4 The fir back door and screen door were replaced but are period appropriate.
- 5 The railings are all original and required extensive restoration.

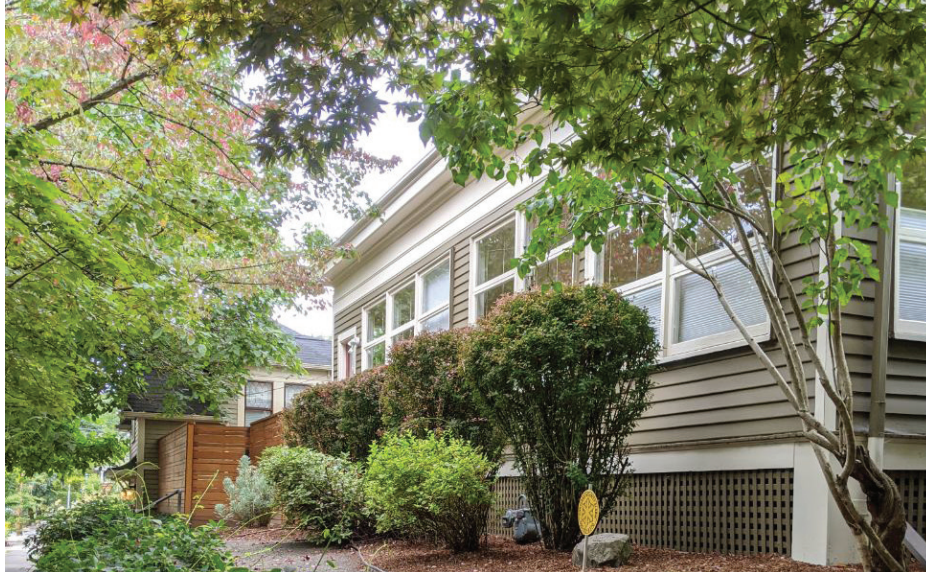
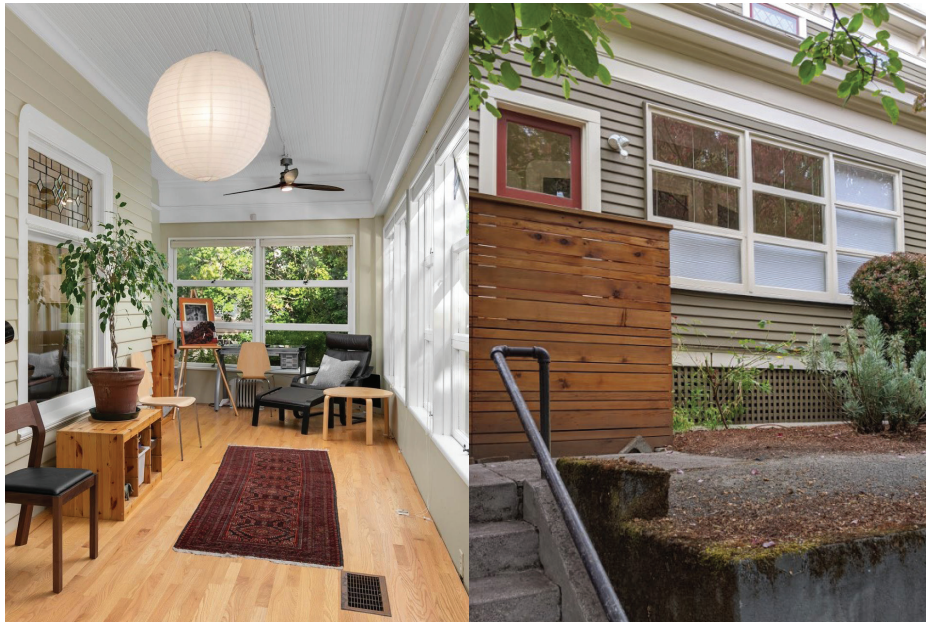
**SOUTH FACADE
DETAIL**

The one alteration from the original design is that the porch on the south side was enclosed in 1954. Windows were installed and columns removed; however, the original siding remains.

The original porch floor and various other details of the interior portion of the porch are intact. This includes the original door from the dining room to the porch with the original hardware.

The porch ceiling, roof and trim have been restored. The original floor is intact under an oak floor.

The house windows have also been restored.
