APPEAL SUMMARY

Appeal ID: 15955	Project Address: 1010 NW Flanders St
Hearing Date: 10/11/17	Appellant Name: Spencer Roedel
Case No.: B-017	Appellant Phone: 503-224-9560
Appeal Type: Building	Plans Examiner/Inspector: John Cooley
Project Type: commercial	Stories: 5 Occupancy: B, S, M, A-3 Occupied Roof Construction Type: III-A
Building/Business Name: 1010 NW Flanders	Fire Sprinklers: Yes - Throughout
Appeal Involves: Reconsideration of appeal, other: Correction of a violation	LUR or Permit Application No.: 16-192301-CO
Plan Submitted Option: pdf [File 1] [File 2] [File 3]	Proposed use: Retail and Office

Date:	October 5, 2017
To:	Fortis Construction 1705 SW Taylor Street, #200 Portland, OR 97205 Sent via email
Attention:	Luke Stillar
From:	David Gessert, P. E. Fire Protection Engineer
Subject/Project:	1010 NW Flanders Street Elevator Shaft – Clipping of Protruding Screws Fire Protection Analysis
Job No.:	2017-49

Elevator Shaft – Clipping of Protruding Screws – Fire Protection Analysis

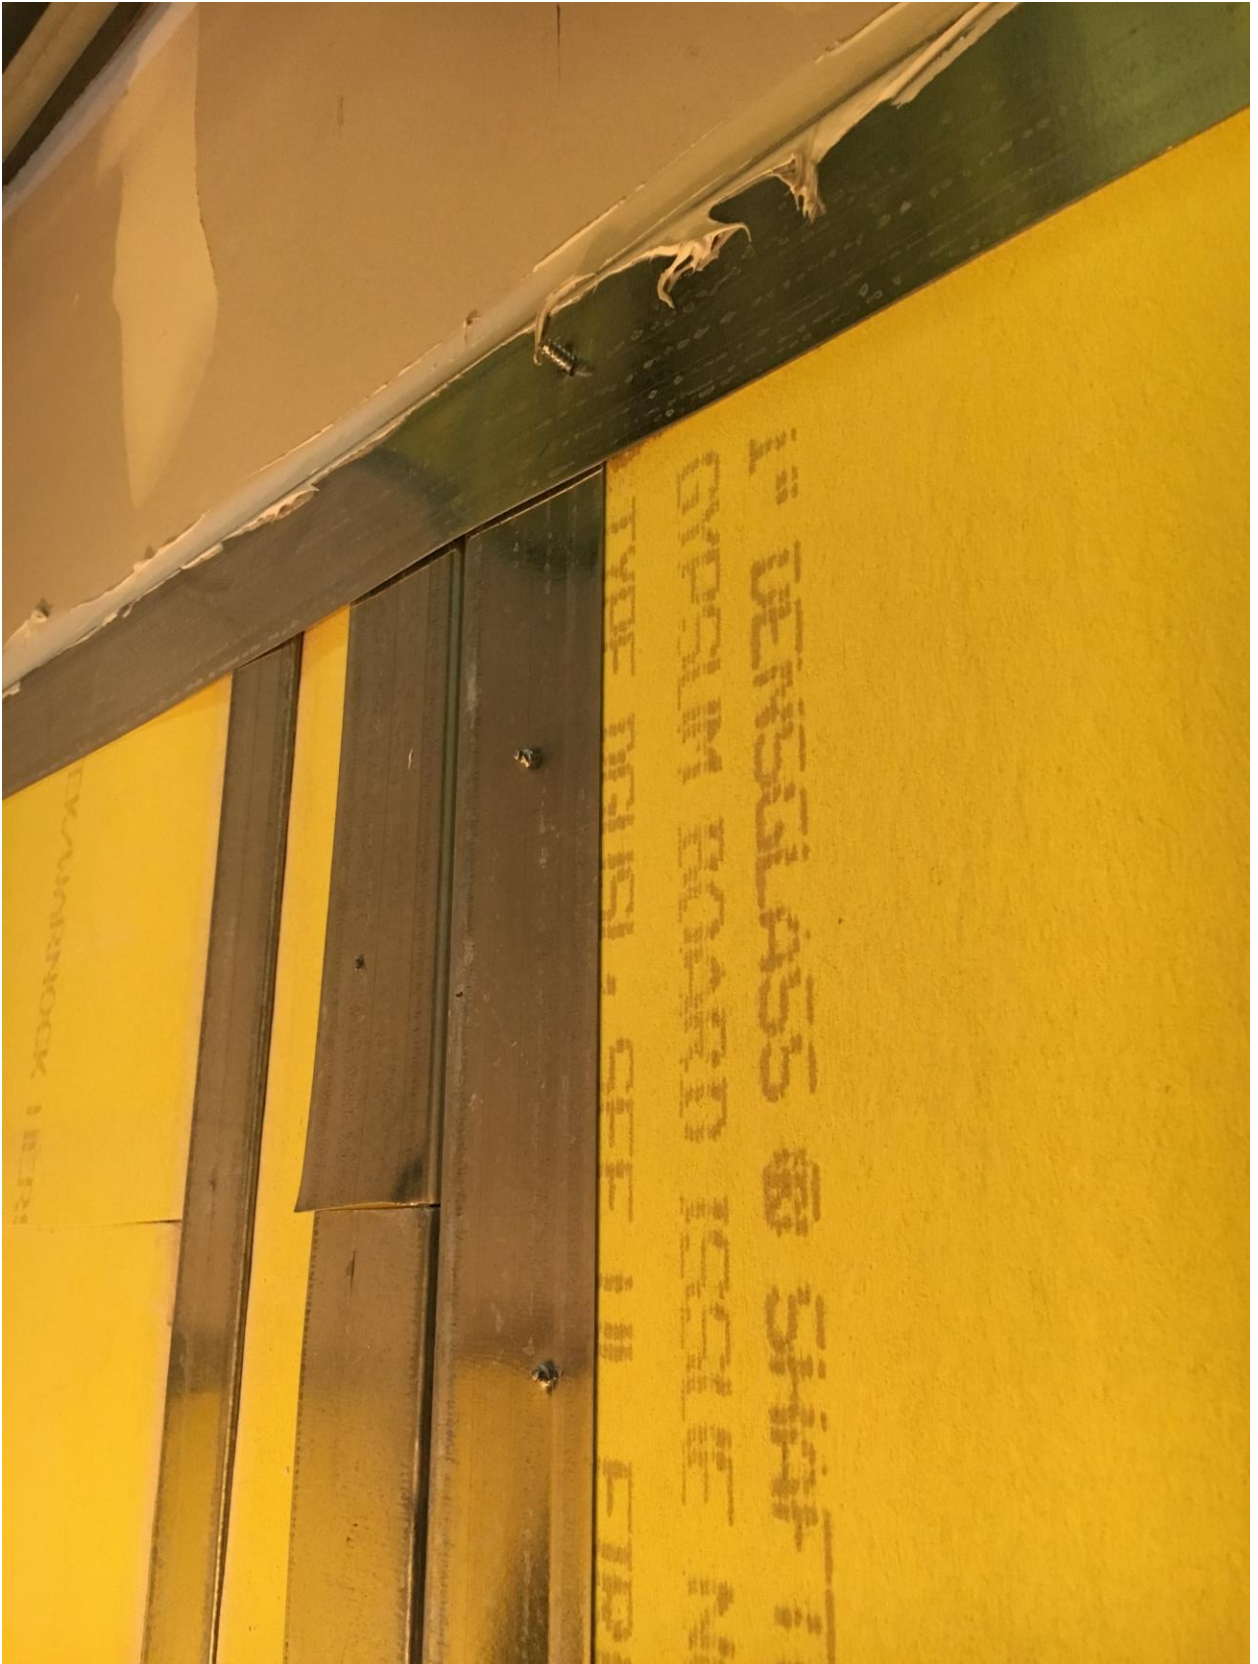
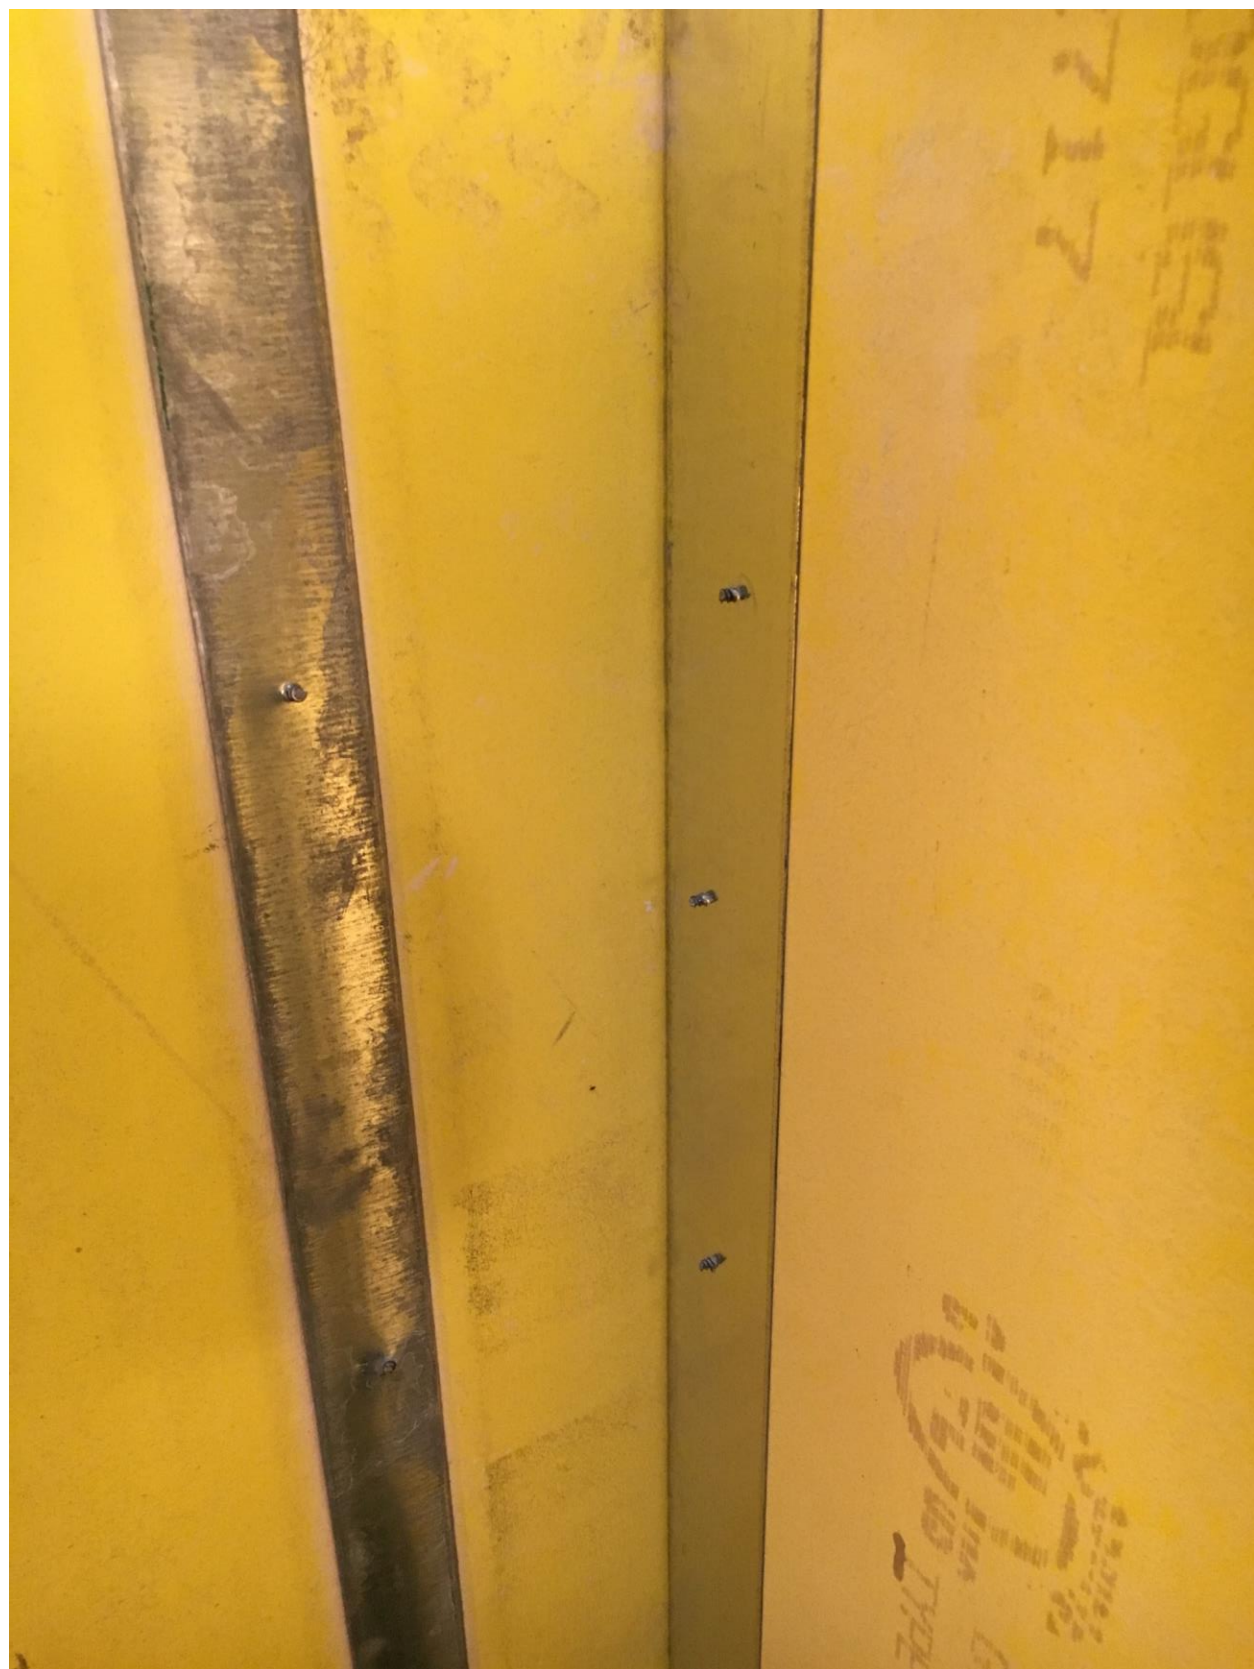
Inspection of the interior of the elevator shaft by the General showed at least 80 percent of the screws protruding into the elevator shaft had at least one or more full threads showing on the screws protruding into the elevator shaft. In failure mode a gypsum board screw can break or pull (or push) through the gypsum board/steel framing. If the screw breaks it is immaterial if the pointed end of the screw is clipped off. If the screw is pulled (or pushed) through the gypsum board and/or steel framing more than one thread showing protruding will have no impact on the shaft wall performing its design goal. Said differently once a screw has either been stripped of its threads or has pulled (or pushed) through the surrounding material additional threads protruding into the elevator shaft would make no difference on the outcome.
