5020 SE 38<sup>th</sup> Ave. 10/5/2022

## Tree Preservation Plan for 5020 SE 38th Ave.

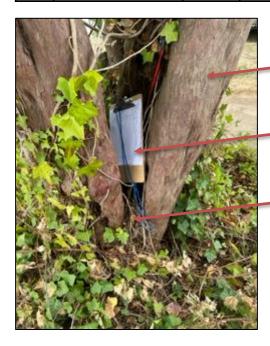
## Tree #9 Pacific yew

The five non-native, Deodar cedar trees are growing from a sort of nurse log. I believe they were originally branches from a fallen tree that have morphed into trees themselves. These, along with the Pacific yew will be removed. The lower trunk of the Pacific yew has split and decayed, and there is an imminent danger that the larger portion will peel off and fall into the street, sidewalk and communication lines to the south. The tree appears to be growing on the property line. shared with the City right-of-way. This makes it imperative that the City Forester is involved with the removal decision.

This half of the tree leans into the street, communication lines and sidewalk.

17-inch clipboard in the split trunk.

The split in the trunk extends to grade and beyond.

The tree is replete with dead and dying branches and foliage.

The healthy green seen here is the notorious English ivy.

This is the larger part of the tree, splitting off towards street.
