THE PORTLAND BUILDING RECONSTRUCTION PROJECT

Type III Historic Resource Review

June 26, 2017
LU 17-153413 HR

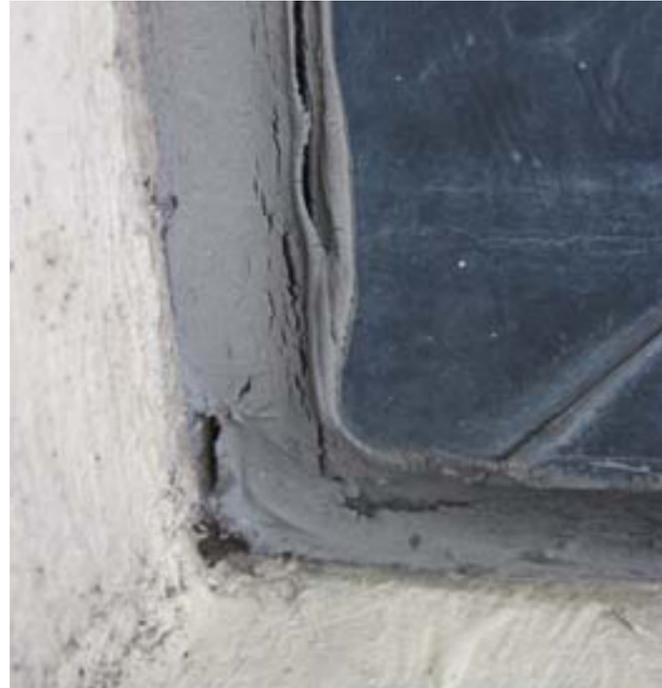
Failed sealant at punched window perimeter joint

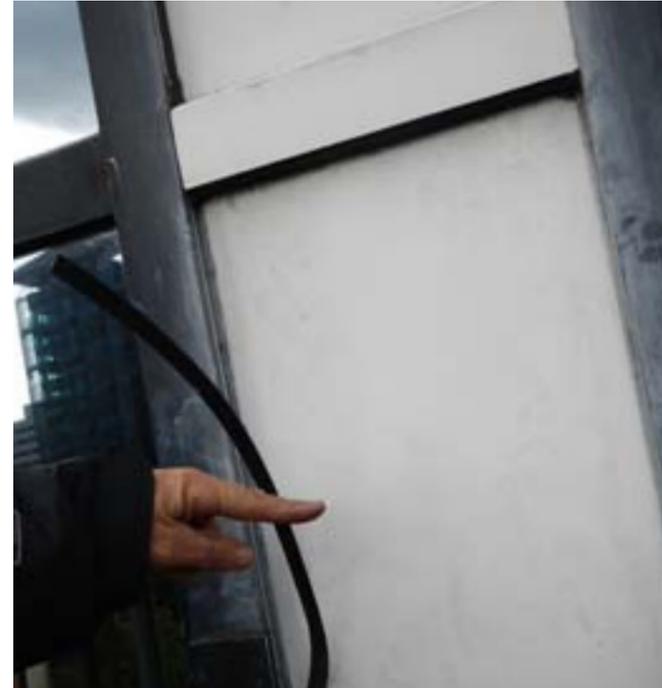
Failed gaskets at curtainwall system

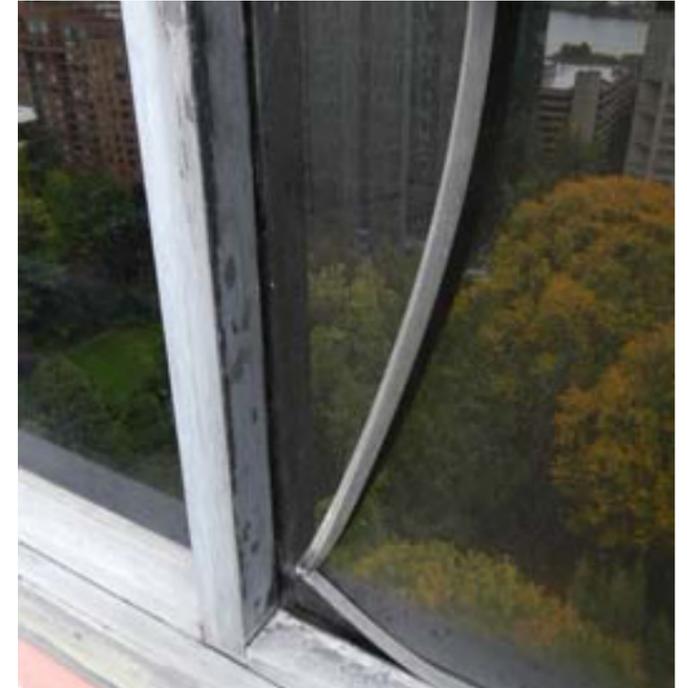
Failed gaskets and oxidized finish at ribbon window frames

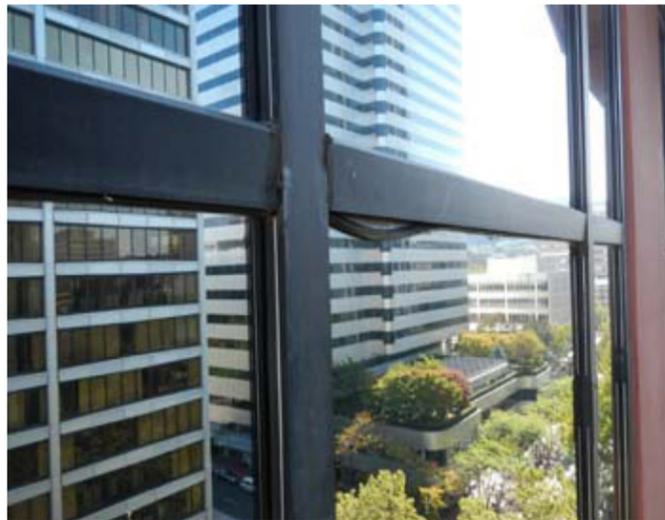
Failed gasket and displaced pressure plate/cap at curtainwall

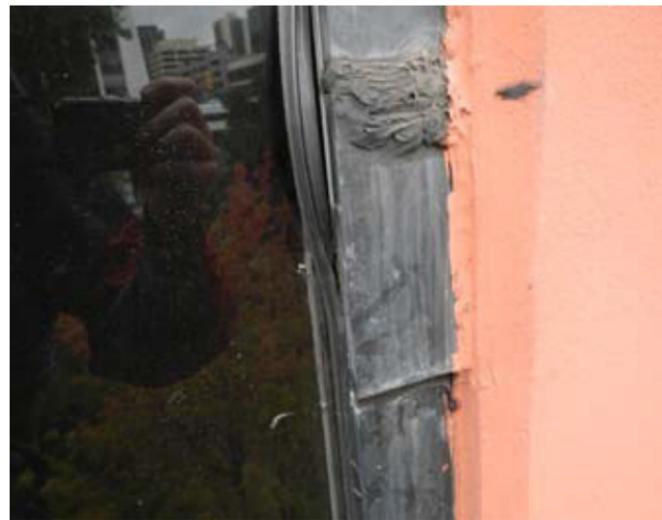
Failed movement splice connection at curtainwall jamb

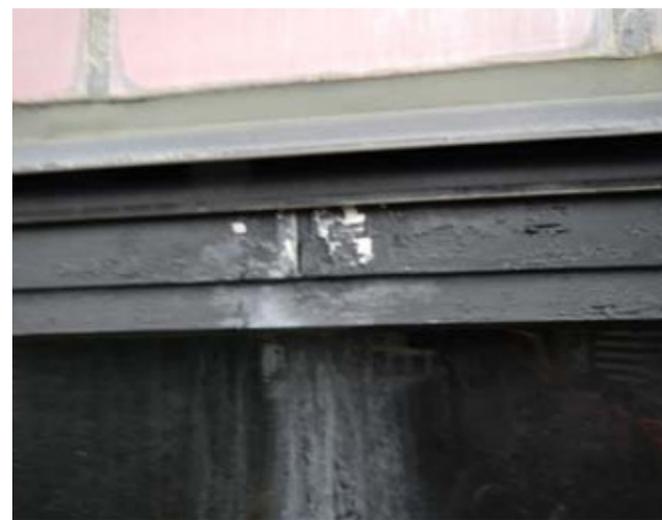
Failed metal finish at ribbon window head

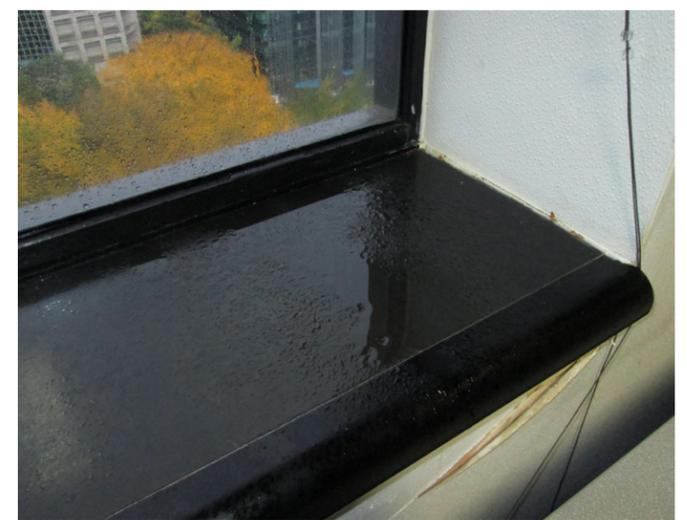
Water infiltration at 14th floor ribbon window

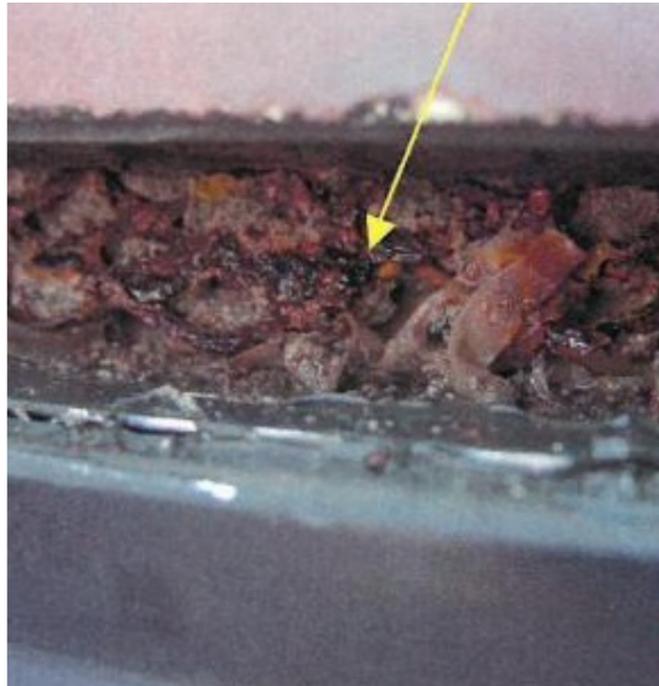
Rusting metal lath expanding behind tile system

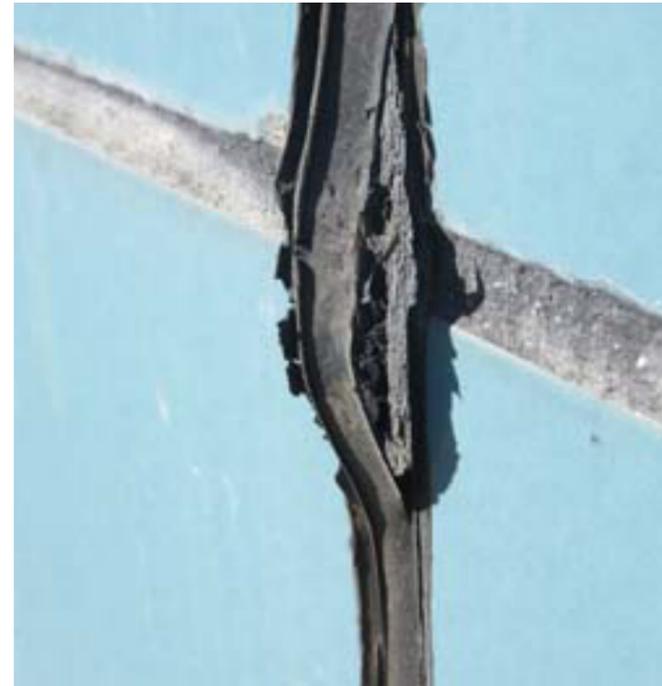
Failed sealant at tile system control joint

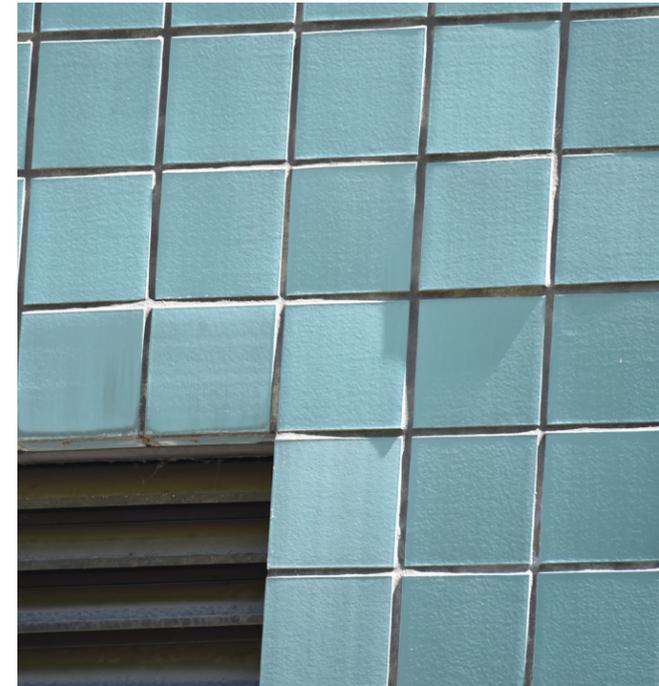
Out of plane tiles potentially delaminated from wall

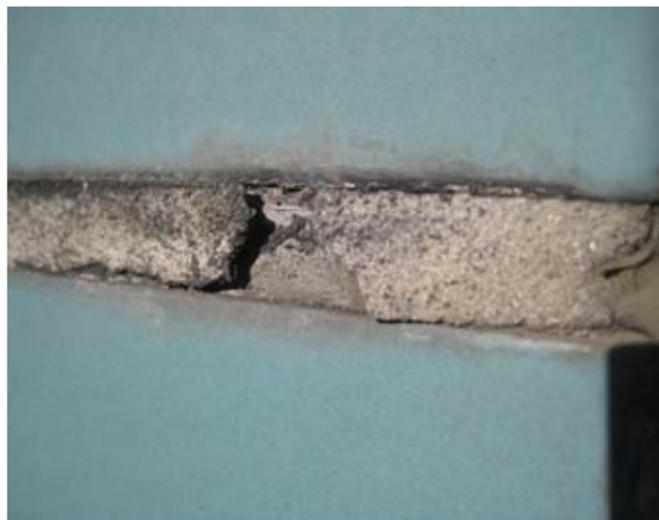
Failed grout in joint/efflorescence

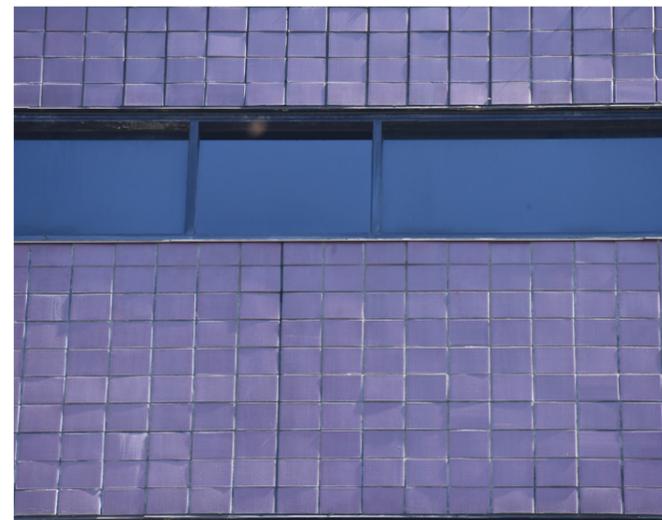
Out of plane tiles potentially delaminated from wall

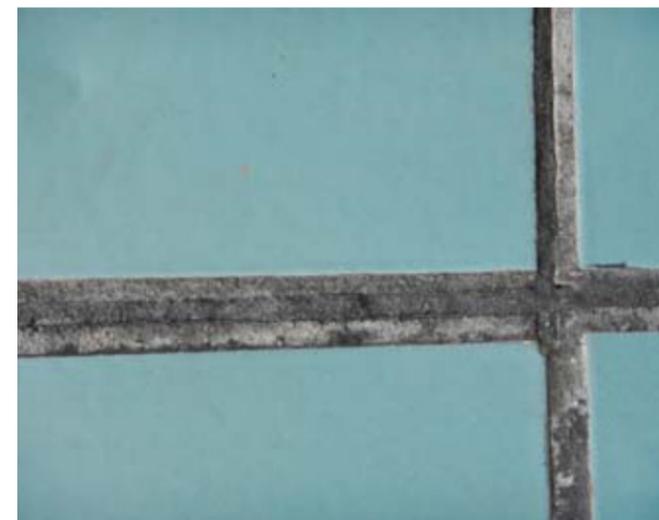
Seams in improperly repointed grout

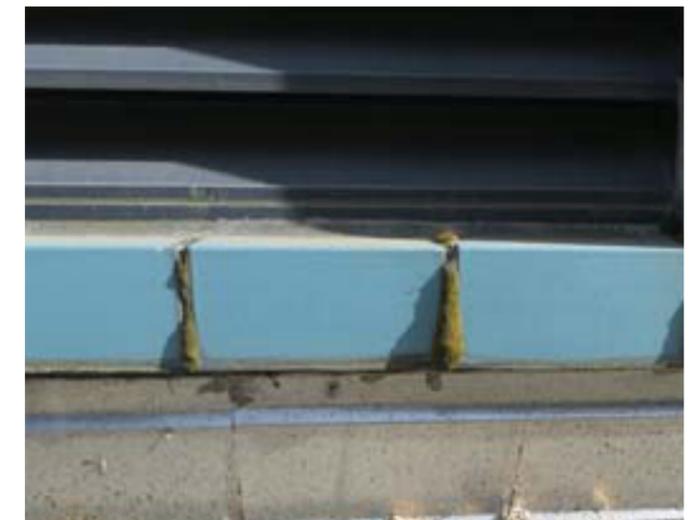
Biological growth at grout in joints

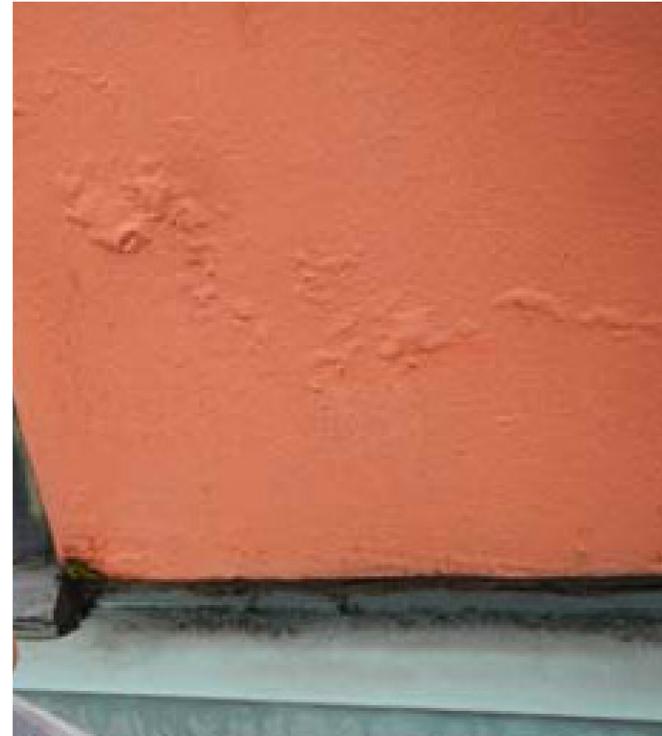
- Failed elastomeric coating - In many areas, the elastomeric paint (which is the concrete's primary defense from water) has been compromised, allowing water to become trapped behind the paint.
- Spalling concrete - Areas where moisture has infiltrated the coating has forced some patches of the concrete to spall.
- Condensation - The concrete wall has little resistance to exterior thermal conditions. The interior side of the mass wall frequently develops condensation which is then trapped within the furring wall. This creates an ideal environment for microbial and fungal growth within the furring cavity.

Bubbling at elastomeric paint

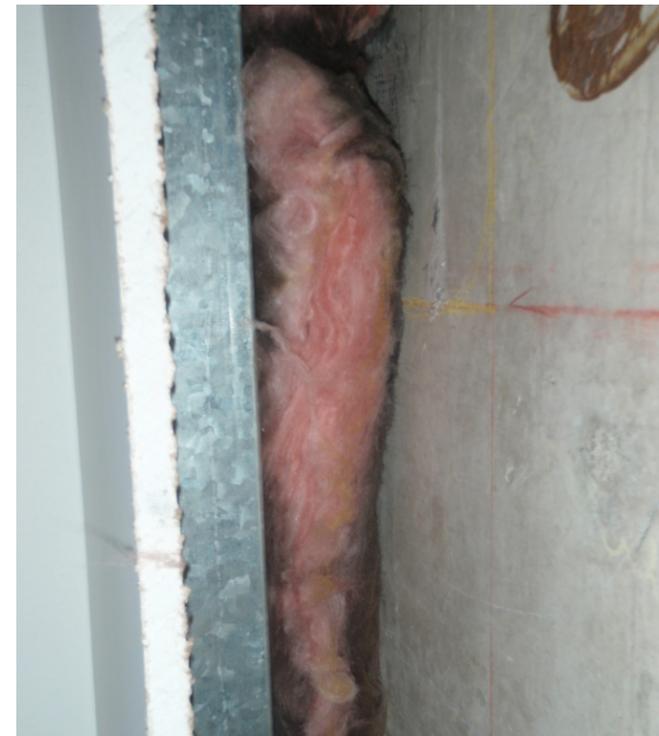
Insulation discolored by moisture from air or water infiltration

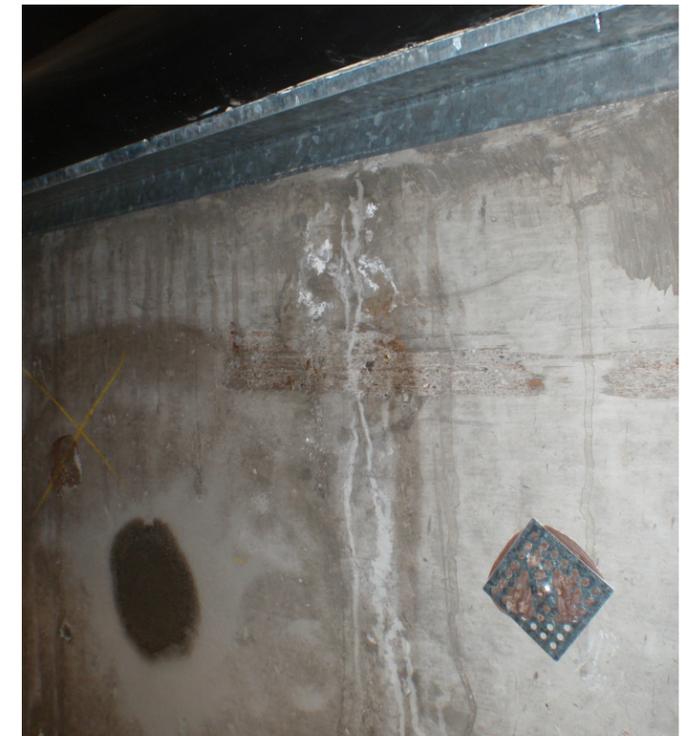
Water staining on interior side of concrete wall

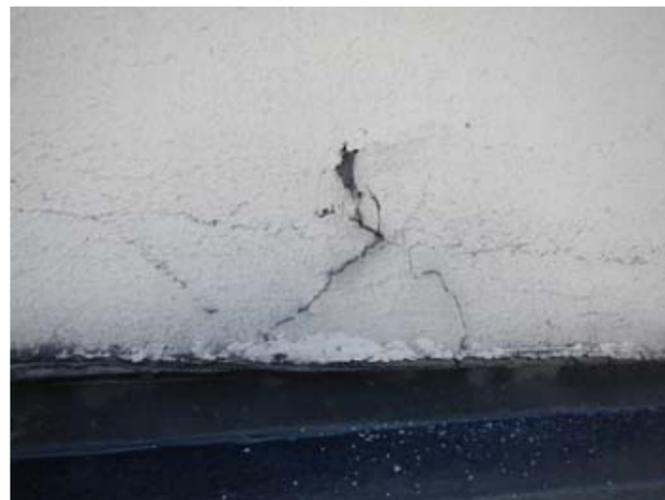
Cracking at exterior side of concrete wall

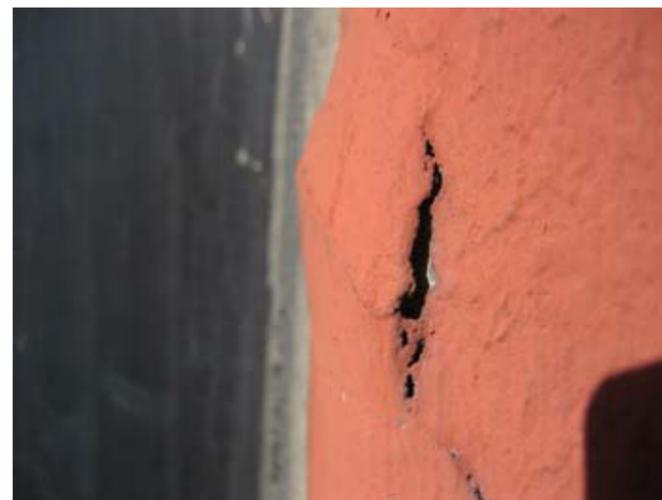
Failed elastomeric paint and loose concrete edge

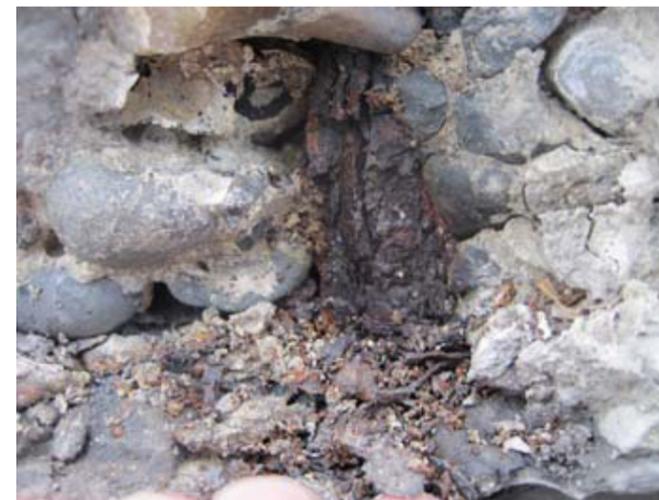
Spall and rusted reinforcing at exterior concrete wall

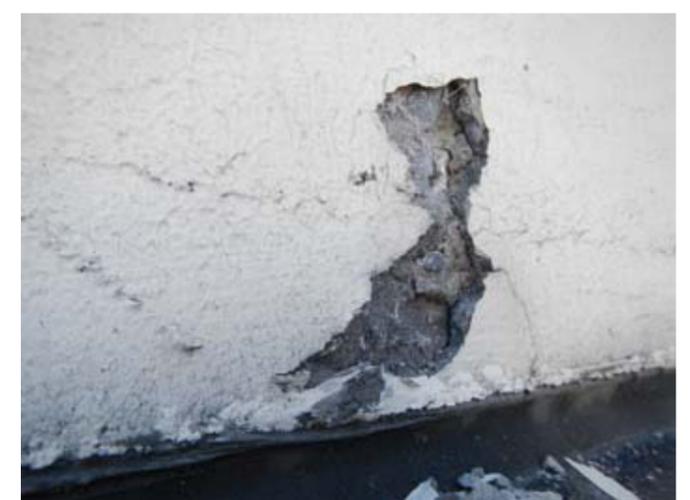
Spall at exterior side of concrete wall

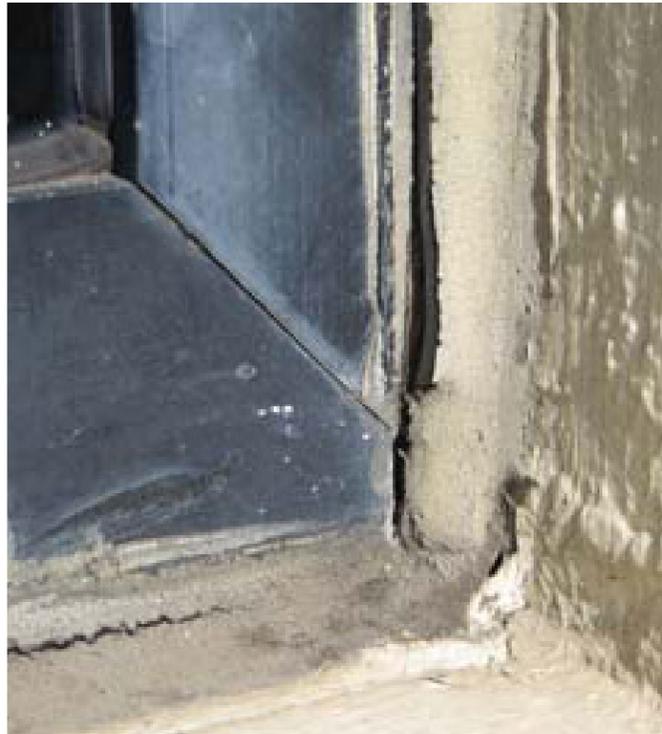
Adhesive and cohesive sealant failure

- Failed sealant joints - Existing sealant materials are experiencing both adhesive and cohesive failures.
- Improper sealant applications - In many instances, joint repair/maintenance was done by applying new sealant over existing sealant rather than removing it and doing proper surface preparation.
- Sealants applied to weeps - In many locations within the curtainwall assemblies and in some tile transitions, the few system weep holes that are existing have been covered with sealant, exacerbating the water issues.

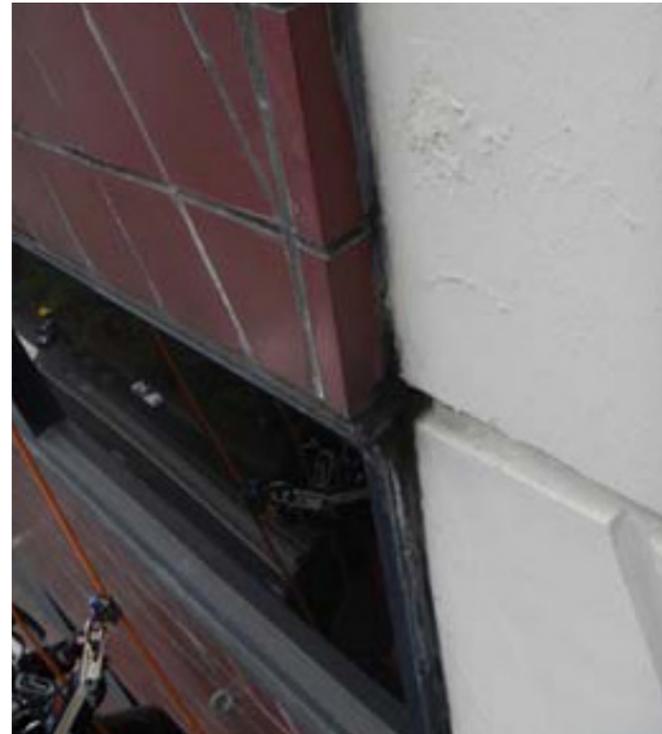
Weather tightness of transition dependent on sealant

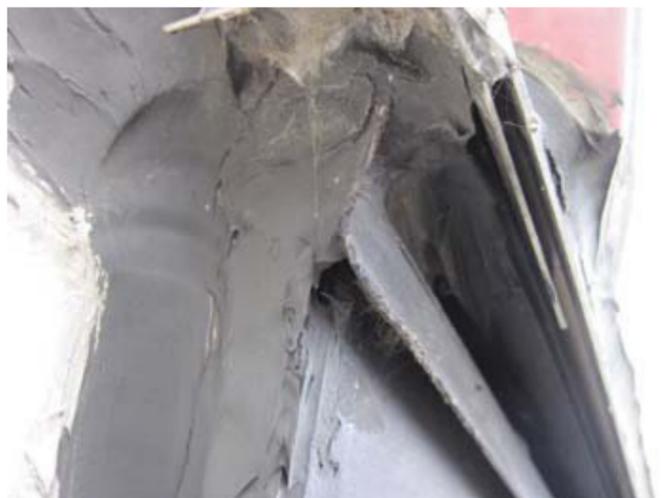
Multiple layers of sealant applications

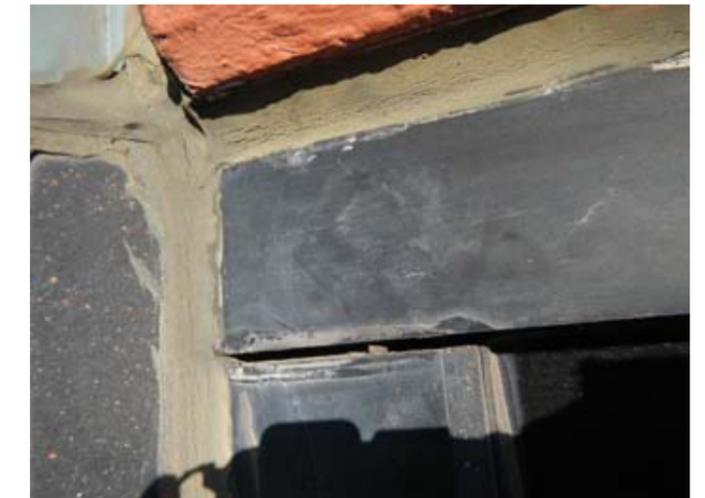
Complex material transition joints dependent on sealant

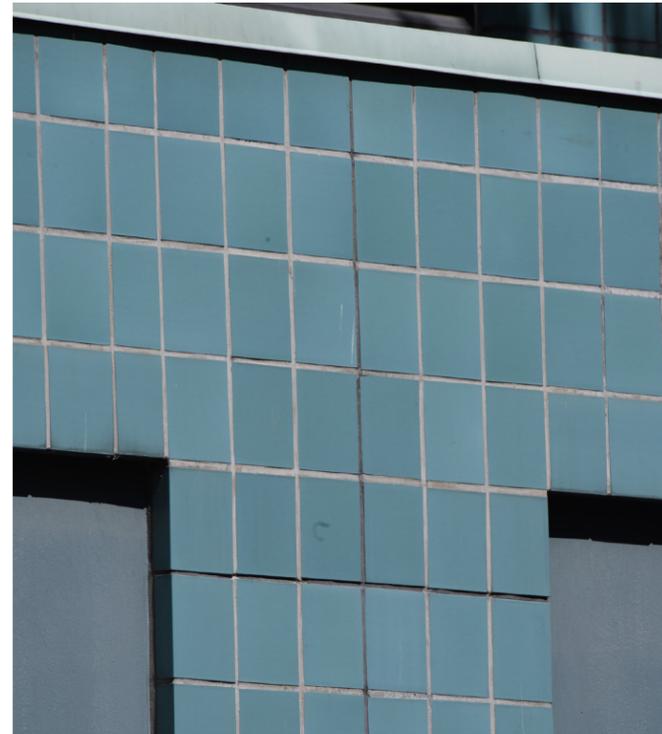
- Irregular grout joint size - The existing grout joints vary from less than 1/2" to over 1" in width. Wide grout joints are more susceptible to shrinking and cracking.
- Tiles cut for size/shape - Tiles were frequently cut down in areas where openings or other features were intended to align with the tile module. While there are some tiles that were fabricated for specialty conditions like corners, there are many instances where field tiles were cut instead. This resulted in conditions where tile bisque is exposed to the elements and/or grout joints are irregular in width.
- Alignment - There appears to be a design intent to align window systems with the reveal pattern, however this alignment is irregular with some elements occurring at the reveal and others below the reveal. These conditions exist at most curtainwall/ribbon window locations.

Tiles cut to different widths to maintain alignment

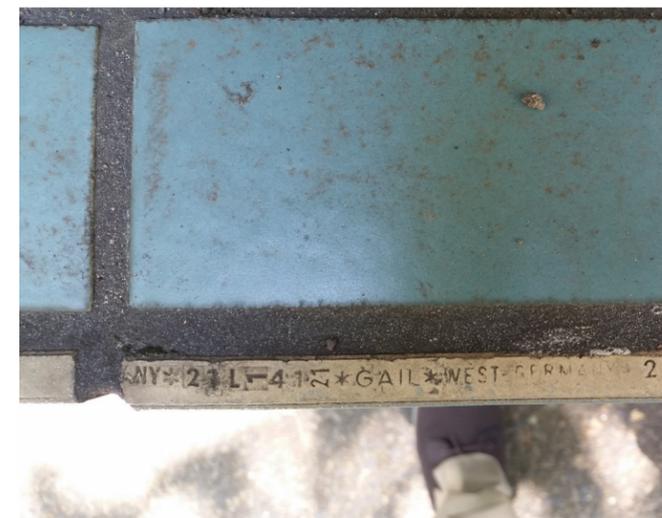
Field tiles modified for a corner condition

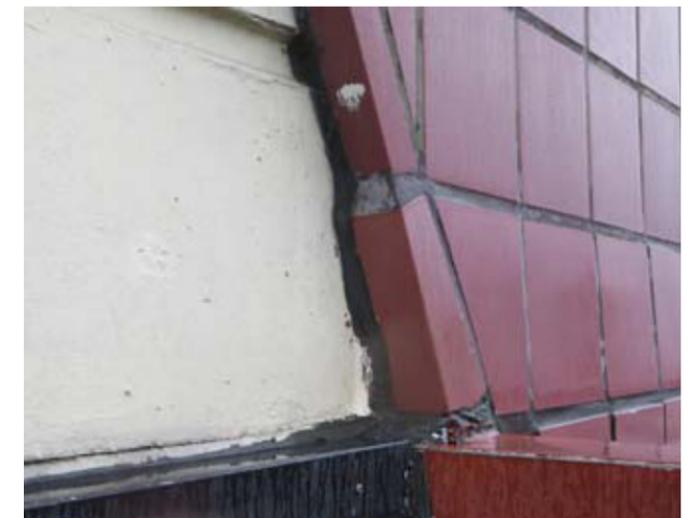
Modified tiles at keystone with irregular joints/alignment
