## TEMPORARY ACCESS EASEMENT

## Luther Road Habitat Restoration Project

**Subject:** Geotechnical Services  
**Project:** SE 73<sup>rd</sup> Avenue Pavement Evaluation  
Luther Road Habitat Restoration Project  
Foundation Engineering Project Number 2142007 Phase 201  
City of Portland Work Center Code and Project No. E06947.D14

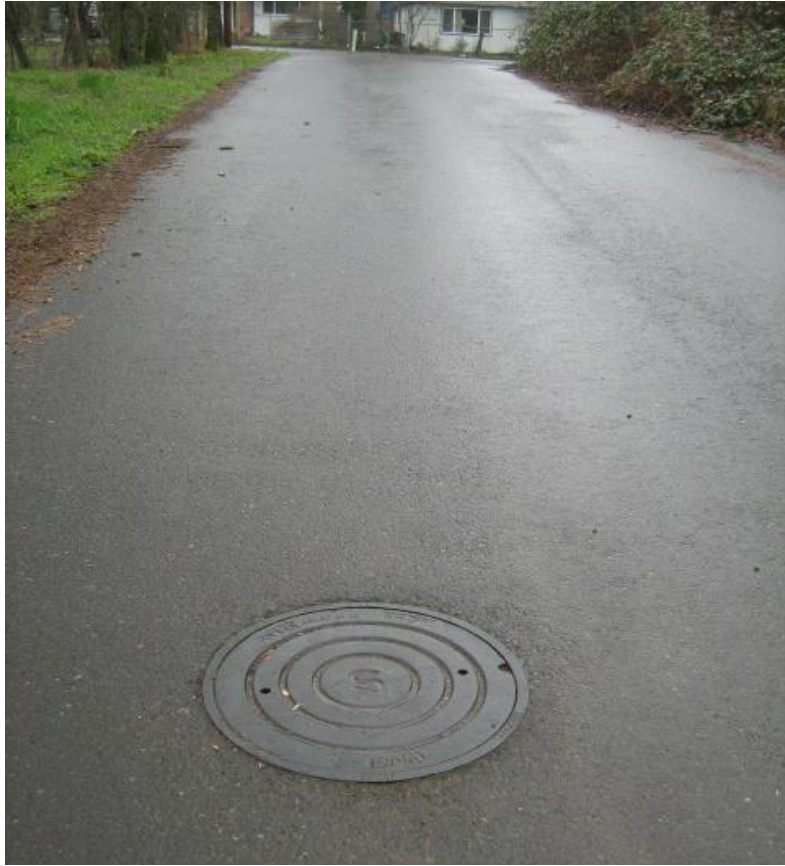
FEI performed a reconnaissance of the site and observed the condition of the AC to consist of two isolated pavement depressions in front of the residence at 8900 SE 73<sup>rd</sup> Avenue. These depressions were  $\pm 8$ -inches in diameter and  $\pm \frac{1}{4}$  inch deep. No other surface cracking or pavement distress was observed. We also observed a  $\pm 75$ -foot long section of the roadway AC that appeared to be a patch. It is located  $\pm 100$  feet north of the residence at 8900 SE 73<sup>rd</sup> Avenue.

**Photo 1: Pre-construction condition of SE 73<sup>rd</sup> Avenue on March 2, 2014.**

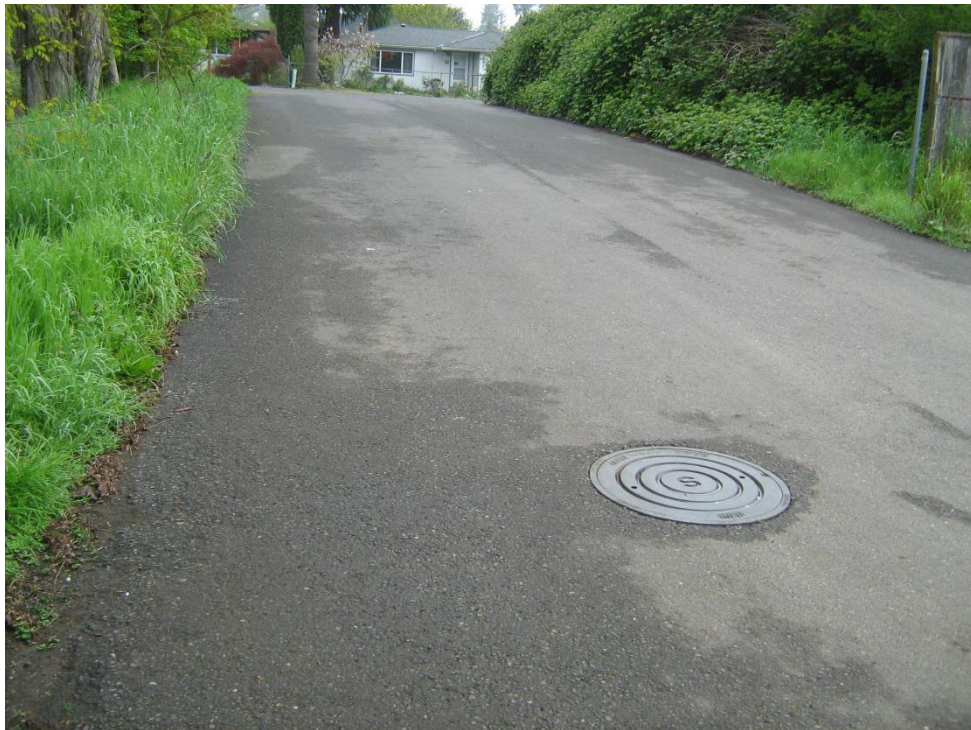
We observed the pavement condition on SE 73<sup>rd</sup> Avenue from SE Luther Road  $\pm 400$  feet south to the entrance to the project site. Severe cracking and some pavement deflection was observed in a  $\pm 3$  by 5-foot area near the edge of the roadway at the site entrance. Minor to moderate asphaltic concrete (A.C.) stripping was observed on the west and east sides of the roadway near the anticipated location of construction traffic wheel loads. Some very minor pavement cracking was also observed at the intersection with SE Luther Road at the locations of truck traffic wheel loads.

Outside of the area mentioned above, we did not observe severe cracking consistent with pavement failure. Minor to severe deflections and rutting of the pavement surface were not observed. From a comparison with our pre-construction observations, the post-construction condition of the pavement appeared to show some additional A.C. stripping and one isolated area of failure, but otherwise no other impacts. Photographs of the pavement condition pre and post-construction are attached.

**Photo 2: Post-construction condition of 73<sup>rd</sup> Avenue on April 9, 2015.**

Therefore, to restore the design life, we recommend a grind and overlay from the project site, north to SE Luther Road, and reconstruction of the failed pavement area observed at the project entrance. Based on our observations that most of the impact of construction traffic was isolated to A.C. stripping, it is our opinion that a grind and  $\pm 2$  inch overlay will substantially restore the pavement to the pre-construction service life.

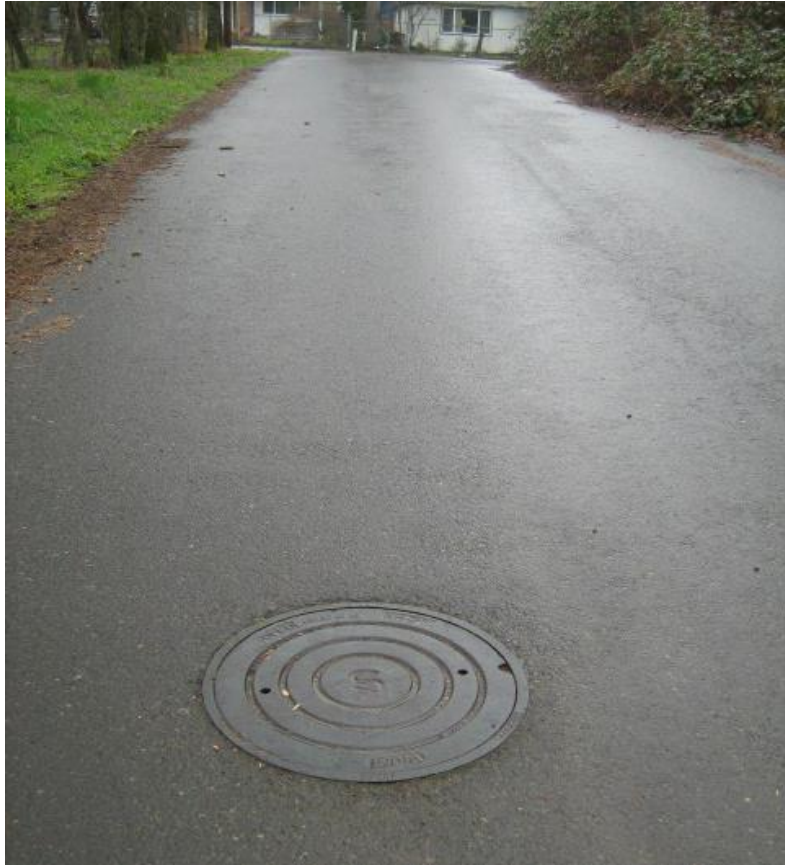
FEI performed a reconnaissance of the site and observed the condition of the AC to consist of two isolated pavement depressions in front of the residence at 8900 SE 73<sup>rd</sup> Avenue. These depressions were  $\pm 8$ -inches in diameter and  $\pm \frac{1}{4}$  inch deep. No other surface cracking or pavement distress was observed. We also observed a  $\pm 75$ -foot long section of the roadway AC that appeared to be a patch. It is located  $\pm 100$  feet north of the residence at 8900 SE 73<sup>rd</sup> Avenue.

**Photo 1: Pre-construction condition of SE 73<sup>rd</sup> Avenue on March 2, 2014.**

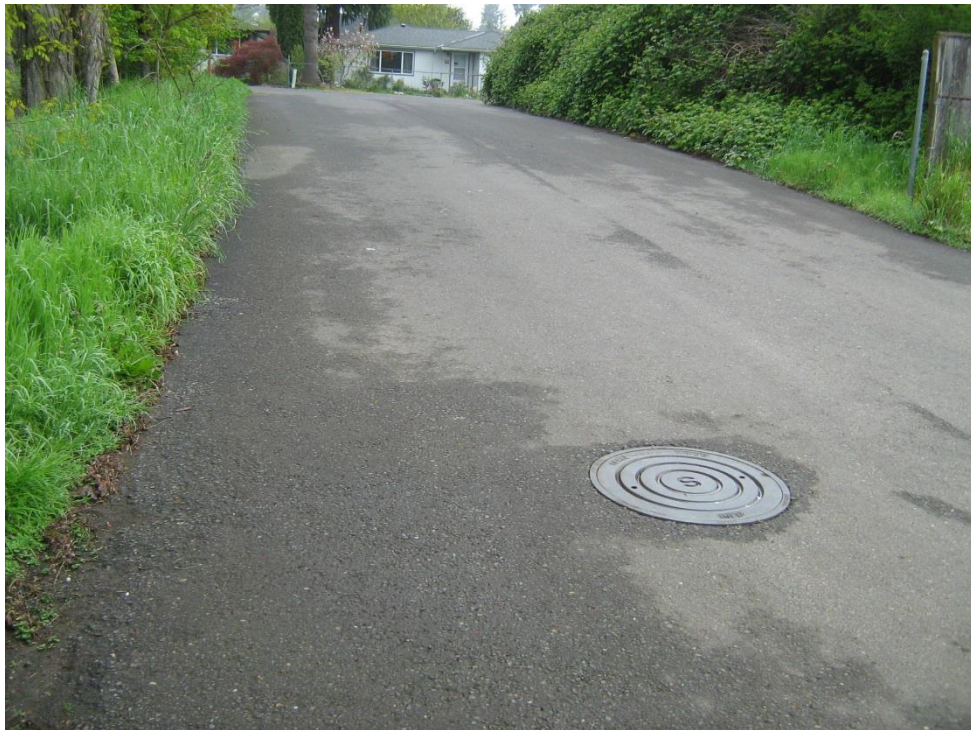
We observed the pavement condition on SE 73<sup>rd</sup> Avenue from SE Luther Road  $\pm 400$  feet south to the entrance to the project site. Severe cracking and some pavement deflection was observed in a  $\pm 3$  by 5-foot area near the edge of the roadway at the site entrance. Minor to moderate asphaltic concrete (A.C.) stripping was observed on the west and east sides of the roadway near the anticipated location of construction traffic wheel loads. Some very minor pavement cracking was also observed at the intersection with SE Luther Road at the locations of truck traffic wheel loads.

Outside of the area mentioned above, we did not observe severe cracking consistent with pavement failure. Minor to severe deflections and rutting of the pavement surface were not observed. From a comparison with our pre-construction observations, the post-construction condition of the pavement appeared to show some additional A.C. stripping and one isolated area of failure, but otherwise no other impacts. Photographs of the pavement condition pre and post-construction are attached.

**Photo 2: Post-construction condition of 73<sup>rd</sup> Avenue on April 9, 2015.**

Therefore, to restore the design life, we recommend a grind and overlay from the project site, north to SE Luther Road, and reconstruction of the failed pavement area observed at the project entrance. Based on our observations that most of the impact of construction traffic was isolated to A.C. stripping, it is our opinion that a grind and  $\pm 2$  inch overlay will substantially restore the pavement to the pre-construction service life.
