WOODLAWN NEIGHBORHOOD DEVELOPMENT PROJECT

PROPERTY IDENTIFICATION

PARCEL NO. 6-11 ADDRESS 1135 N. E. Woodlawn Street

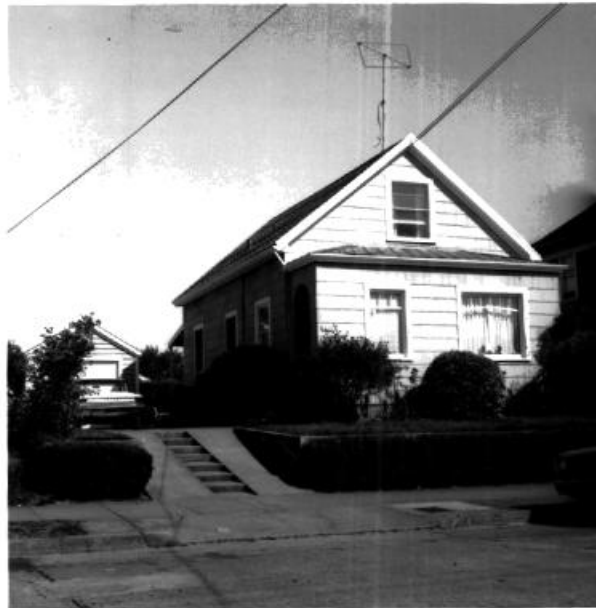
The entire property is in very good condition.

Subject is a 50'x100' lot, 2 feet above street grade; all public utilities connected; concrete street, concrete curbs, concrete wks, concrete retaining wall, concrete driveway, steps in very good condition; good lawn; good shrubs; covered and open patio area at the rear; attractive rear yard, lawn and hedge.

Improvements include a 1-story and attic frame dwelling built in 1903. It has fairly new asbestos shake siding, new composition roof, new galvanized iron gutters and downspouts. There is a recessed entryway, a storm door, a new hardwood hollow-core door.
